REPORT NO. 3317
CHICAGO AND NORTH WESTERN RAILWAY COMPANY
IN RE ACCIDENT
NEAR WITTENBERG, WIS., ON
APRIL 14, 1950

Kind of accident: Head-end collision

Accident near Wittenberg, Wis., on April 14, 1950,
caused by an inferior train occupying the main
track on the time of an opposing superior train
without flag protection.

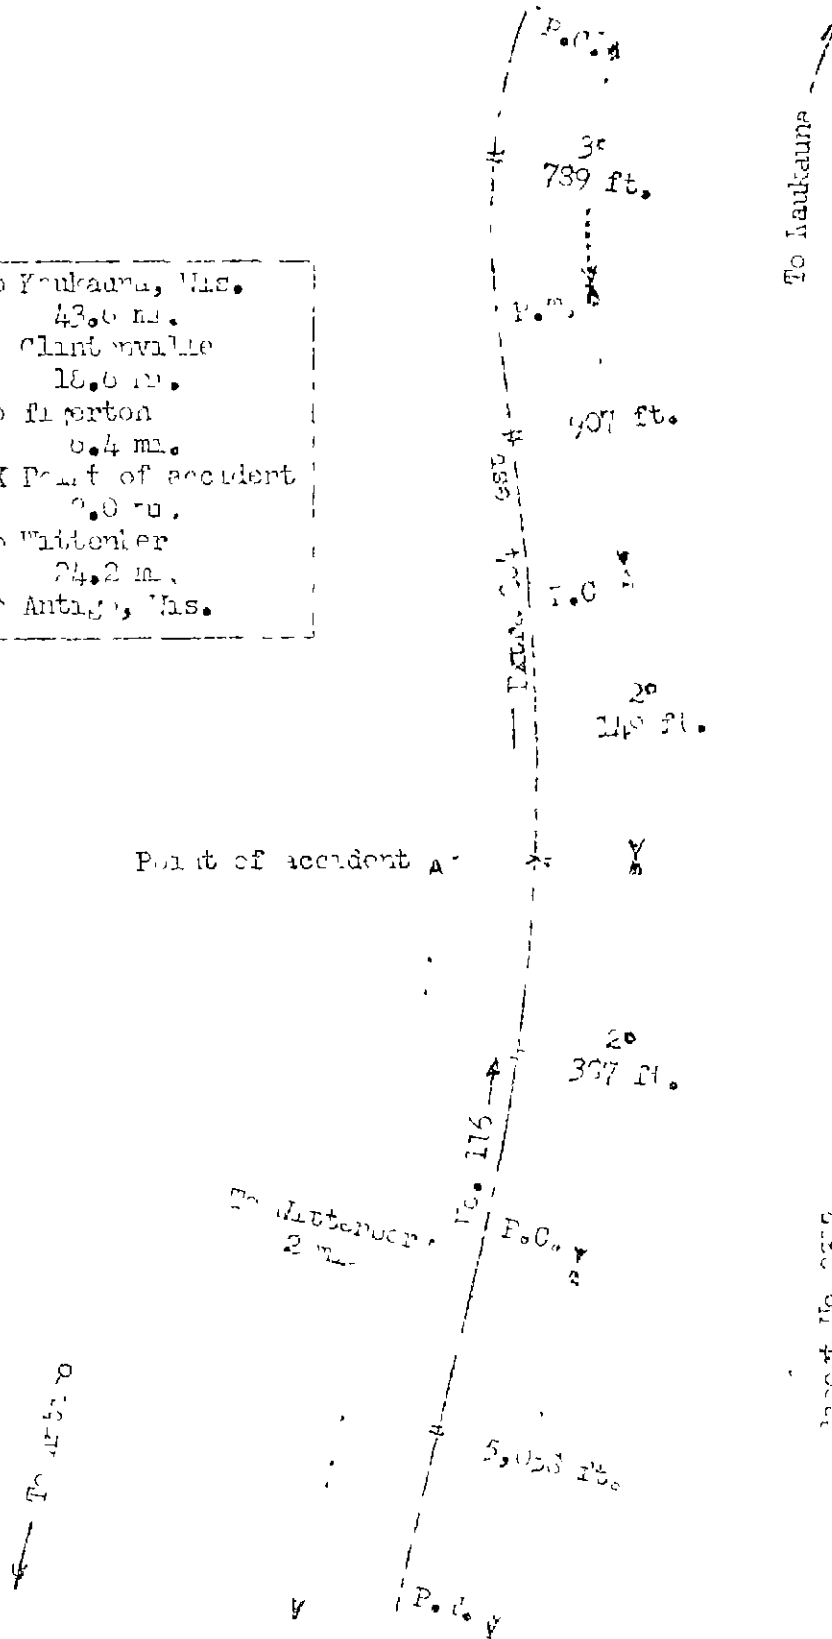
Report No. 2317
 Chicago and North Western Railway
 File No. 25, 118.
 April 14, 1950

o Youkauna, Wis.	43.6 m.
o Clintonville	18.6 m.
o Wittenber	6.4 m.
X Point of accident	0.0 m.
o Wittenber	24.2 m.
o Antago, Wis.
