REPORT NO. 3681
CHICAGO AND NORTH WESTERN RAILWAY COMPANY
IN RE ACCIDENT
AT BALATON, MINN., ON
MARCH 11, 1956

Accident at Balaton, Minn., on March 11, 1956, caused by failure to provide adequate protection for the preceding train.

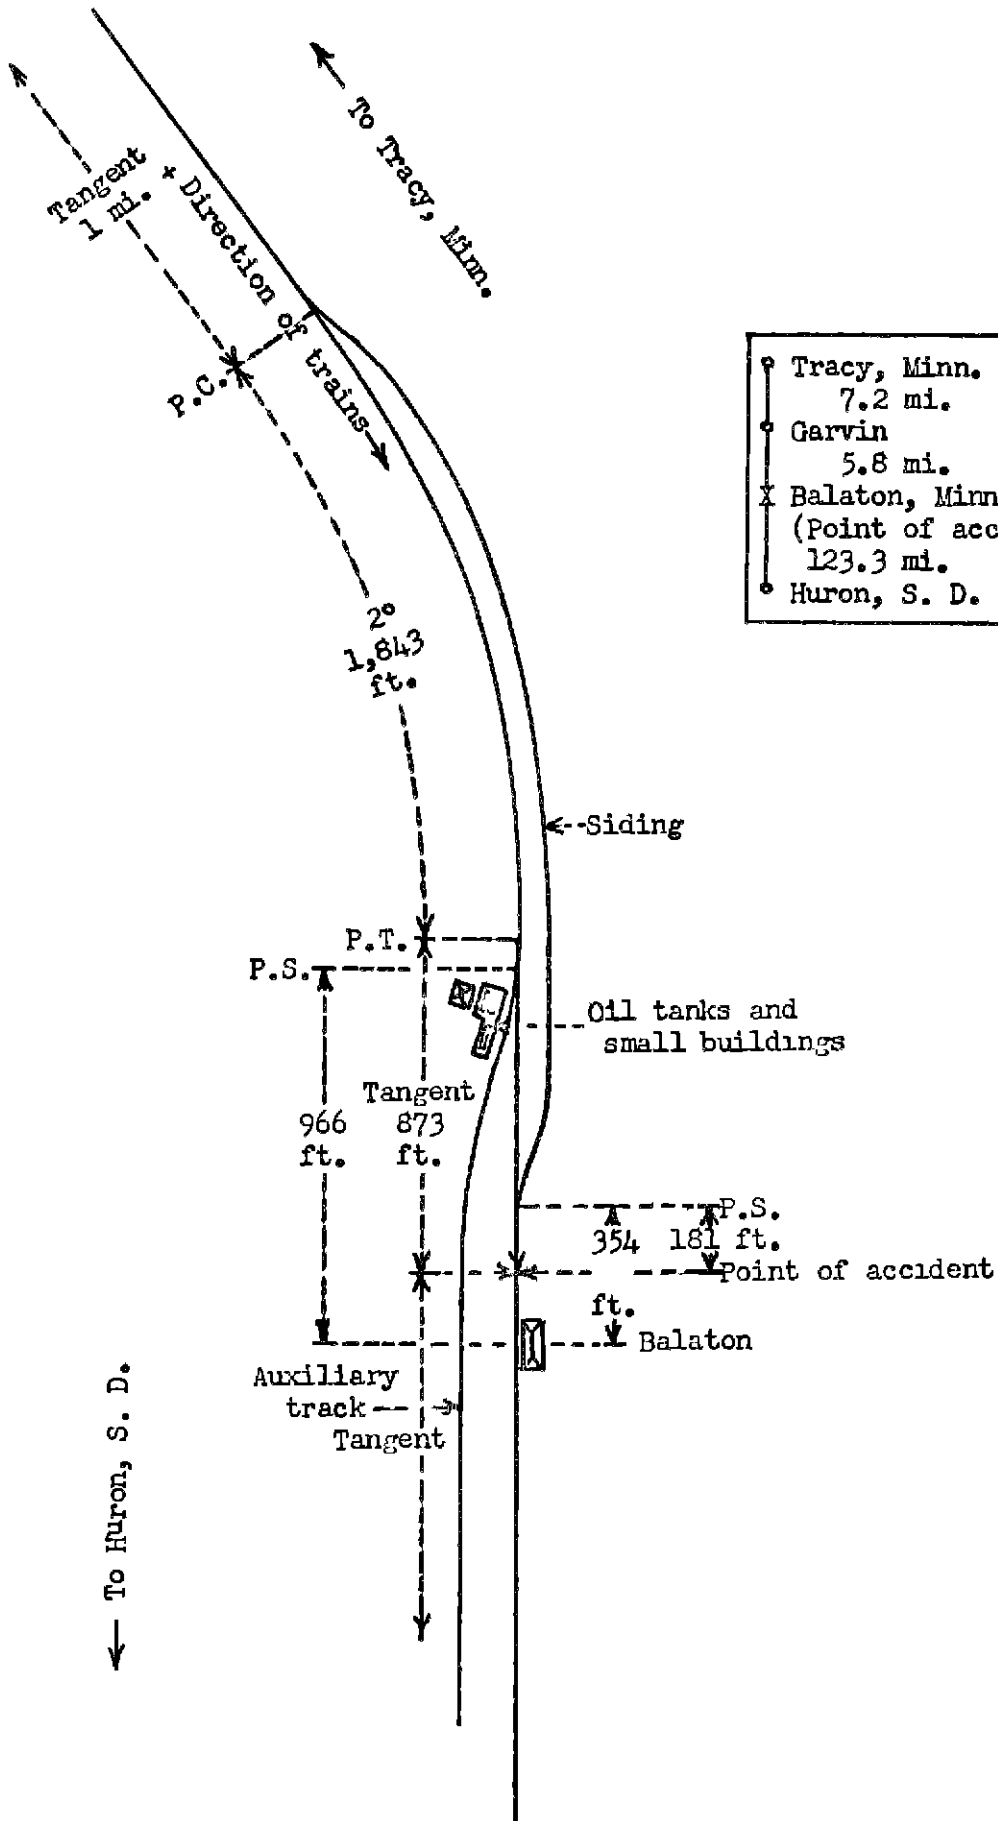
Report No. 3681
 Chicago and North Western Railway
 Balaton, Minn.
 March 11, 1956

○	Tracy, Minn.	7.2 mi.
○	Garvin	5.8 mi.
X	Balaton, Minn.	(Point of accident)
		123.3 mi.
○	Huron, S. D.

Location of Accident and Method of Operation

As a west-bound train moves on the curve east of the station at Balaton the enginemen's view of the track in the vicinity of the station is restricted by several oil tanks and small buildings located approximately 150 feet west of the auxiliary-track switch and 30 feet north of the main track. In observations made after the accident occurred it was found that an object at the point of accident is visible throughout a maximum distance of 1,455 feet immediately east of that point.
