RAILROAD ACCIDENT INVESTIGATION

Report No 3799

CHICAGO AND NORTH WESTERN RAILWAY COMPANY

CARY, ILL

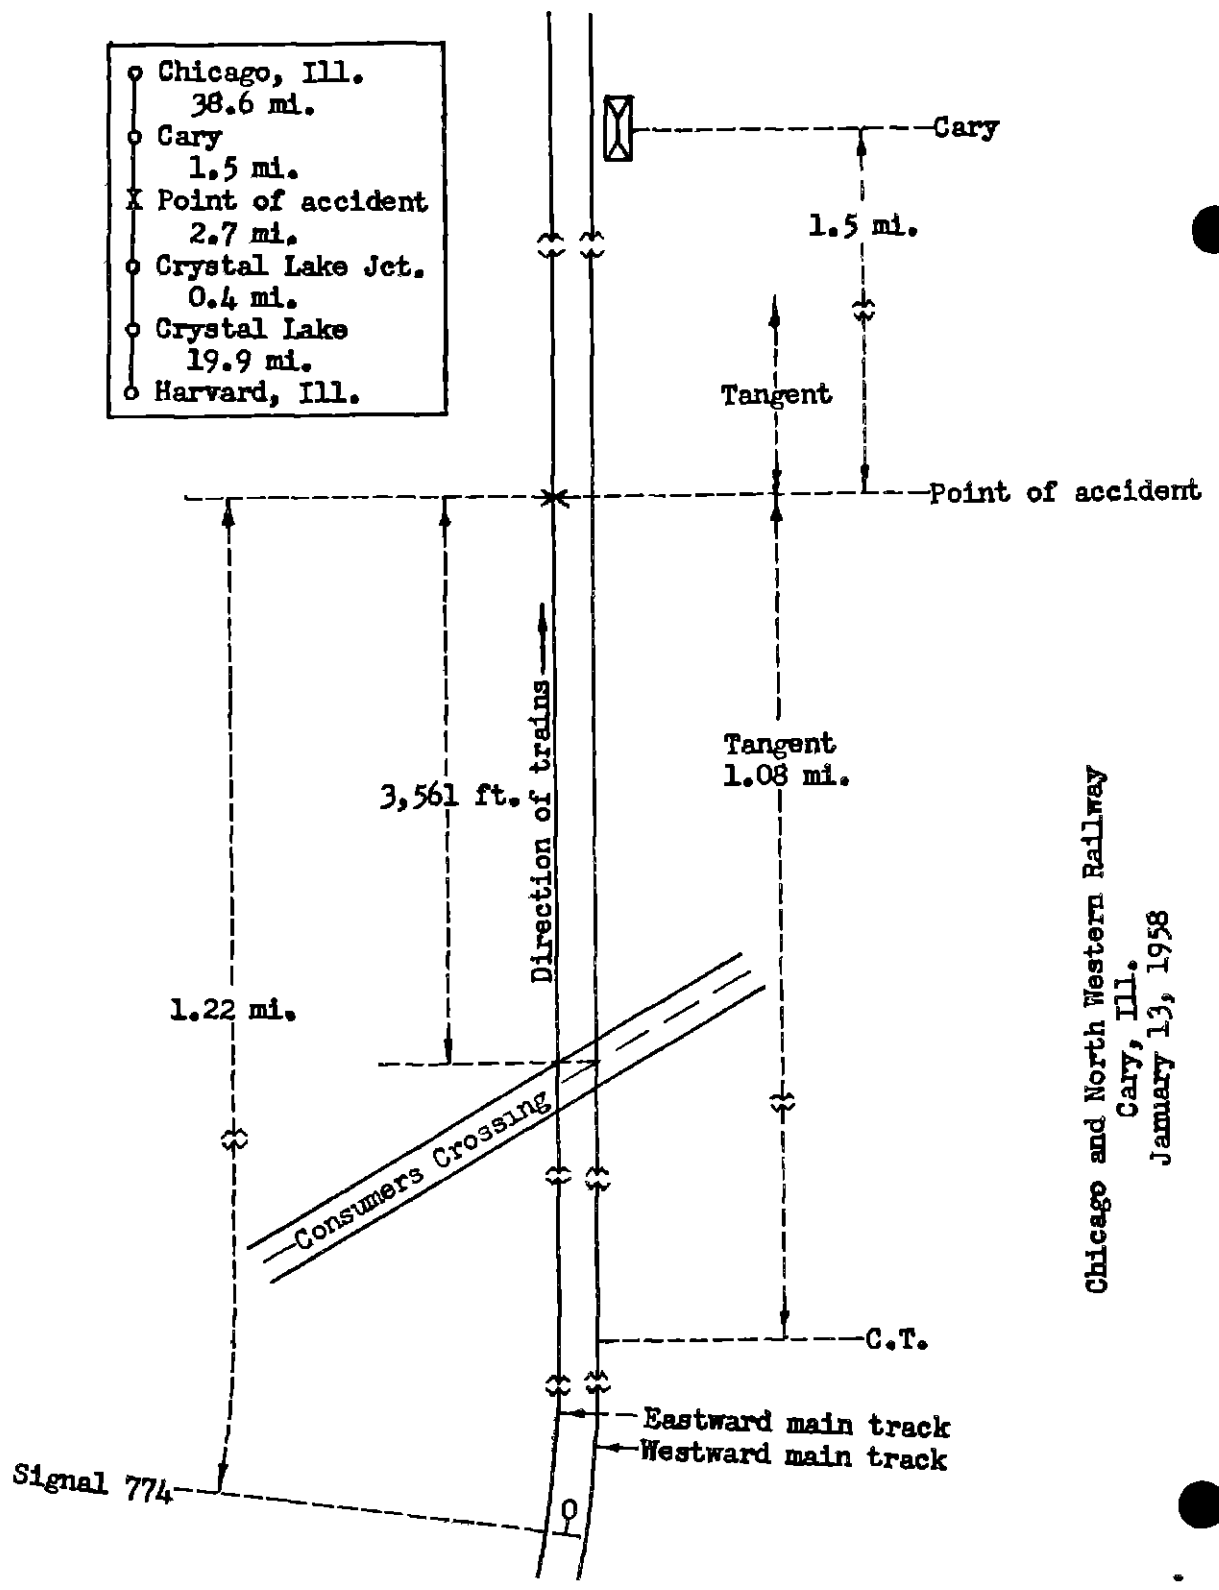
Chicago and North Western Railway
 Cary, Ill.
 January 13, 1958

- Chicago, Ill. 38.6 mi.
- Cary 1.5 mi.
- X Point of accident 2.7 mi.
- Crystal Lake Jct. 0.4 mi.
- Crystal Lake 19.9 mi.
- Harvard, Ill.

Location of Accident and Method of Operation
