RAILROAD ACCIDENT INVESTIGATION

REPORT NO. 4109

CHICAGO AND NORTH WESTERN RAILWAY COMPANY

SERGEANT BLUFF, IOWA

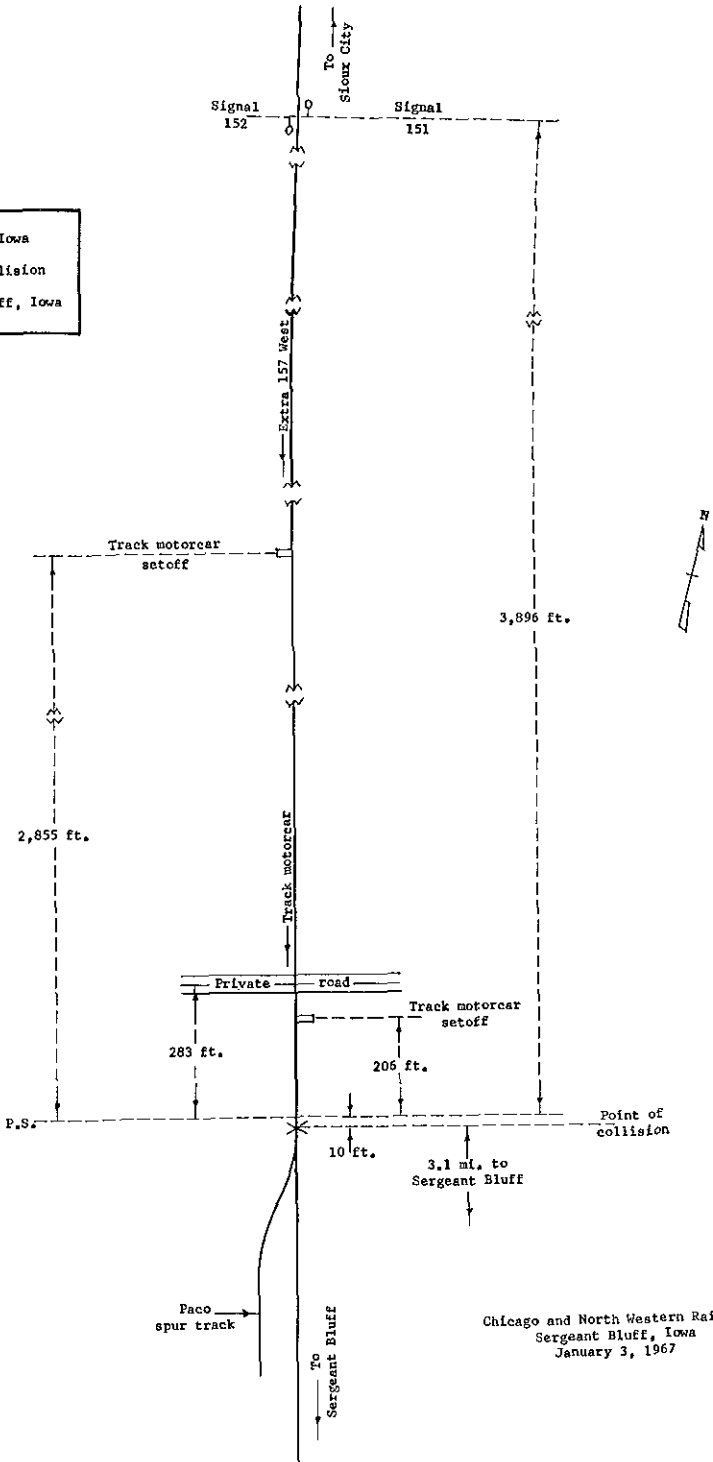
Chicago and North Western Railway
 Sergeant Bluff, Iowa
 January 3, 1967

○	Sioux City, Iowa
	4.8 mi.
×	Point of collision
	3.1 mi.
○	Sergeant Bluff, Iowa

When the track motorcar was approximately 1,000 feet from the Paco spur-track switch, one of the trackmen looked back again and saw the headlight of the approaching train come into view at a relatively short distance. He called this to the attention of the foreman, who then directed the trackman to light a fusee. The trackman said that by the time he found a fusee, the track motorcar had passed the private road crossing and setoff located short distances east of the Paco spur-track switch, and had stopped on the main track immediately west of that switch. He said the foreman then told him to forget about the fusee and gave instructions to place the track motorcar on the rails of the spur-track turnout. The trackmen and foreman promptly lifted the track motorcar from the main track to the spur-track turnout and one of the trackman then saw that the approaching train was nearing the spur-track switch. He called a warning, and the foreman instructed the trackmen to try to push the track motorcar westward on the spur-track turnout far enough to clear the main track for the train. After the track motorcar had been pushed only a few feet westward, both trackmen saw that a collision was imminent. They called a warning, and ran away from the track structure. Immediately thereafter, at 7:45 a.m., while the foreman continued to push it, the track motorcar was struck by Extra 157 West, 10 feet west of the Paco spur-track switch.

Extra 157 West stopped with the front end 581 feet west of the collision point. None of its equipment was derailed or damaged.

The track motorcar was derailed and was heavily damaged. It stopped on the north side of the track structure, 175 feet west of the collision point.
