RAILROAD ACCIDENT INVESTIGATION

Report No. 3853

CHICAGO AND NORTH WESTERN RAILWAY COMPANY

WAUKEGAN, ILL

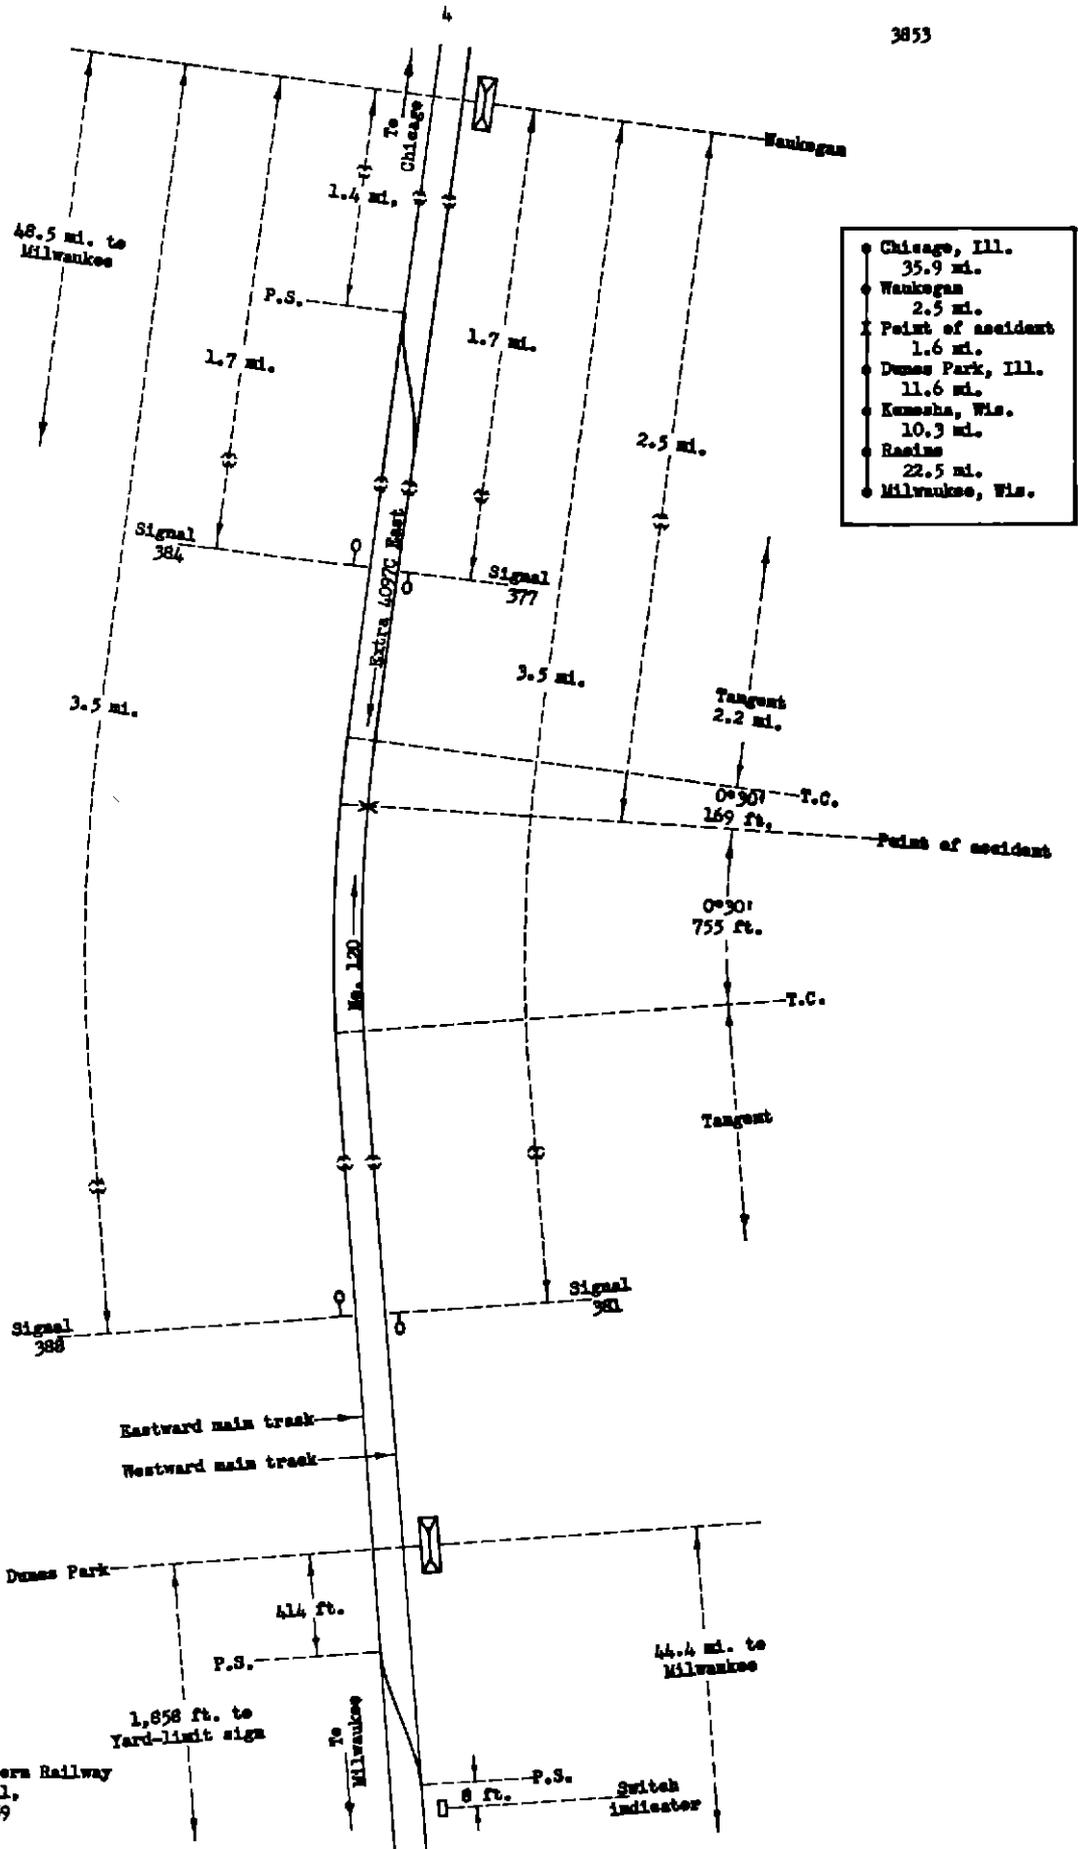
Chicago and North Western Railway
 Waukegan, Ill.,
 July 29, 1959

- Chicago, Ill. 35.9 mi.
- Waukegan 2.5 mi.
- ✕ Point of accident 1.6 mi.
- Dunes Park, Ill. 11.6 mi.
- Kewaunee, Wis. 10.3 mi.
- Racine 22.5 mi.
- Milwaukee, Wis.
