INTERSTATE COMMERCE COMMISSION

INVESTIGATION NO. 3066

CHICAGO GREAT WESTERN RAILWAY COMPANY

REPORT IN RE ACCIDENT

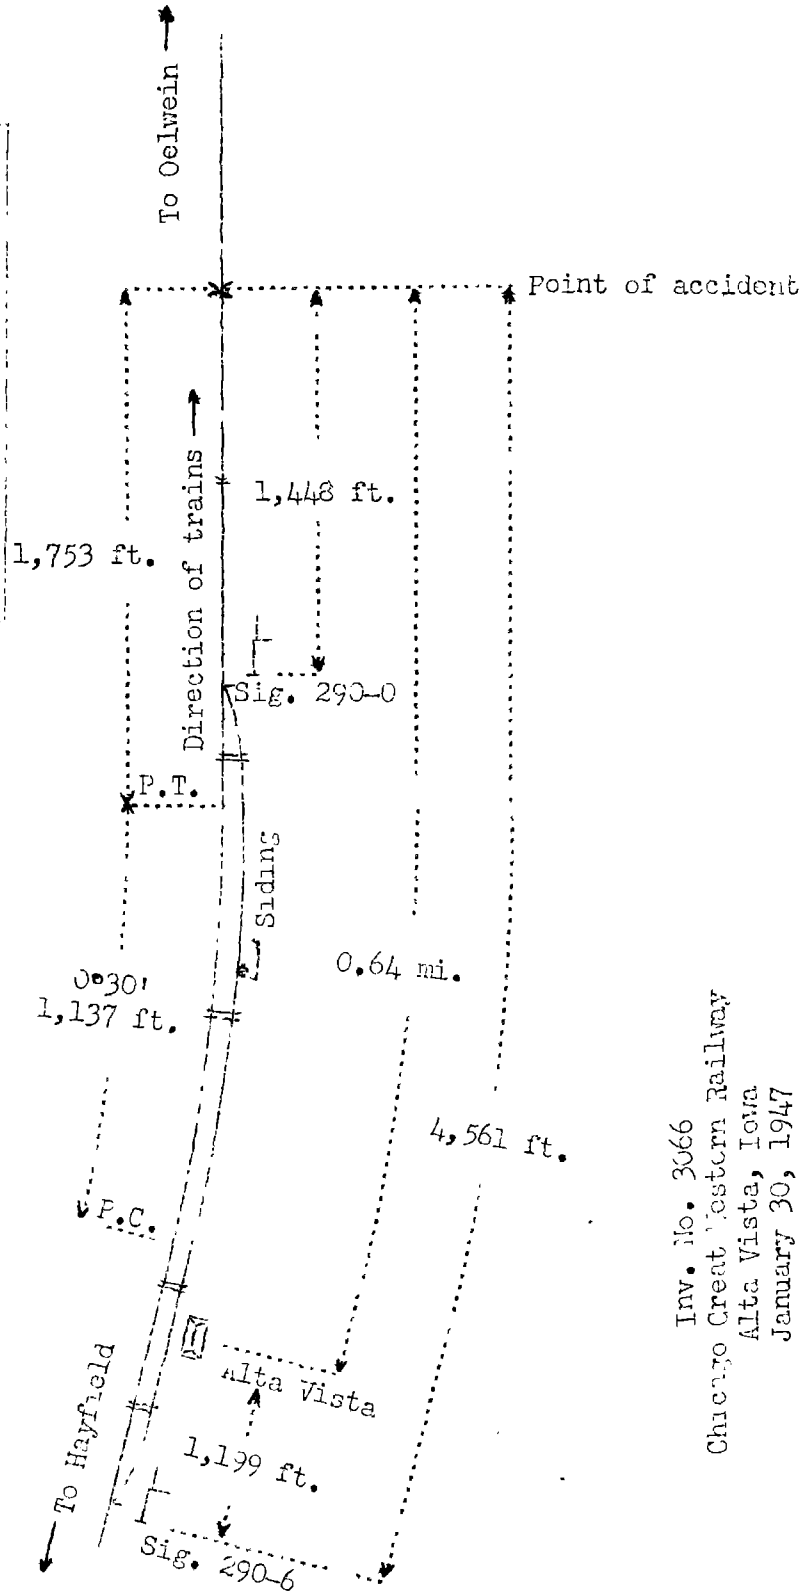
Inv. No. 3066
Chicago Great Western Railway
Alta Vista, Iowa
January 30, 1947

- o Oelwein, Iowa
33.80 mi.
- o New Hampton
10.26 mi.
- X Point of accident
0.64 mi.
- o Alta Vista
3.40 mi.
- o Elma
10.40 mi.
- o Riceville
5.60 mi.
- o McIntire, Iowa
34.00 mi.
- o Hayfield, Minn.
