INVESTIGATION NO. 3036
CHICAGO GREAT WESTERN RAILWAY COMPANY
REPORT IN RE ACCIDENT
NEAR CORNELIA, IOWA, ON
NOVEMBER 9, 1946

Kind of accident: Derailment

CHICAGO GREAT WESTERN RAILWAY COMPANY

Inv. No. 3036
Chicago Great Western Railway
Cornelia, Iowa
November 9, 1946

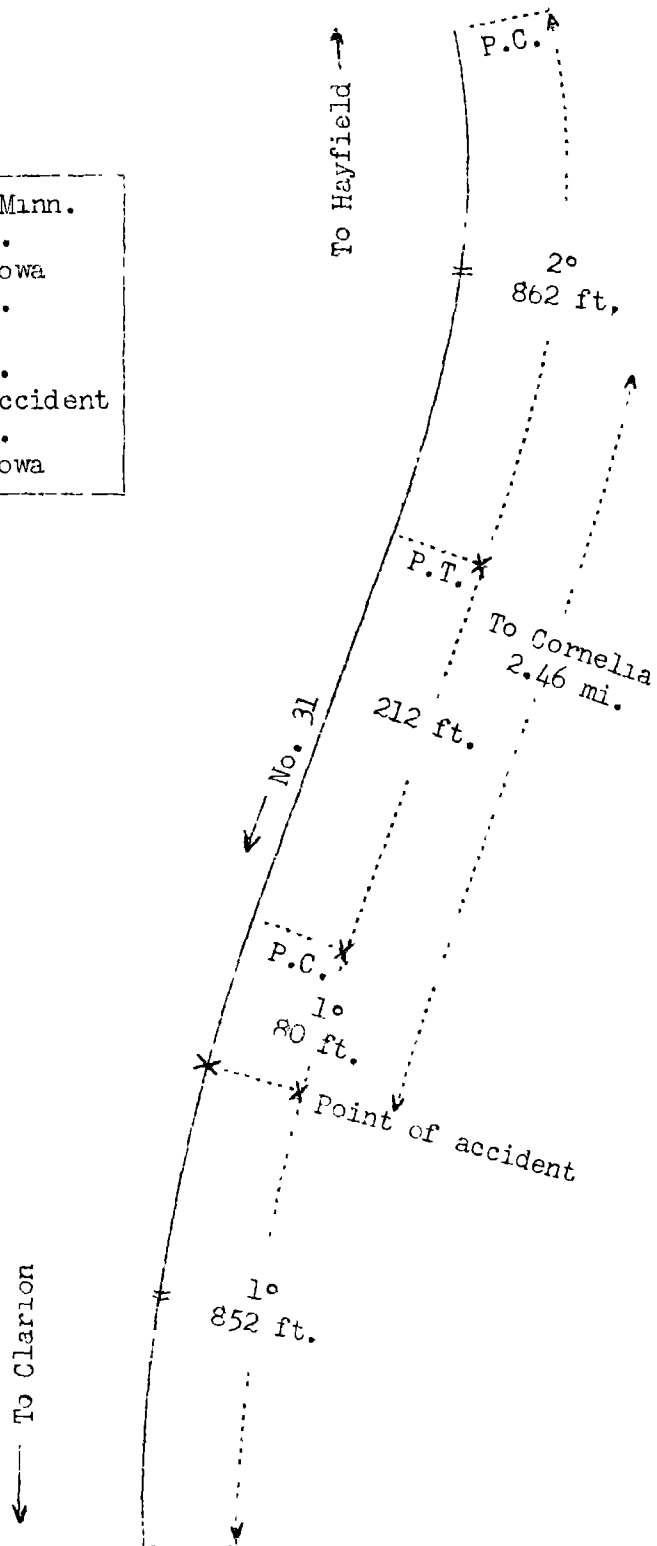
o	Hayfield, Minn.
	90.40 mi.
o	Belmond, Iowa
	5.50 mi.
o	Cornelia
	2.46 mi.
X	Point of accident
	2.64 mi.
o	Clarion, Iowa

Location of Accident and Method of Operation
