REPORT OF THE DIRECTOR
BUREAU OF SAFETY

ACCIDENT ON THE
CHICAGO GREAT WESTERN RAILROAD

MESERVEY, IOWA

INVESTIGATION NO. 2404

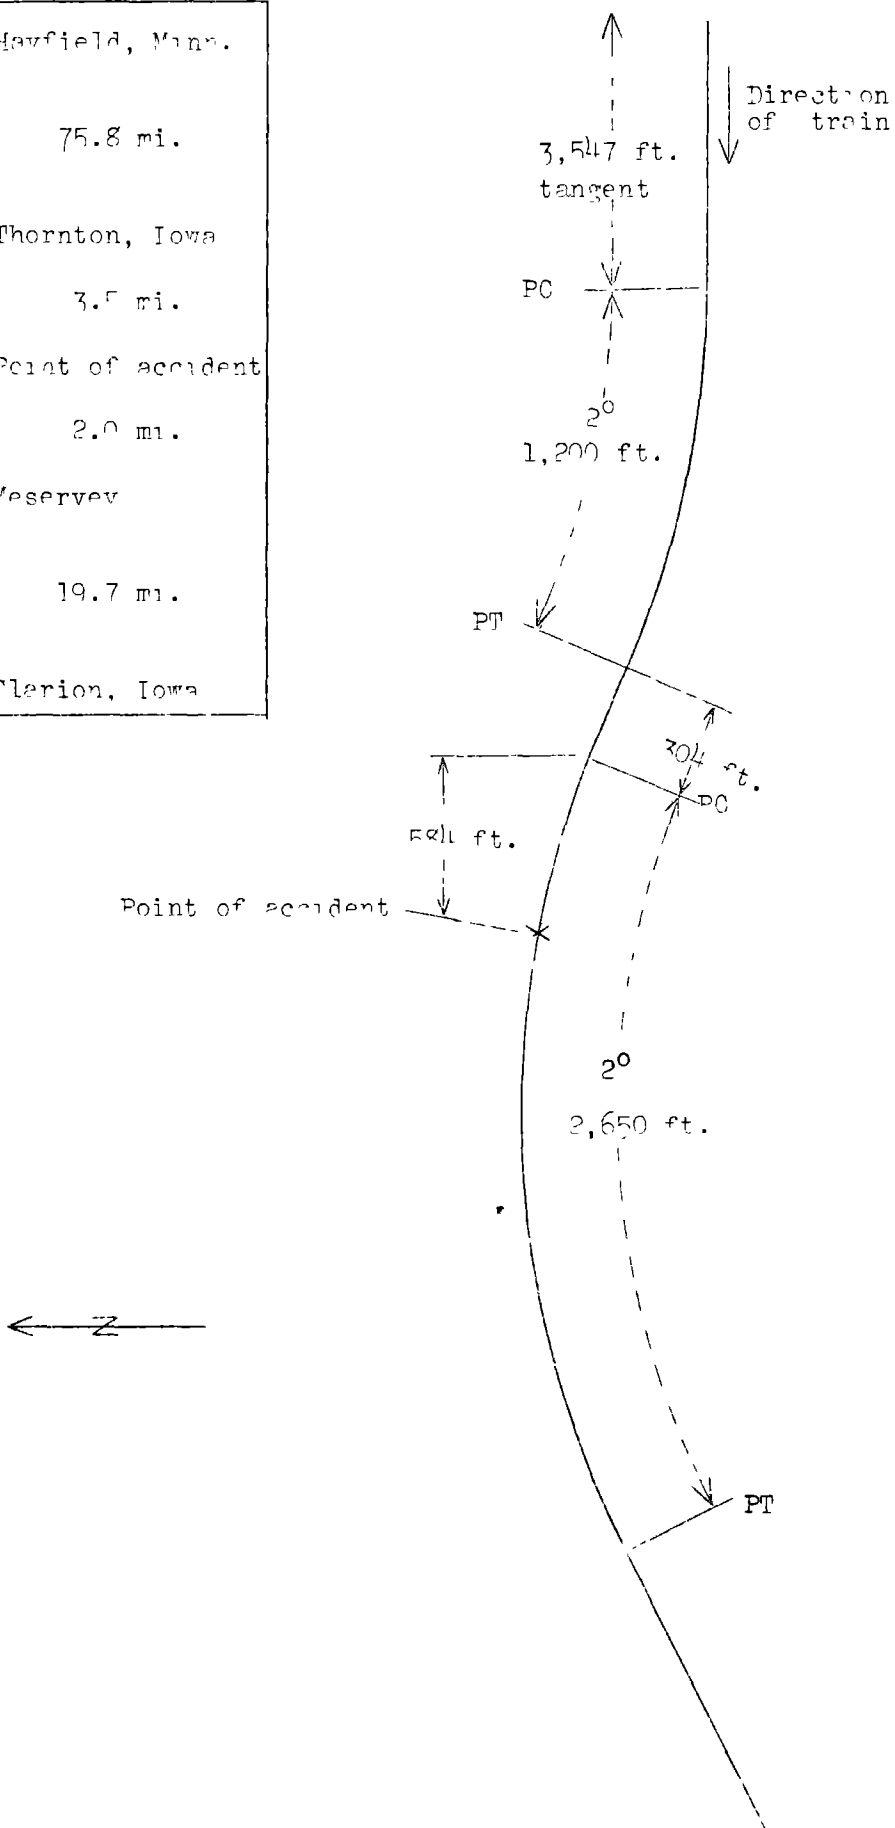
Inv. No. 2404
Chicago Great Western P.R.
Meservey, Iowa
Jan. 5, 1940

o	Hayfield, Mann.
	75.8 mi.
o	Thornton, Iowa
	3.5 mi.
X	Point of accident
	2.0 mi.
o	Meservey
	19.7 mi.
o	Clarion, Iowa
