RAILROAD ACCIDENT INVESTIGATION

Report No 3790

CHICAGO, BURLINGTON & QUINCY RAILROAD COMPANY

ASHLAND, NEBR.

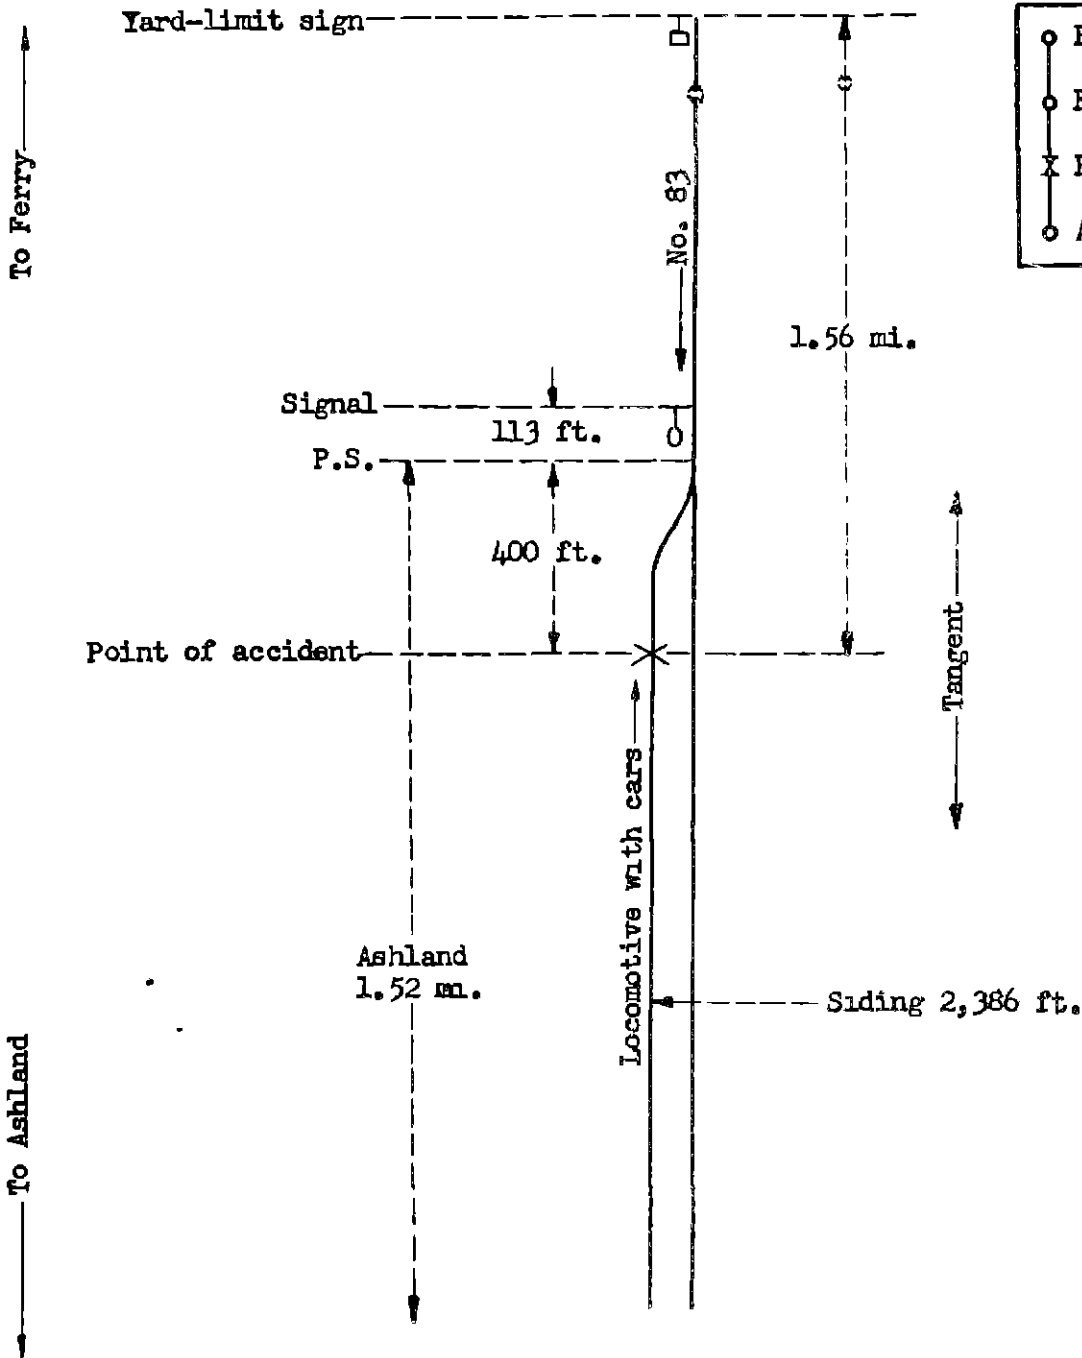
- Ferry, Nebr. 75.28 mi.
- Fremont 27.78 mi.
- X Point of accident 1.44 mi.
- Ashland, Nebr.

Chicago, Burlington & Quiney Railroad
 Ashland, Nebr.
 October 11, 1957
