REPORT NO. 3276
CHICAGO, BURLINGTON & QUINCY RAILROAD COMPANY
IN RE ACCIDENT
NEAR BRIAR BLUFF, ILL., ON
SEPTEMBER 3, 1949

Accident near Briar Bluff, Ill., on September 3, 1949,
caused by failure to obey a meet order.

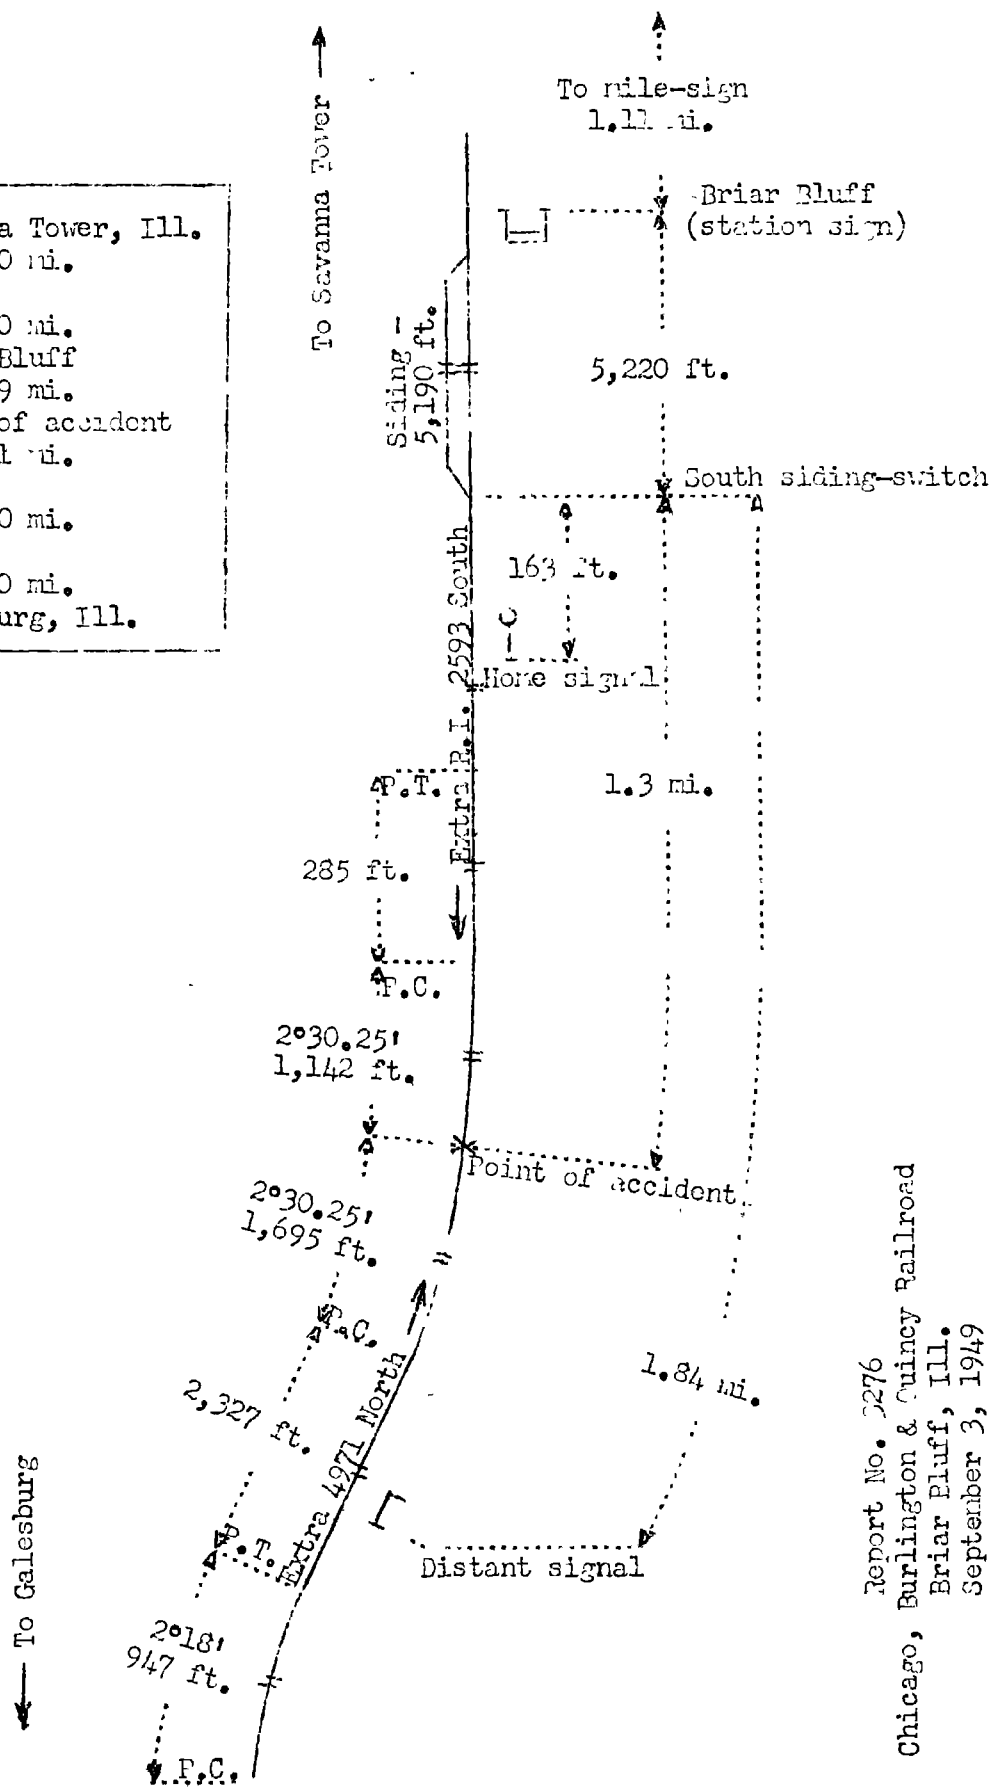
Report No. 3276
 Chicago, Burlington & Quincy Railroad
 Briar Bluff, Ill.
 September 3, 1949

- o Savanna Tower, Ill.
- | 57.60 mi.
- o Colona
- | 1.60 mi.
- o Briar Bluff
- | 2.29 mi.
- X Point of accident
- | 6.41 mi.
- o Orion
- | 12.00 mi.
- o Alpha
- | 18.00 mi.
- o Galesburg, Ill.
