REPORT NO. 3537

IN RE ACCIDENT
AT FAIRFIELD, IOWA, ON
OCTOBER 5, 1953

Kind of accident: Side collision

Cause: Failure to operate Chicago, Rock Island and Pacific train in accordance with signal indications

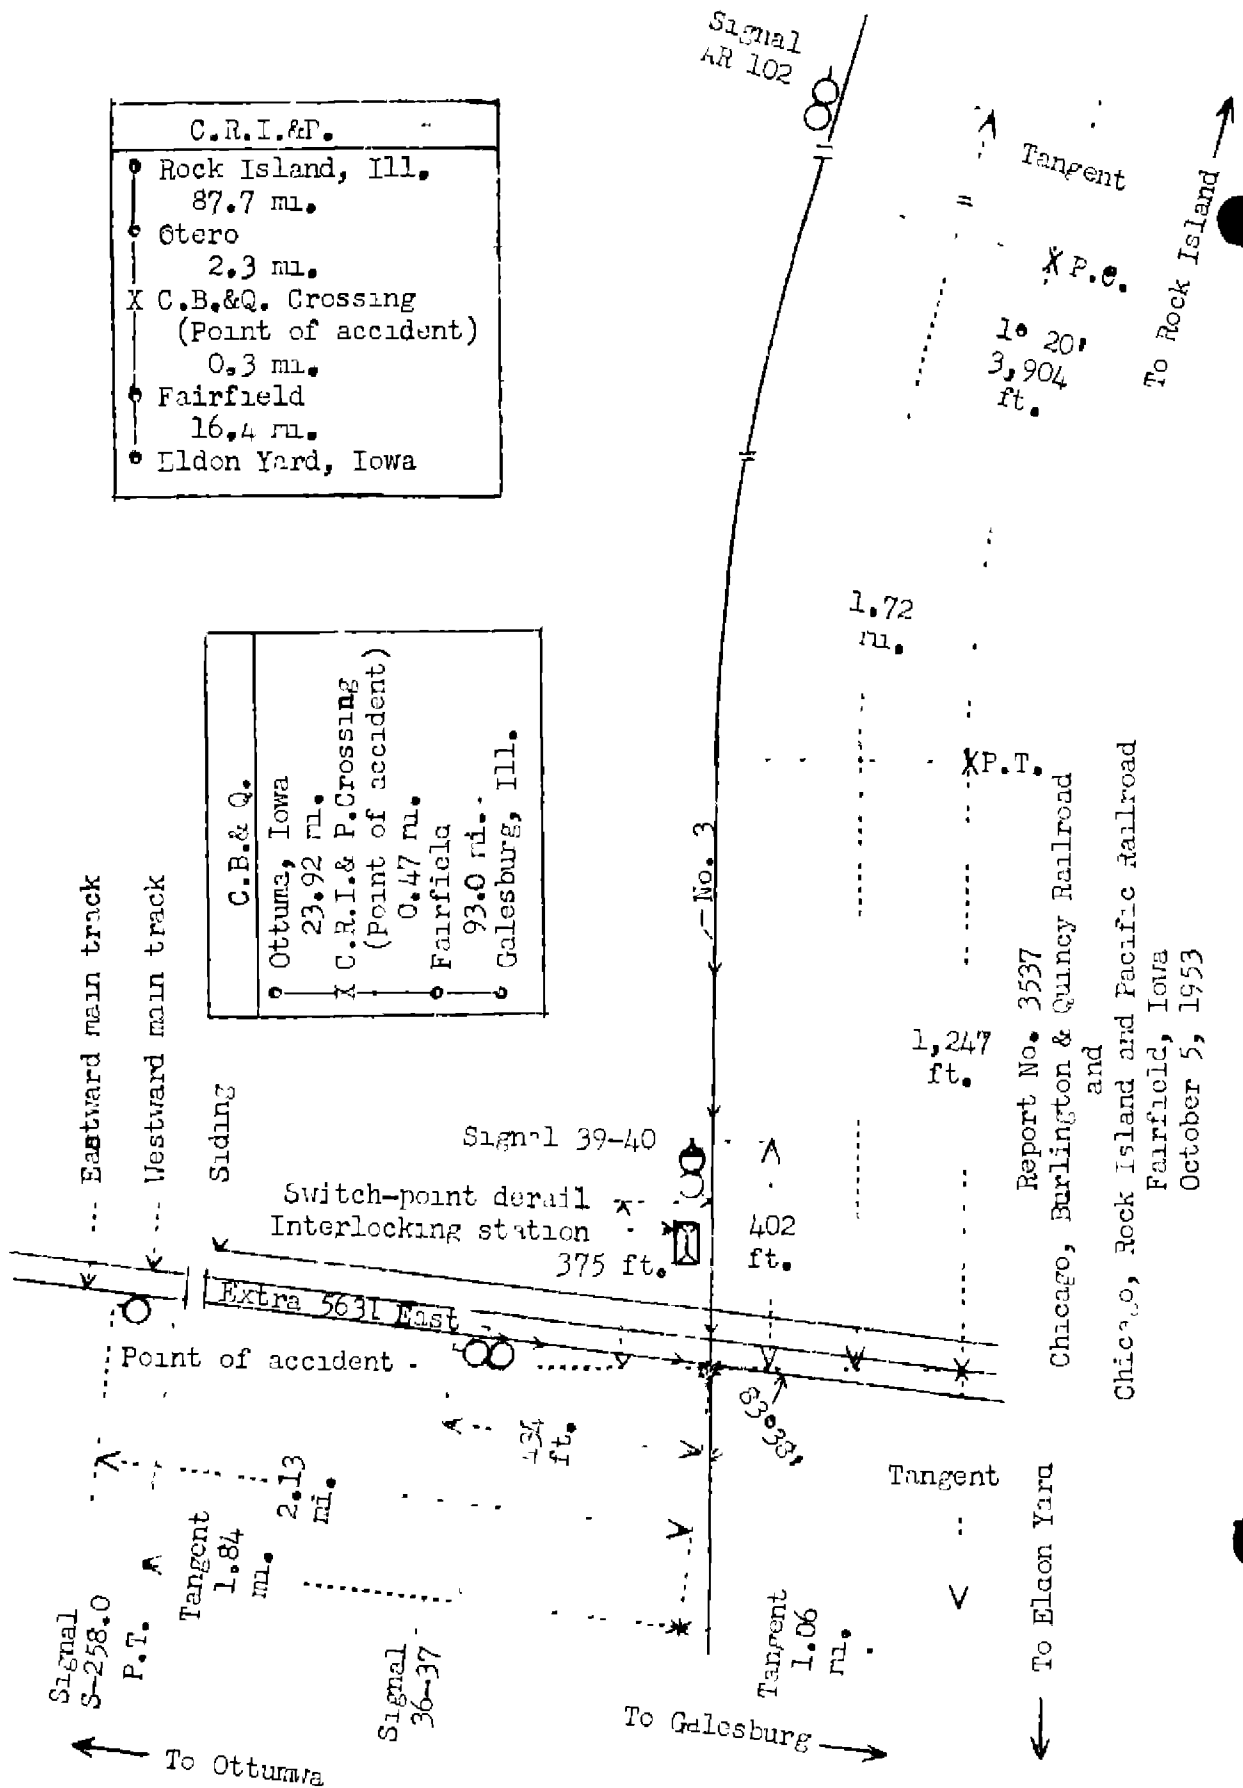
C.R.I.&P.	
•	Rock Island, Ill.
	87.7 mi.
•	Otero
	2.3 mi.
X	C.B.&Q. Crossing
	(Point of accident)
	0.3 mi.
•	Fairfield
	16.4 mi.
•	Eldon Yard, Iowa

C.B.&Q.	
•	Ottumwa, Iowa
	23.92 mi.
X	C.R.I. & P. Crossing
	(Point of accident)
	0.47 mi.
•	Fairfield
	93.0 mi.
•	Galesburg, Ill.

This accident occurred at the intersection of the Chicago, Burlington & Quincy Railroad, hereinafter referred to as the C.B. & Q., and the Chicago, Rock Island and Pacific Railroad, hereinafter referred to as the C.R.I. & P., at Fairfield, Iowa. The crossing is located on that part of the Ottumwa and Creston Divisions of the C.B. & Q. extending between Ottumwa, Iowa, and Galesburg, Ill., 117.39 miles, and on that part of the Rock Island Division of the C.R.I. & P. extending between Rock Island, Ill., and Eldon Yard, Iowa, 106.7 miles. The crossing is 23.92 miles east of Ottumwa and 0.47 miles west of the C.B. & Q. station at Fairfield, and 90 miles west of Rock Island and 1,466 feet east of the C.R.I. & P. station at Fairfield. In the vicinity of the crossing the C.B. & Q. extends east and west and the C.R.I. & P. extends north and south. Timetable directions on both lines are east and west, and these directions are used in this report. The lines intersect at an angle of $83^{\circ}38'$. An interlocking station is located in the northwest angle of the intersection. In the vicinity of the point of accident the C.B. & Q. is a double-track line, over which trains are operated by signal indications. The main tracks from north to south are designated as westward main track and eastward main track. A siding which extends over the crossing parallels the westward main track on the north in the immediate vicinity of the point of accident. From the west the main tracks are tangent throughout a distance of 1.64 miles to the crossing and 1.06 miles eastward. The grade for east-bound trains on the eastward main track varies between 0.68 percent and 0.077 percent ascending throughout a considerable distance immediately west of the crossing. At the crossing the grade is practically level. In the vicinity of the point of accident the C.R.I. & P. is a single-track line, over which trains are operated by signal indications. From the east there are, in succession, a tangent over 2 miles in length, a $1^{\circ}20'$ curve to the left 3,004 feet, and a tangent 1,247 feet to the point of accident and a considerable distance westward. Throughout a distance of 1.72 miles immediately east of the point of accident the grade for west-bound trains varies between 0.52 percent descending and 0.53 percent ascending. At the point of accident the grade is 0.46 percent descending.
