REPORT OF THE DIRECTOR
BUREAU OF SAFETY

ACCIDENT ON THE
CHICAGO, BURLINGTON & QUINCY RAILROAD

KEMP, NEBR.

INVESTIGATION NO. 2205

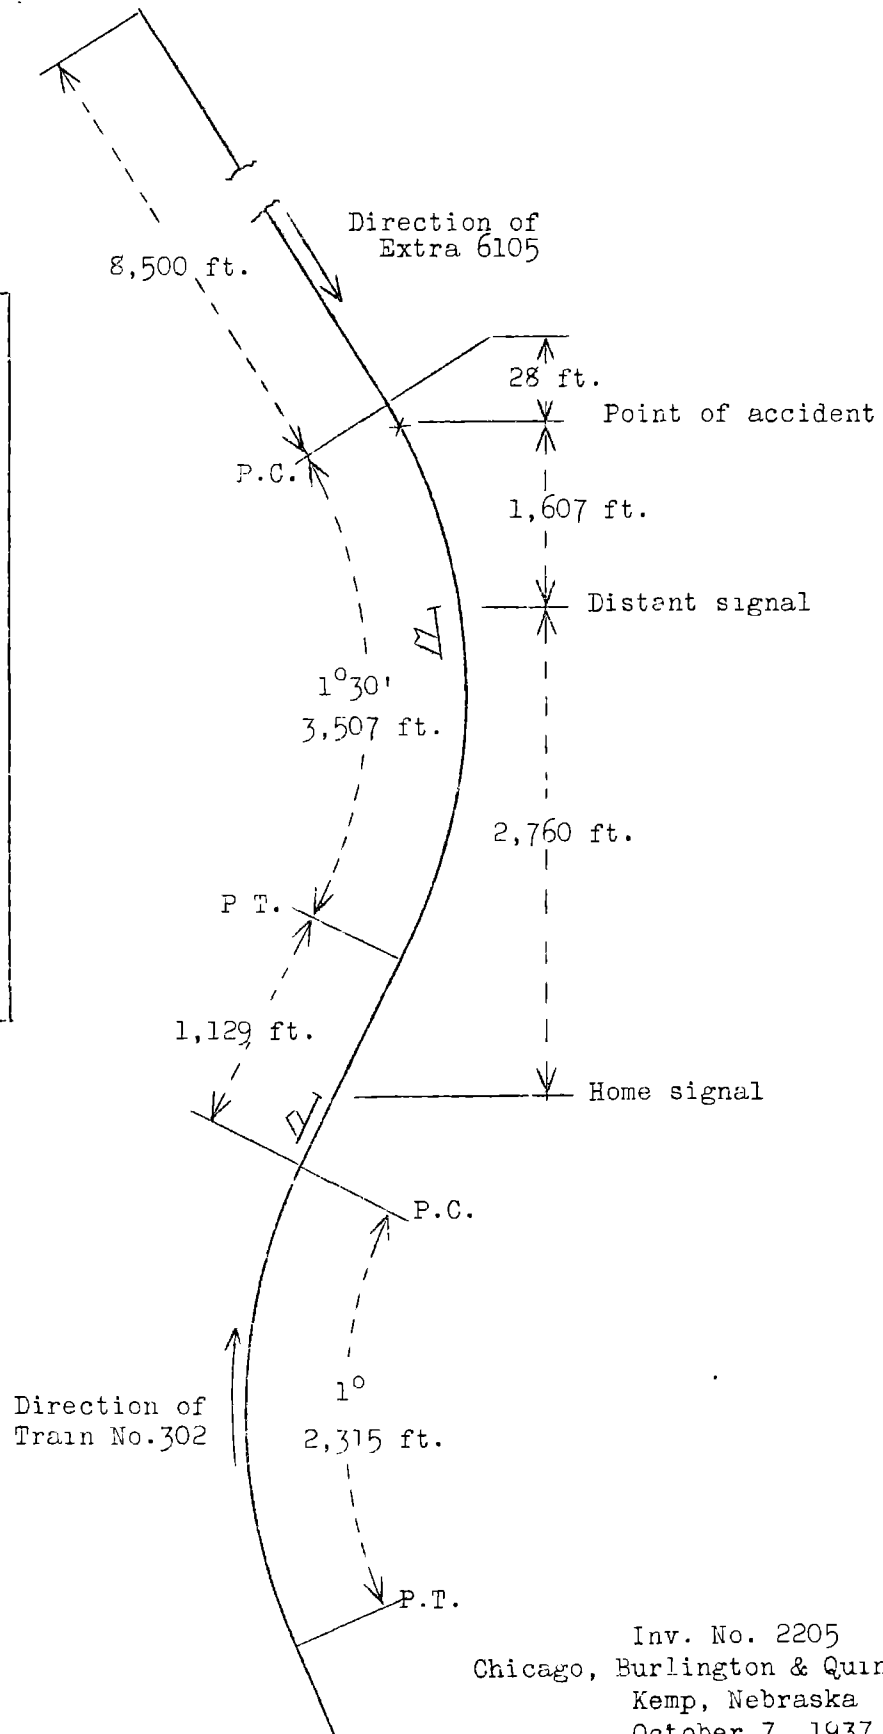
Inv. No. 2205
Chicago, Burlington & Quincy RR,
Kemp, Nebraska
October 7, 1937

o Alliance, Nebr.	
	13.59 mi.
o Bonner	
	8.22 mi.
o Angora	
	6.04 mi.
o Vance	
	4.65 mi.
X Point of accident	
o Kemp	
	1.31 mi.
o Northport	
	2.73 mi.
o bridgeport	
	78.58 mi.
o Sterling, Nebr.
