INVESTIGATION NO. 2815
THE CHICAGO, BURLINGTON & QUINCY
RAILROAD COMPANY
REPORT IN RE ACCIDENT
AT SHELBYNA, MO., ON
AUGUST 9, 1944

Accident at Shelbina, Mo., on August 9, 1944, caused by
failure properly to control the speed of a train
entering a siding.

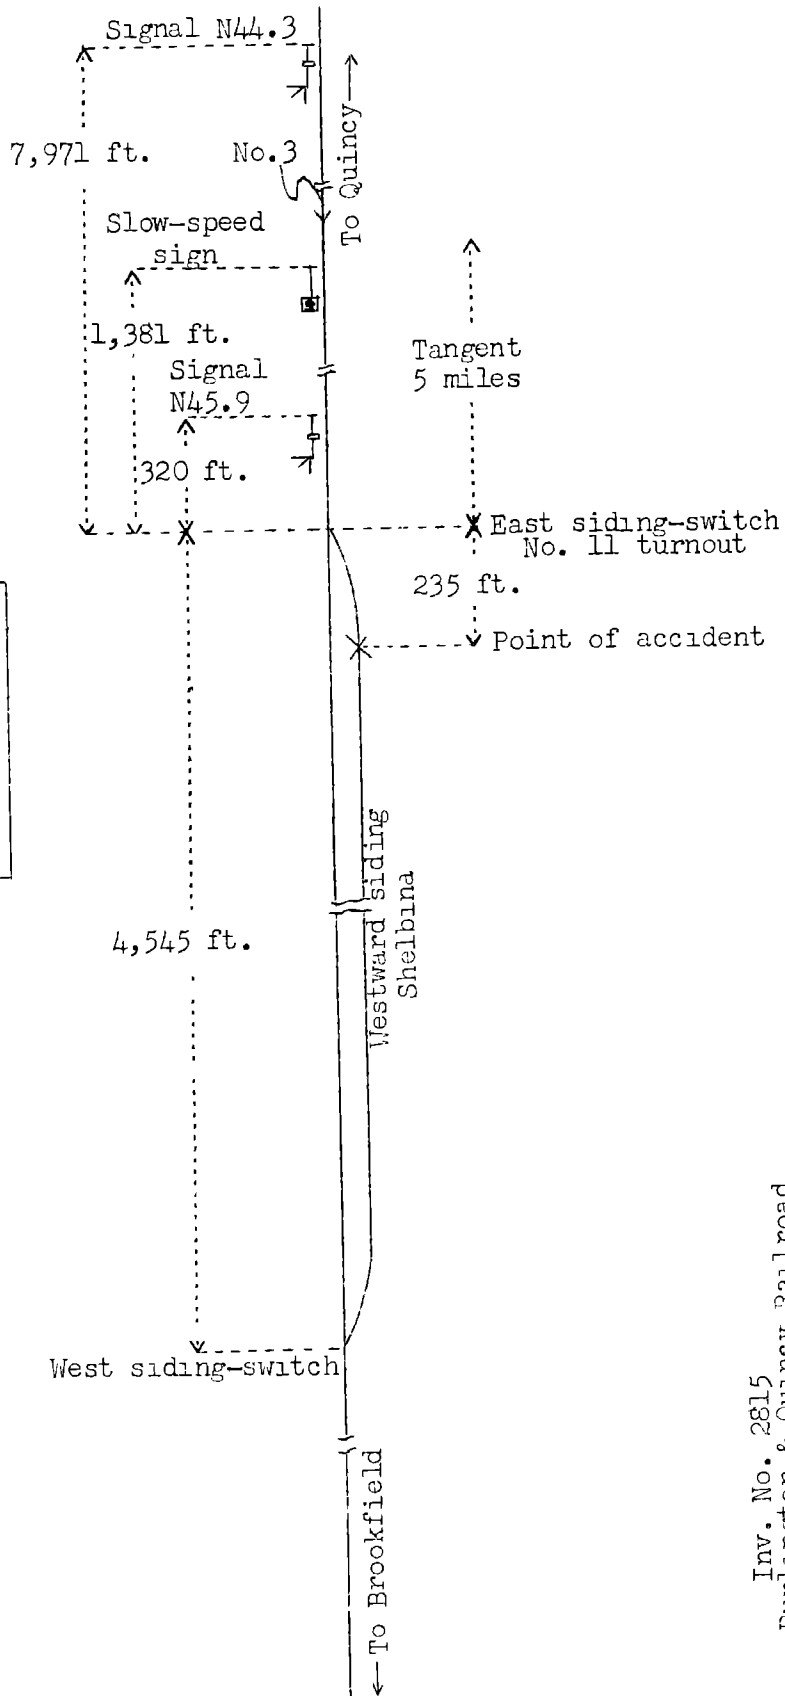
Inv. No. 2815
 Chicago, Burlington & Quincy Railroad
 Shelbina, Mo.
 August 9, 1944

- Quincy, Ill. 14.5 mi.
- Palmyra, Mo. 22.0 mi.
- Hunnewell 9.9 mi.
- X Shelbina (P.of A.) 57.4 mi.
- Brookfield, Mo.

The engine and the first car stopped on their right sides south of the siding, with the front end of the engine about 220 feet west of the point of derailment. The second, third and fourth cars stopped practically upright south of the siding and in line with it. The engine was badly damaged, the first car was considerably damaged, and the second and third cars were slightly damaged.
