REPORT OF THE DIRECTOR

BUREAU OF SAFETY

CHICAGO, BURLINGTON & QUINCY RAILROAD

SPEAR, MONT.

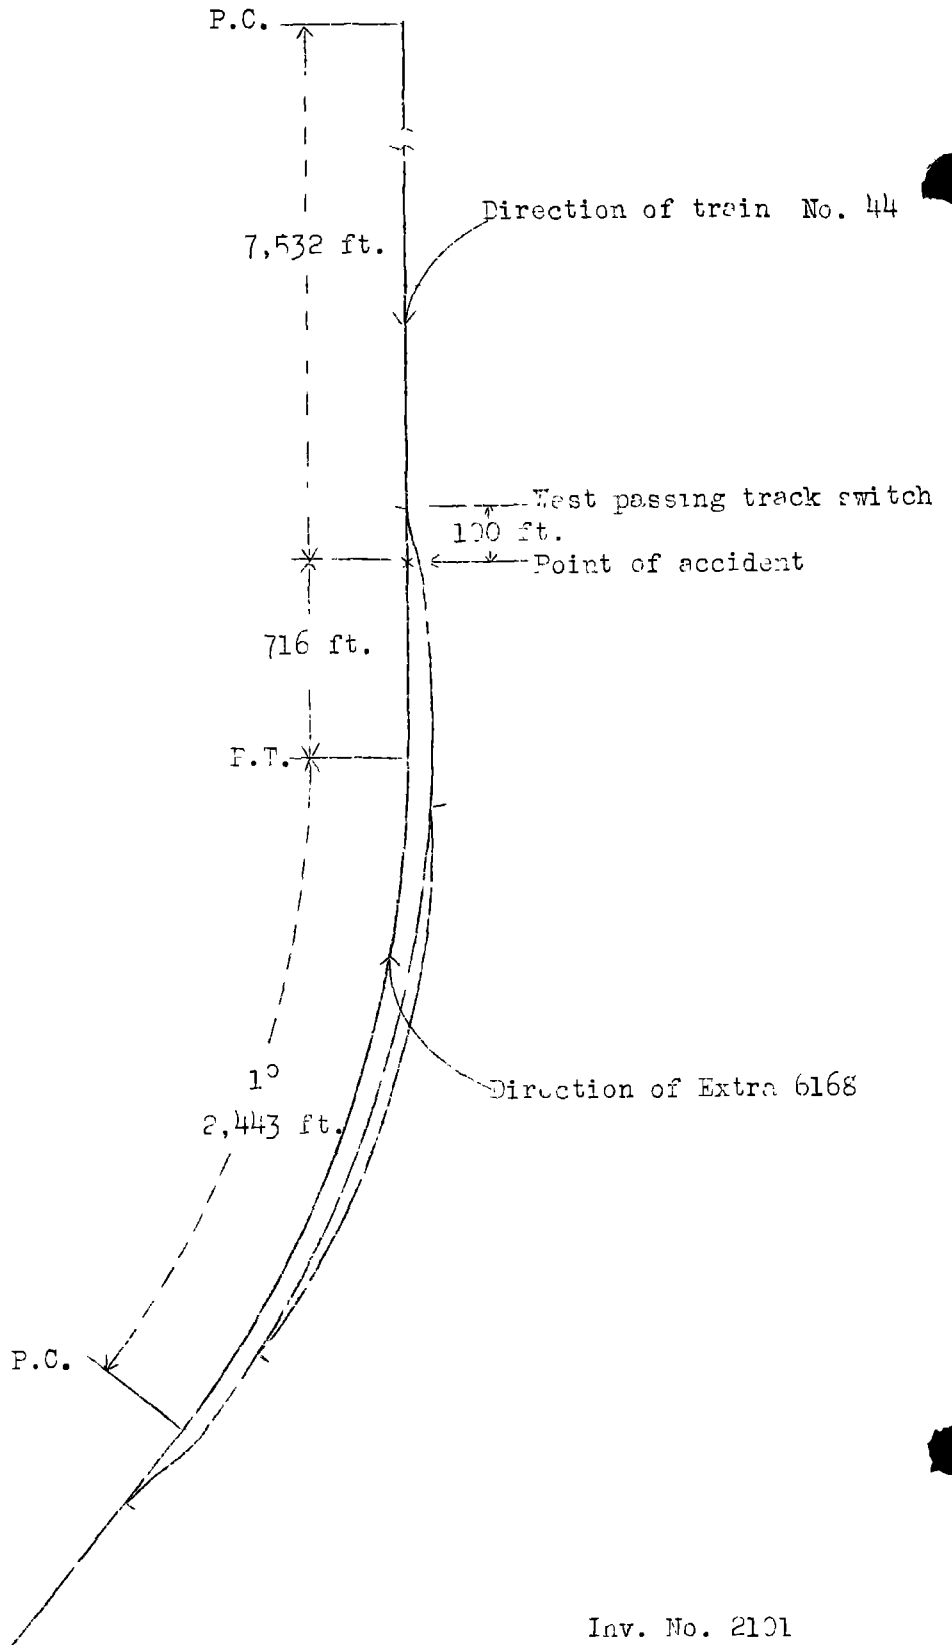
Inv. No. 2101
 Chicago, Burlington & Quincy R.R.
 Spear, Montana
 Sept. 22, 1936

| X | Point of accident | 43.16 mi. |
| o | Sheridan, Wyo. | |

This accident occurred on the Sheridan and Billings Sub-division of the Sheridan Division, extending between Sheridan, Wyo., and Huntley, Mont., a distance of 130.47 miles. In the vicinity of the point of accident this is a single-track line over which trains are operated by timetable, train orders, and a manual block system for following movements only, no provision being made for blocking opposing trains. The accident occurred at a point approximately 100 feet east of the west switch of the passing track at Spear; approaching this point from the west, the track is tangent for more than 1 mile, the accident occurring on this tangent at a point 716 feet from its eastern end. Approaching from the east, there is a 1° curve to the left for a distance of 2,443 feet, followed by the tangent on which the accident occurred. The grade for eastbound movements is 0.7 percent ascending at the point of accident.
