INTERSTATE COMMERCE COMMISSION  
WASHINGTON

INVESTIGATION NO. 2522  
THE CHICAGO, BURLINGTON & QUINCY  
RAILROAD COMPANY  
REPORT IN RE ACCIDENT  
NEAR WINNEBAGO, NEBR., ON  
SEPTEMBER 6, 1941

Accident near Winnebago, Nebr., on September 6, 1941, caused  
by an inferior train occupying the main track on the  
time of an opposing superior train.

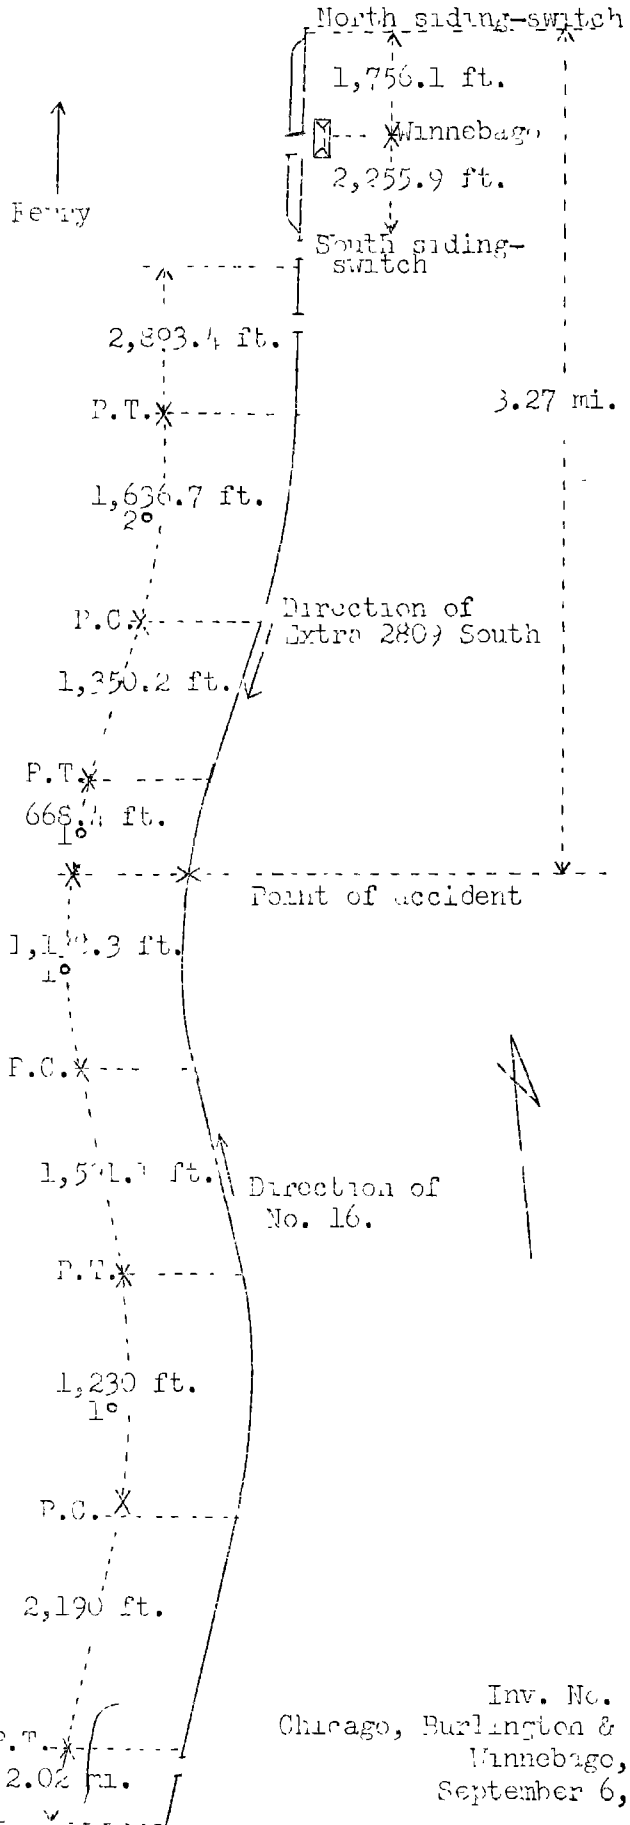
Inv. No. 2522  
 Chicago, Burlington & Quincy R. R.,  
 Winnebago, Nebr.,  
 September 6, 1941.

o	Ferry, Nebr.	10.02 mi.
o	Homer	6.23 mi.
o	Winnebago	2.94 mi.
X	Point of accident	2.12 mi.
o	Waltnhill	32.08 mi.
o	Ashland, Nebr.
