INTERSTATE COMMERCE COMMISSION
WASHINGTON

REPORT OF THE DIRECTOR
BUREAU OF SAFETY

ACCIDENT ON THE
CHICAGO, BURLINGTON & QUINCY RAILROAD

BEVERLY, MO.

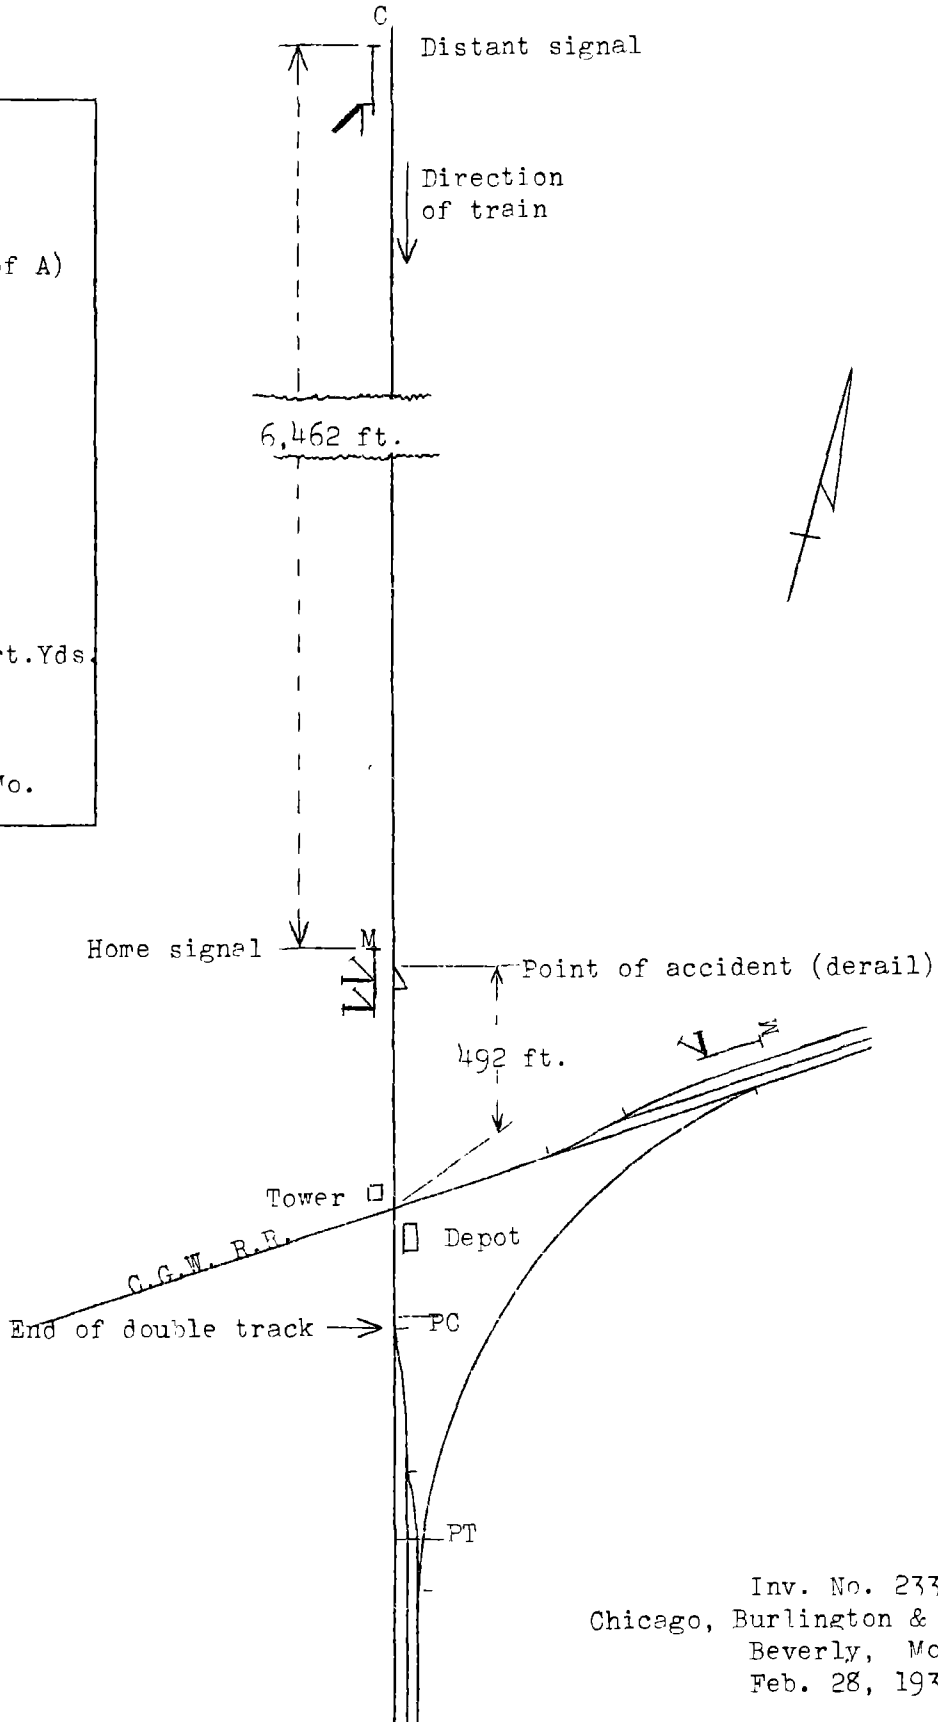
Inv. No. 2337
 Chicago, Burlington & Quincy R.R.
 Beverly, Mo.
 Feb. 28, 1939

o	Ustick, Mo.
	25.8 mi.
X	Beverly (P of A)
	3.3 mi.
o	Weston
	12.8 mi.
o	Armour
	16.6 mi.
o	St. Joseph Frt. Yds.
	1.6 mi.
o	St. Joseph, Mo.

This accident occurred on that part of the St. Joseph Division extending between St. Joseph and Ustick, Mo., a distance of 60.1 miles; in the immediate vicinity of the point of accident this is a single-track line over which trains are operated by timetable, train orders and a controlled manual block system. The accident occurred at a switch-point derail within the limits of Beverly interlocking plant.

Approaching from the north there is a 1° curve to the right 990 feet long, followed by a tangent 2,655 feet long on which the accident occurred at a point 662 feet from its southern end. The grade is slightly descending southward at the point of accident.
