RAILROAD ACCIDENT INVESTIGATION

Report No 3777

CHICAGO, BURLINGTON & QUINCY RAILROAD COMPANY

Accident at Chariton, Iowa, on August 25, 1957, caused by a false flange, resulting from a sliding wheel, coming in contact with the gage side of a stock rail

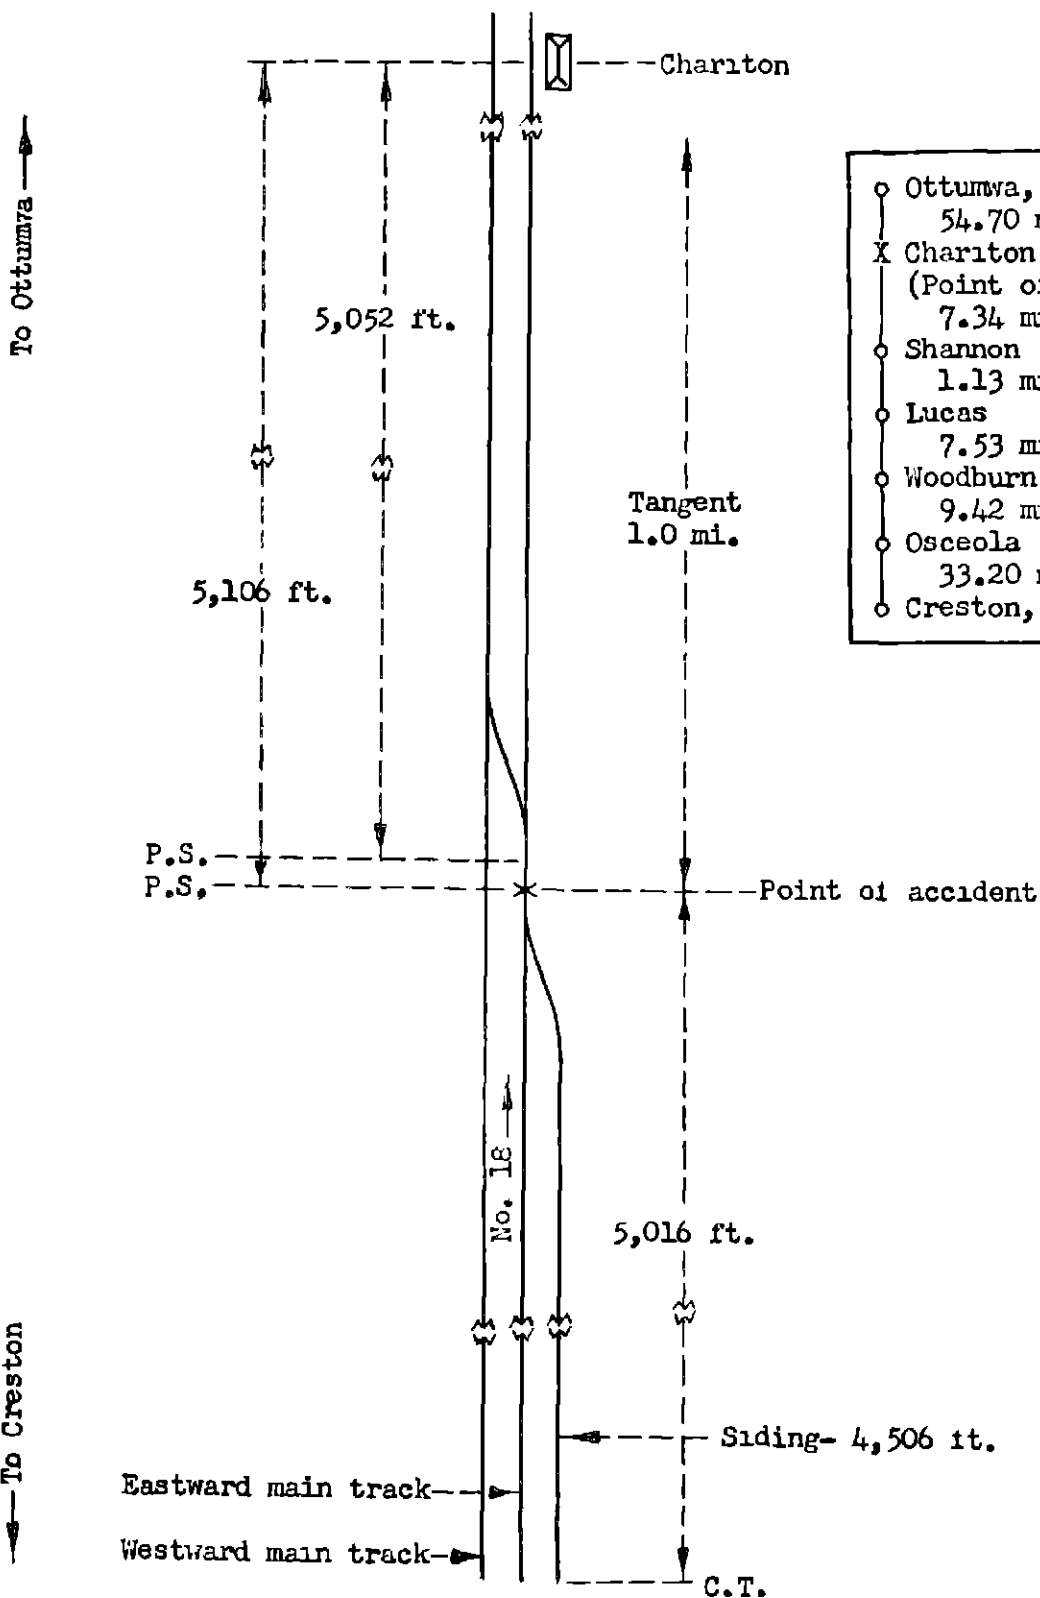
○	Ottumwa, Iowa	54.70 mi.
X	Chariton (Point of accident)	7.34 mi.
○	Shannon	1.13 mi.
○	Lucas	7.53 mi.
○	Woodburn	9.42 mi.
○	Osceola	33.20 mi.
○	Creston, Iowa

Chicago, Burlington & Quincy Railroad
 Chariton, Iowa
 August 25, 1957
