INTERSTATE COMMERCE COMMISSION

INVESTIGATION NO. 2623

THE CHICAGO, BURLINGTON & QUINCY RAILROAD COMPANY

REPORT IN RE ACCIDENT

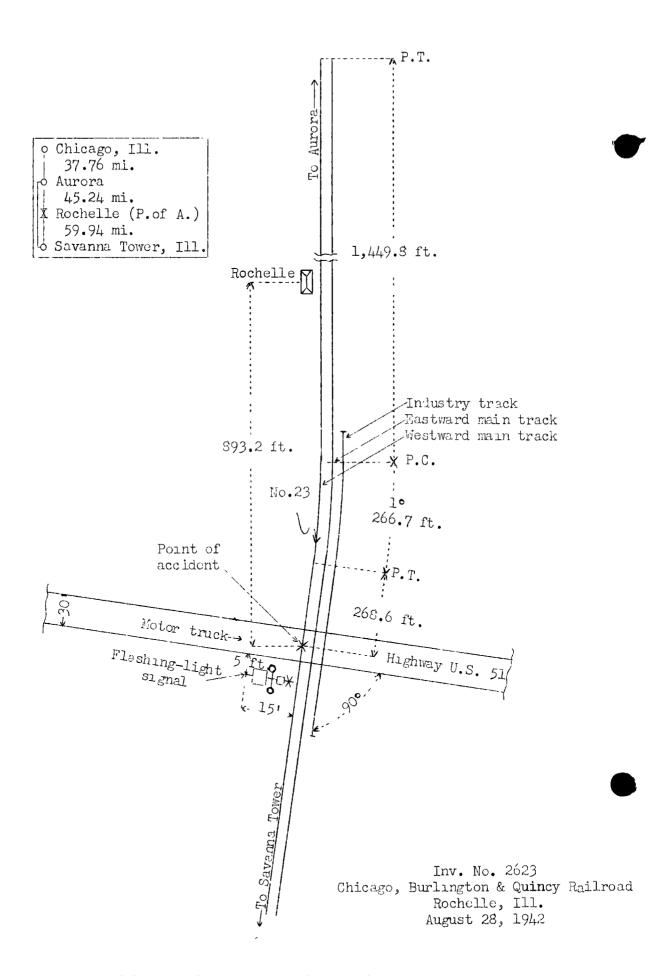
This accident occurred on that part of the Aurora Division designated as the Aurora and Savanna Sup-division and extending between Aurora and Savanna Tower, Ill., a distance of 105.18 miles. In the vicinity of the point of accident this is a double-track line over which trains are operated by a centralized-traffic-control system. The accident occurred on the westward main track at a point 893.2 feet west of the station at Rochelle where the railroad is crossed at grade by Highway U. S. 51. At the point of accident an industry track parallels the main tracks on the south. As the point of accident is approached from the east on the railroad there are, in suc-cession, a tangent 1,449.8 feet in length, a 1° curve to the right 266.7 feet and a tangent 268.6 feet to the point of accident and a considerable distance beyond. At the point of accident the grade for west-bound trains is 0.413 percent ascending. Highway U. S. 51 crosses the three tracks at right angles. As the point of accident is approached from the north on the highway there is a tangent more than 1 mile to the crossing and several miles beyond. At the point of accident the grade is level. The highway and the crossing are 30 feet wide and are surfaced with concrete. The crossing is well maintained.

The crossing is protected on each side of the tracks by two-way hooded flashing-light signals. The signal governing south-bound traffic is located in the northwest angle of the intersection at a point 15 feet north of the center-line of the westward main track and 5 feet west of the highway. On the mast of this signal a cross-buck sign is mounted II feet 8 inches above the level of the pavement, and bears the words "RAILROAD CROSSING." Immediately below the cross-buck sign the words "3 TRACKS" are displayed in reflector buttons. A norizontal bar, to which a hooded red light is attached at each end, is mounted on the mast 8 feet 6 inches above the level of the pavement. Beneath the red lights a rectangular plate 25-1/2 inches by 22-1/2 inches displays in reflector buttons the words "STOP ON RED SIGNAL." The flashing-light signals are actuated when a west-bound train reaches a point 2,516 feet east of the crossing. While the grade-crossing signal is being actuated a bell on the signal mast rings.

There was no unusual condition about the enclosed cab that obscured the vision of the truck driver. Because of buildings, a pole line and vegetation on the east side of the highway, a west-bound train approaching on the railroad cannot be seen by the driver of a south-bound vehicle until the vehicle is within 10 feet of the north rail of the crossing, then an unobstructed view can be had a distance of about 540 feet.
