REPORT NO. 3404
CHICAGO GREAT WESTERN RAILWAY COMPANY
IN RE ACCIDENT
NEAR NORTH HANOVER, ILL., ON
JUNE 2, 1951

Kind of accident: Head-end collision

Accident near North Hanover, Ill., on June 2, 1951, caused
by an inferior train occupying the main track on the
time of an opposing superior train without flag
protection.

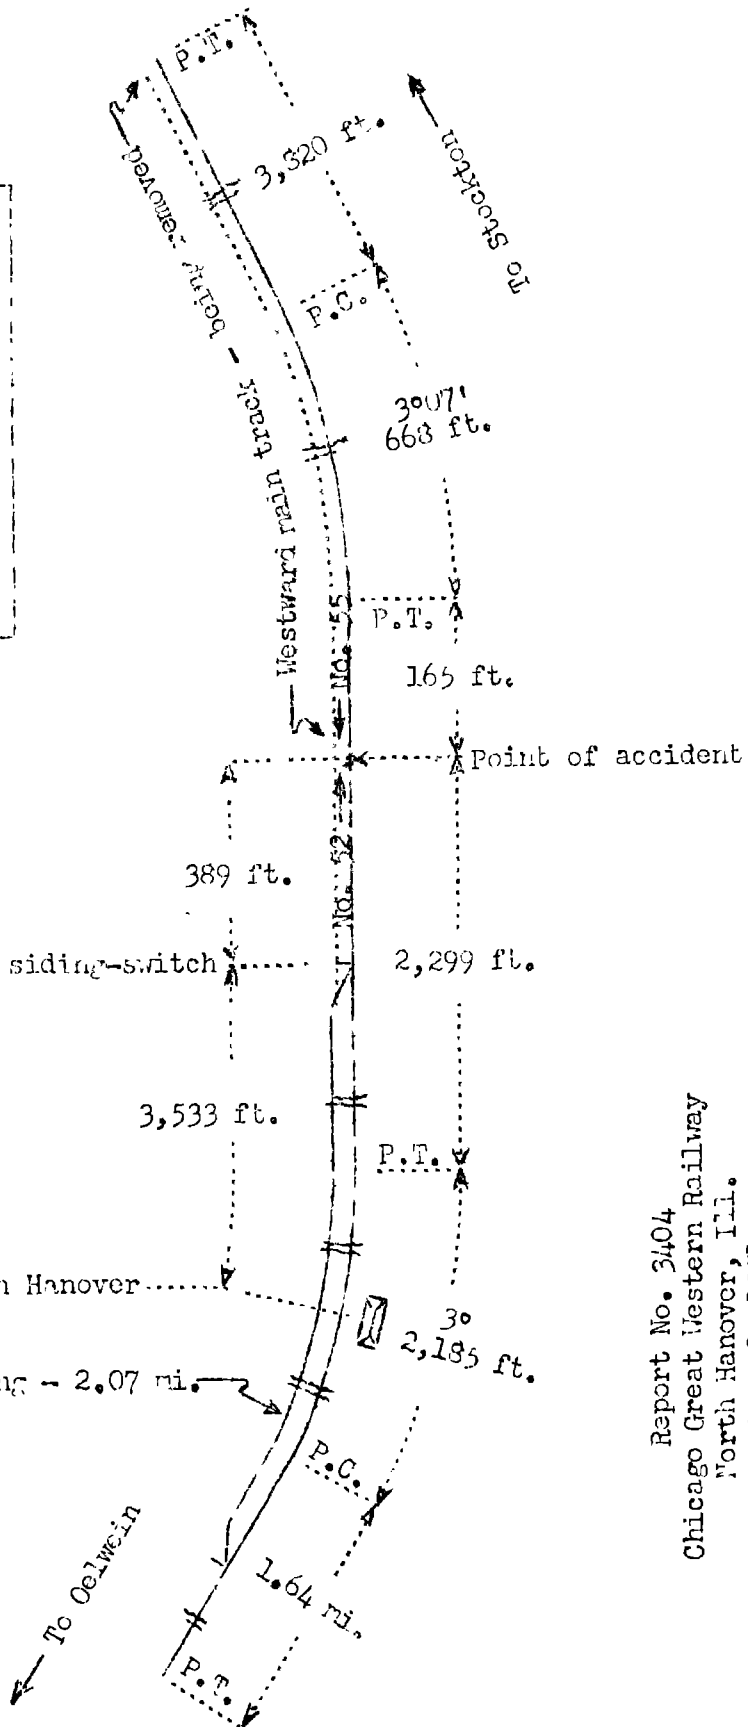
Report No. 3404
 Chicago Great Western Railway
 North Hanover, Ill.
 June 2, 1951

Location of Accident and Method of Operation
