INVESTIGATION NO. 2800
THE CHICAGO, MILWAUKEE, ST. PAUL AND PACIFIC
RAILROAD COMPANY
REPORT IN RE ACCIDENT
AT ASPINWALL, IOWA, ON
MAY 30, 1944

Accident at Aspinwall, Iowa, on May 30, 1944, caused by
failure to provide adequate protection for engine
during switching movement.

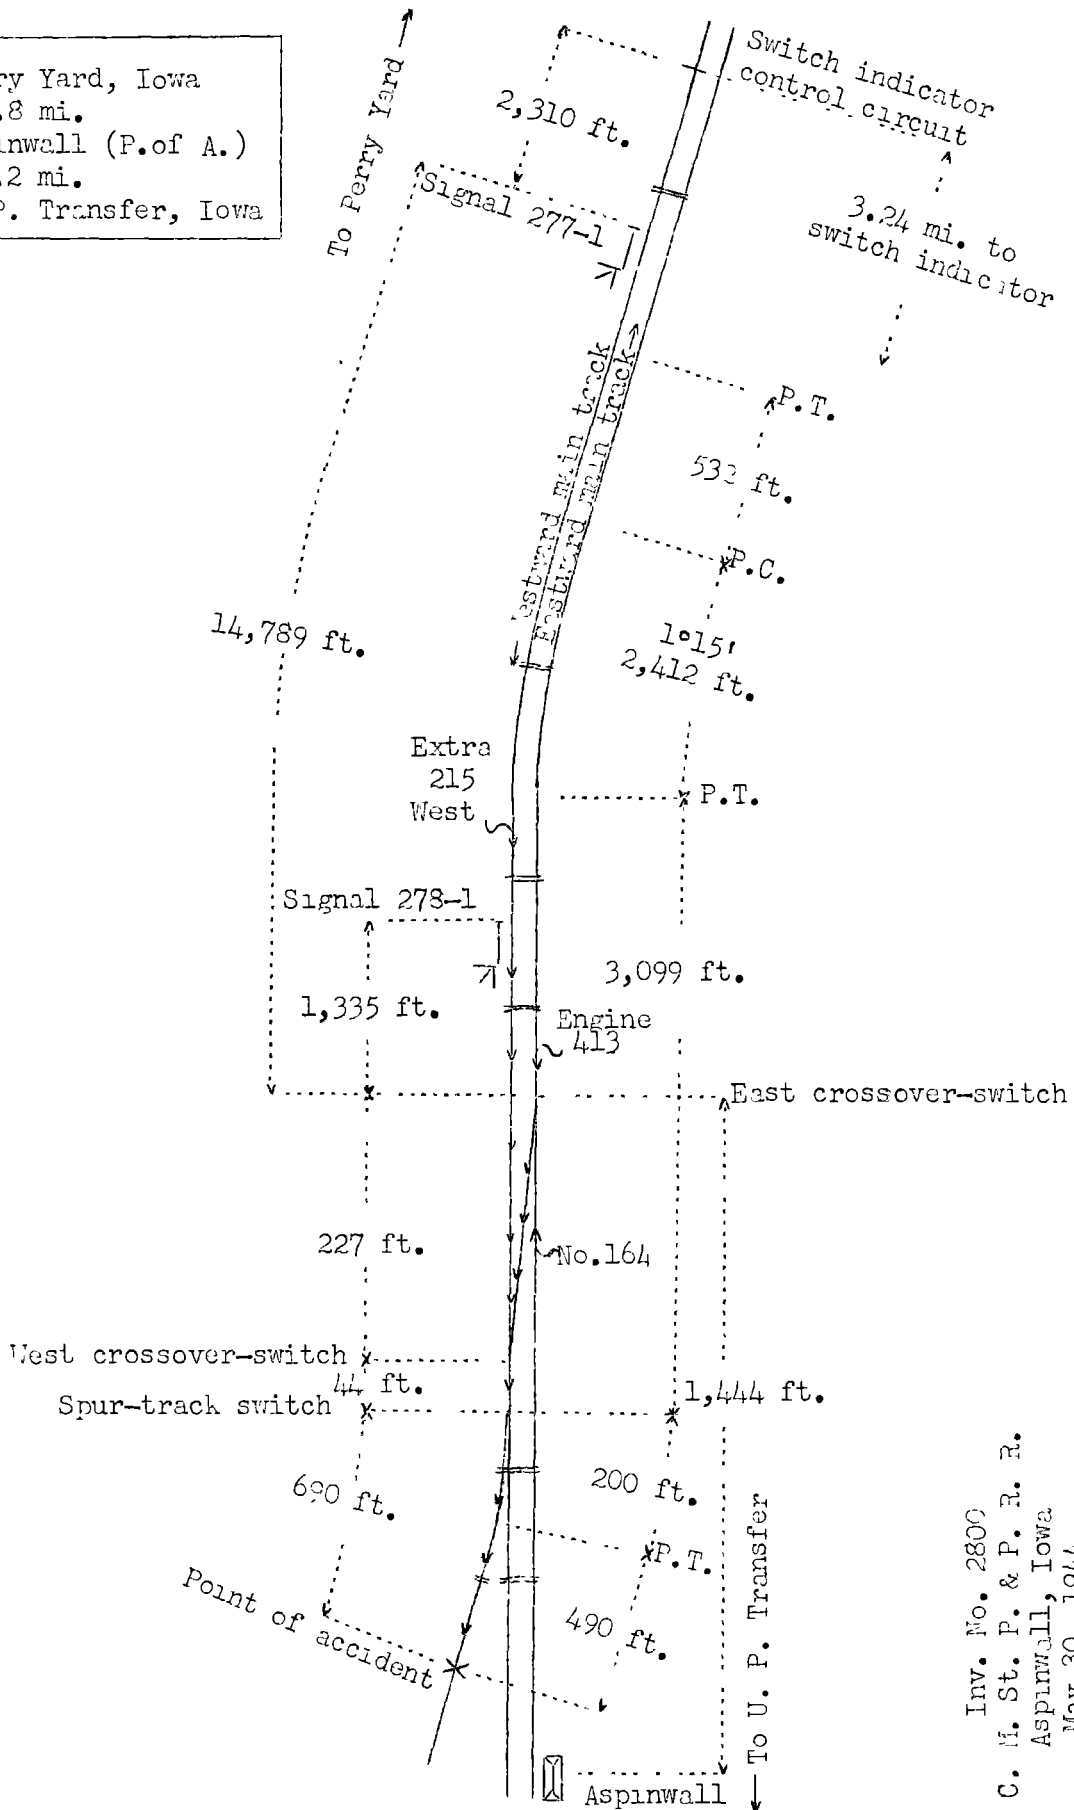
Inv. No. 2800
 C. M. St. P. & P. R. R.
 Aspinwall, Iowa
 May 30, 1944

o	Perry Yard, Iowa
	53.8 mi.
X	Aspinwall (P. of A.)
	68.2 mi.
o	U. P. Transfer, Iowa

Location of Accident and Method of Operation

When No. 164 stopped at Aspinwall, about 7:23 a. m., it fouled the east crossover-switch and stopped with the gangway of the engine about opposite the switch indicator. The rear brakeman, who had been on the engine, observed that the indicator was clear, then crossed over through the train and opened the west crossover switch. The switch indicator at the west crossover switch was controlled only by the circuits on the eastward track, and a period of approximately two minutes elapsed between the time he observed the indicator at the east crossover switch and the time he opened the west crossover switch. He then crossed back to the other side of the train and after the engine had moved the train westward a sufficient distance to clear the crossover switch he uncoupled the engine. Then the engine moved forward to a point east of the crossover, the front brakeman lined the east crossover-switch for the crossover movement, and proceeded eastward to provide flag protection, and the crossover movement was started about six minutes after the train first stopped at Aspinwall. The brakeman thought the crossover movement would not be started until after he had reached a point where he could furnish adequate flag protection. About 7:31 a. m., after the engine had moved through the crossover and had entered the spur track, it was struck by Extra 215 West.

When Extra 215 West was approaching Aspinwall it was moving at a speed of about 55 miles per hour. Signal 277-1 displayed proceed, and Extra 215 passed that signal after the rear brakeman of No. 164 had observed the switch indicator and before he opened the west crossover-switch. Because of track curvature in a cut, the view of signal 278-1 was obstructed until a point approximately 2,300 feet east of the signal was reached. Soon after the engine emerged from the cut the fireman observed signal 278-1 displaying stop, and called the indication to the engineer. The engineer stated that he immediately made a service brake-pipe reduction, but he was not certain as to the amount of reduction. When his engine was just west of signal 278-1, located 1,606 feet east of the spur-track switch, he saw engine 413 in the vicinity of that switch, and he moved the brake valve to emergency position, closed the throttle, placed the reverse lever in position for backward movement and then opened the throttle. Immediately afterward he placed the reverse lever in position for forward movement to avoid the

sliding of the driving wheels. The flagman of No. 164 had reached a point variously estimated as from 500 to 1,100 feet east of the east crossover-switch. According to his statement, he had not proceeded as far as signal 278-1 when the engine of Extra 215 passed him. He stated that at that time the engine was still working steam and the brakes had not been applied. The front brakeman said that after the accident he entered the engine cab and found the engine still working steam and the driving wheels moving in forward motion. All the employees on Extra 215 were in agreement that the brakes on their train had been properly tested and had functioned properly where used en route. The fireman, front brakeman, conductor, and flagman said that an emergency application was made prior to the accident, but none of them gave definite information as to the time or location when this was done. The engineer was not certain that emergency operation of the brakes was obtained.
