REPORT OF THE DIRECTOR  
BUREAU OF SAFETY

ACCIDENT ON THE  
CHICAGO, MILWAUKEE, ST. PAUL & PACIFIC RAILROAD

LANARK, ILL.

INVESTIGATION NO. 2244

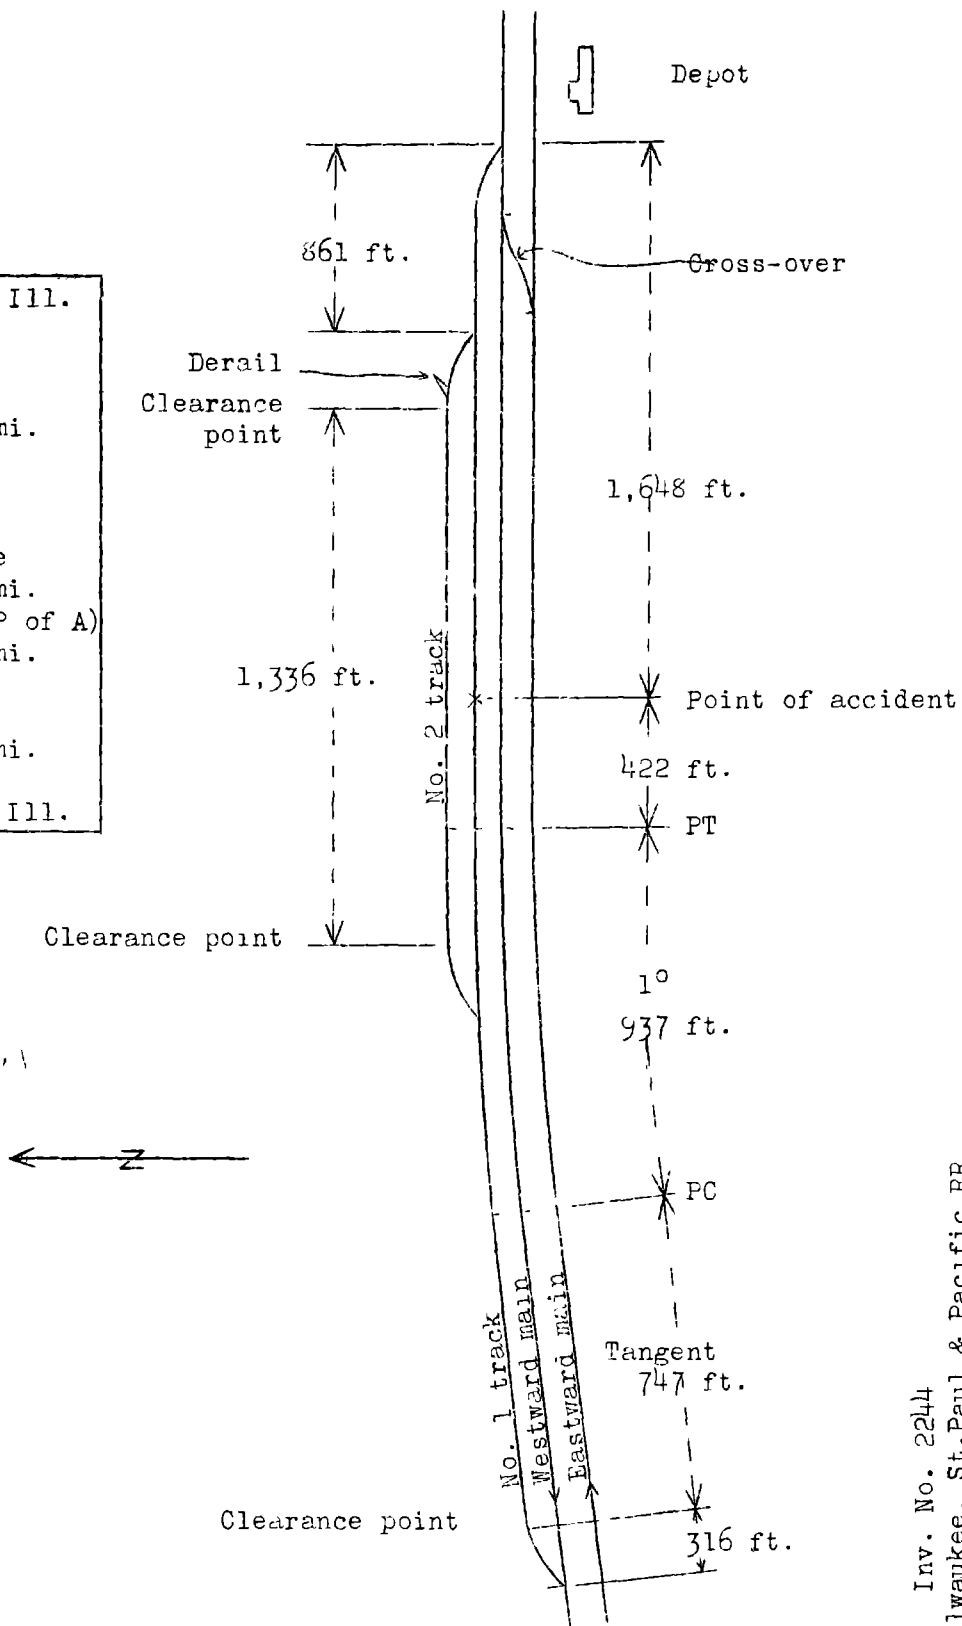
Inv. No. 2244  
 Chicago, Milwaukee, St. Paul & Pacific RR,  
 Lanark, Ill.  
 Jan. 12, 1938

○	Chicago, Ill.
	116.6 mi.
○	Kittredge
	3.6 mi.
✱	Lanark (P of A)
	4.9 mi.
○	Ashdale
	13.0 mi.
○	Savanna, Ill.
