REPORT OF THE DIRECTOR

ACCIDENT ON THE

CHICAGO, MILWAUKEE, ST. PAUL AND PACIFIC RAILROAD

MARVIN, S. DAK.

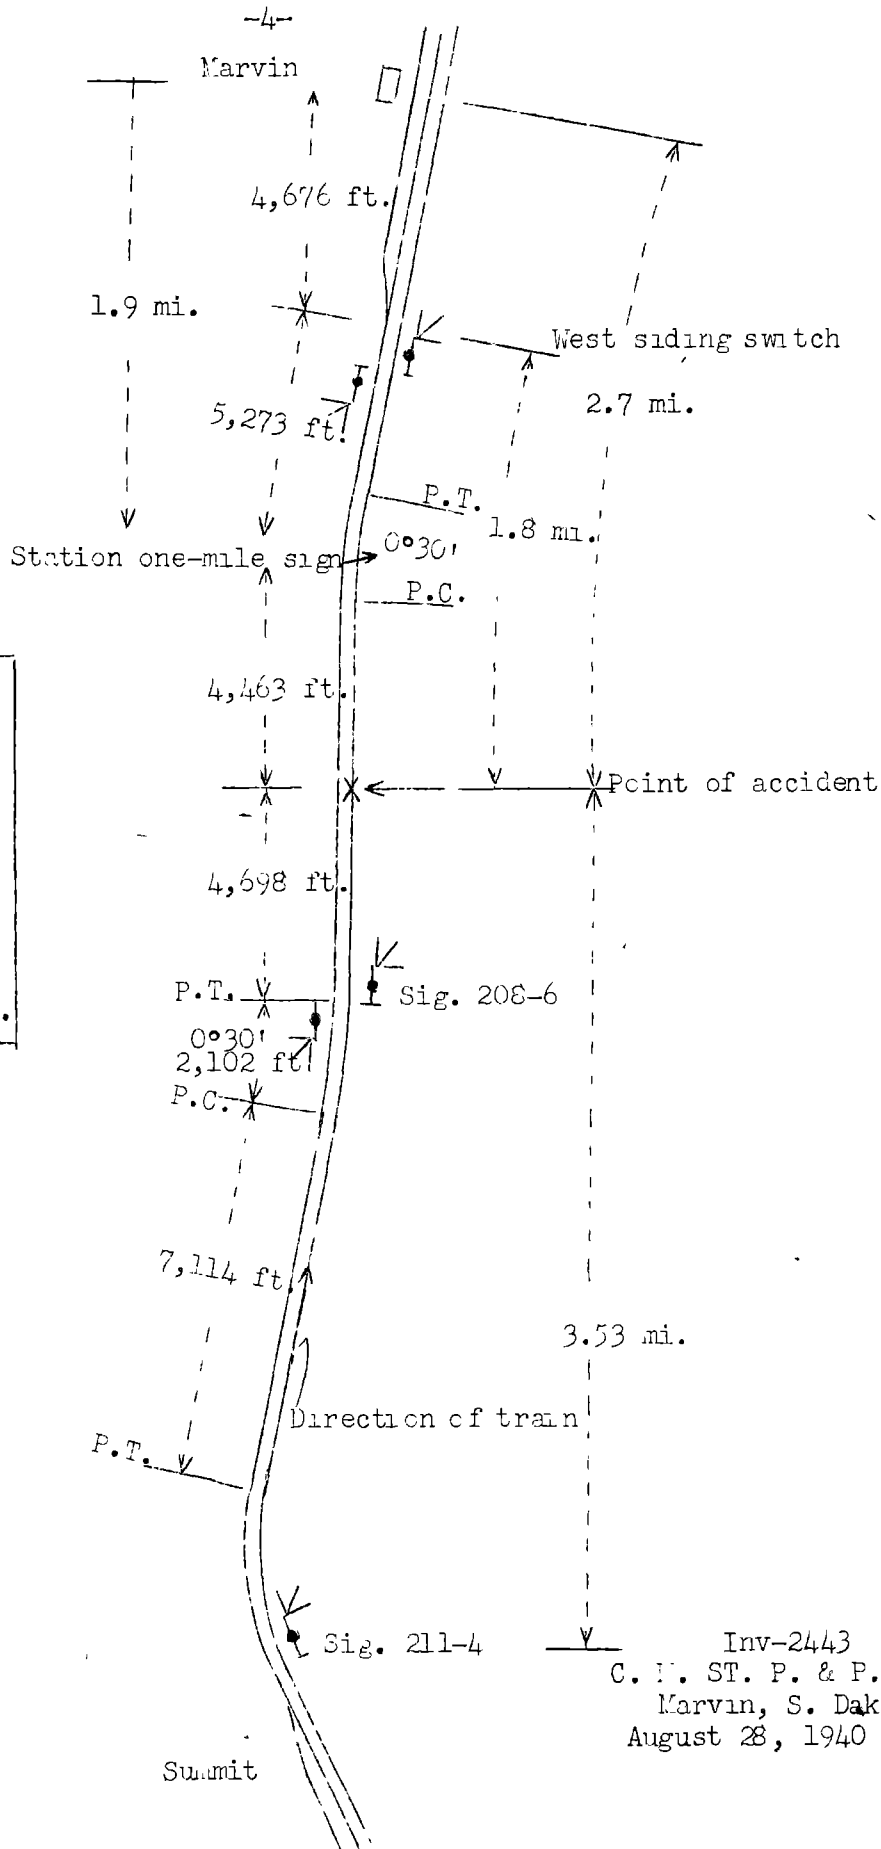
Inv-2443
 C. N. ST. P. & P.R.R.
 Marvin, S. Dak.
 August 28, 1940

○	Montevideo, Min..	71.6 mi.
○	Marvin, S. Dak.	2.7 mi.
x	Point of accident	4.5 mi.
○	Summit	77.9 mi.
○	Aberdeen	0.5 mi.
○	Aberdeen Yard, S. Dak.
