INVESTIGATION NO. 2624
THE CHICAGO, MILWAUKEE, ST. PAUL AND PACIFIC
RAILROAD COMPANY
REPORT IN RE ACCIDENT
AT MILES CITY, MONT., ON
SEPTEMBER 1, 1942

Kind of accident: Rear-end collision

Accident at Miles City, Mont., on September 1, 1942, caused
by failure properly to control speed of following train
moving within yard limits.

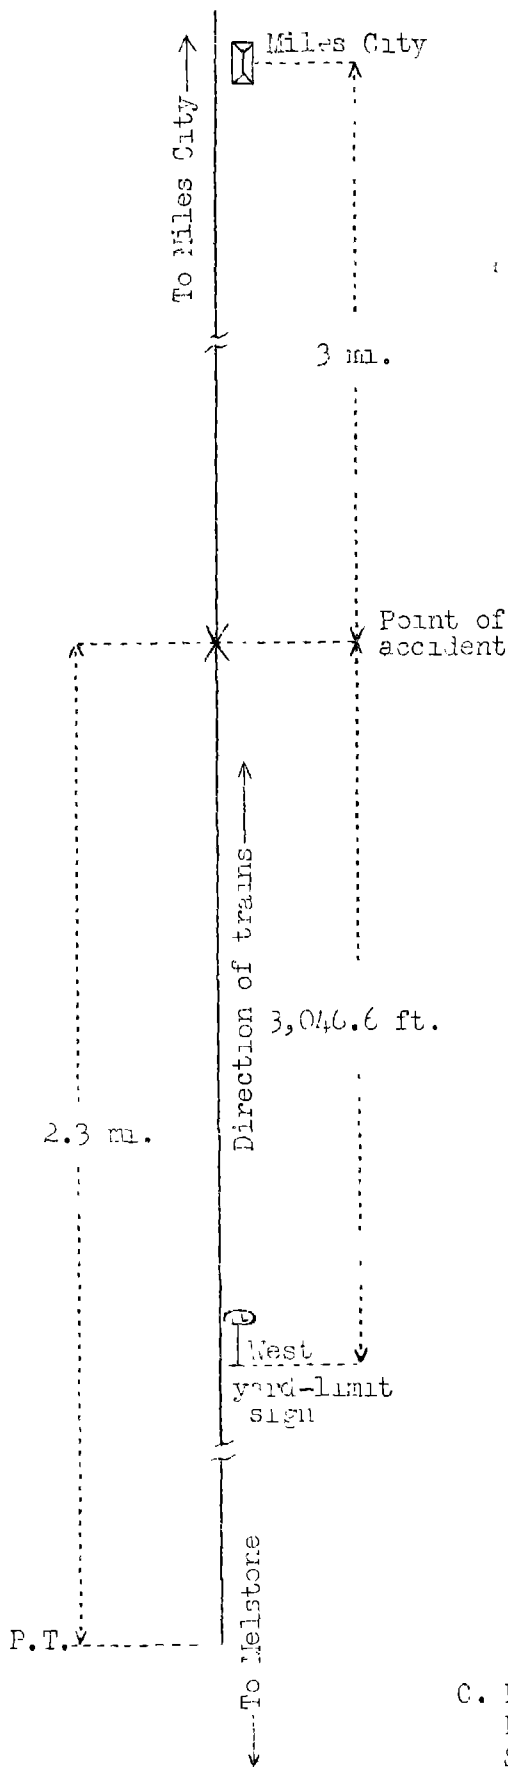
Inv. No. 2624
C. M. St. F. & P. R. R.
Miles City, Mont.
September 1, 1942

- Miles City, Mont.
3.0 mi.
- X Point of accident
4.8 mi.
- Paragon
54.4 mi.
- Vananda
49.4 mi.
- Melstone, Mont.
