REPORT NO. 3390  
CHICAGO, MILWAUKEE, ST. PAUL AND PACIFIC  
RAILROAD COMPANY

IN RE ACCIDENT  
AT MITCHELL, S. DAK., ON  
MARCH 6, 1951

Report No. 3390  
 Chicago, Milwaukee, St. Paul  
 and Pacific Railroad  
 Mitchell, S. Dak.  
 March 6, 1951

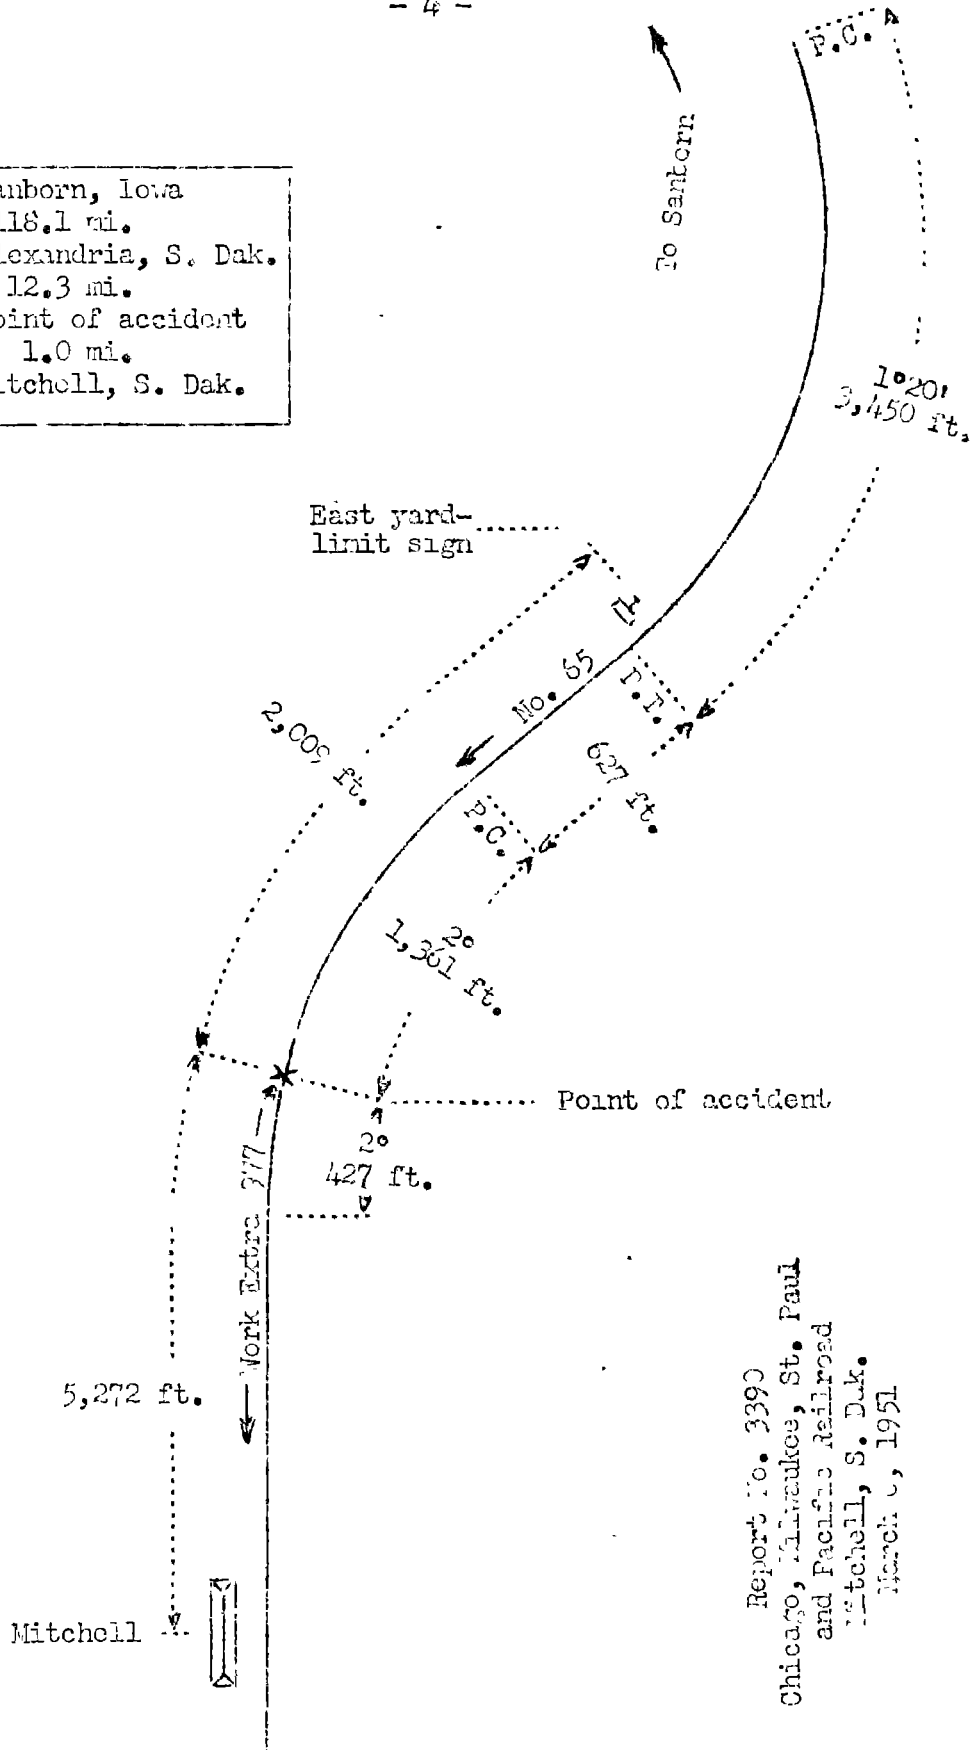
- o Sanborn, Iowa
- | 118.1 mi.
- o Alexandria, S. Dak.
- | 12.3 mi.
- X Point of accident
- | 1.0 mi.
- o Mitchell, S. Dak.
