INTERSTATE COMMERCE COMMISSION

REPORT OF THE DIRECTOR

ACCIDENT ON THE

CHICAGO, MILWAUKEE, ST. PAUL & PACIFIC R.R.

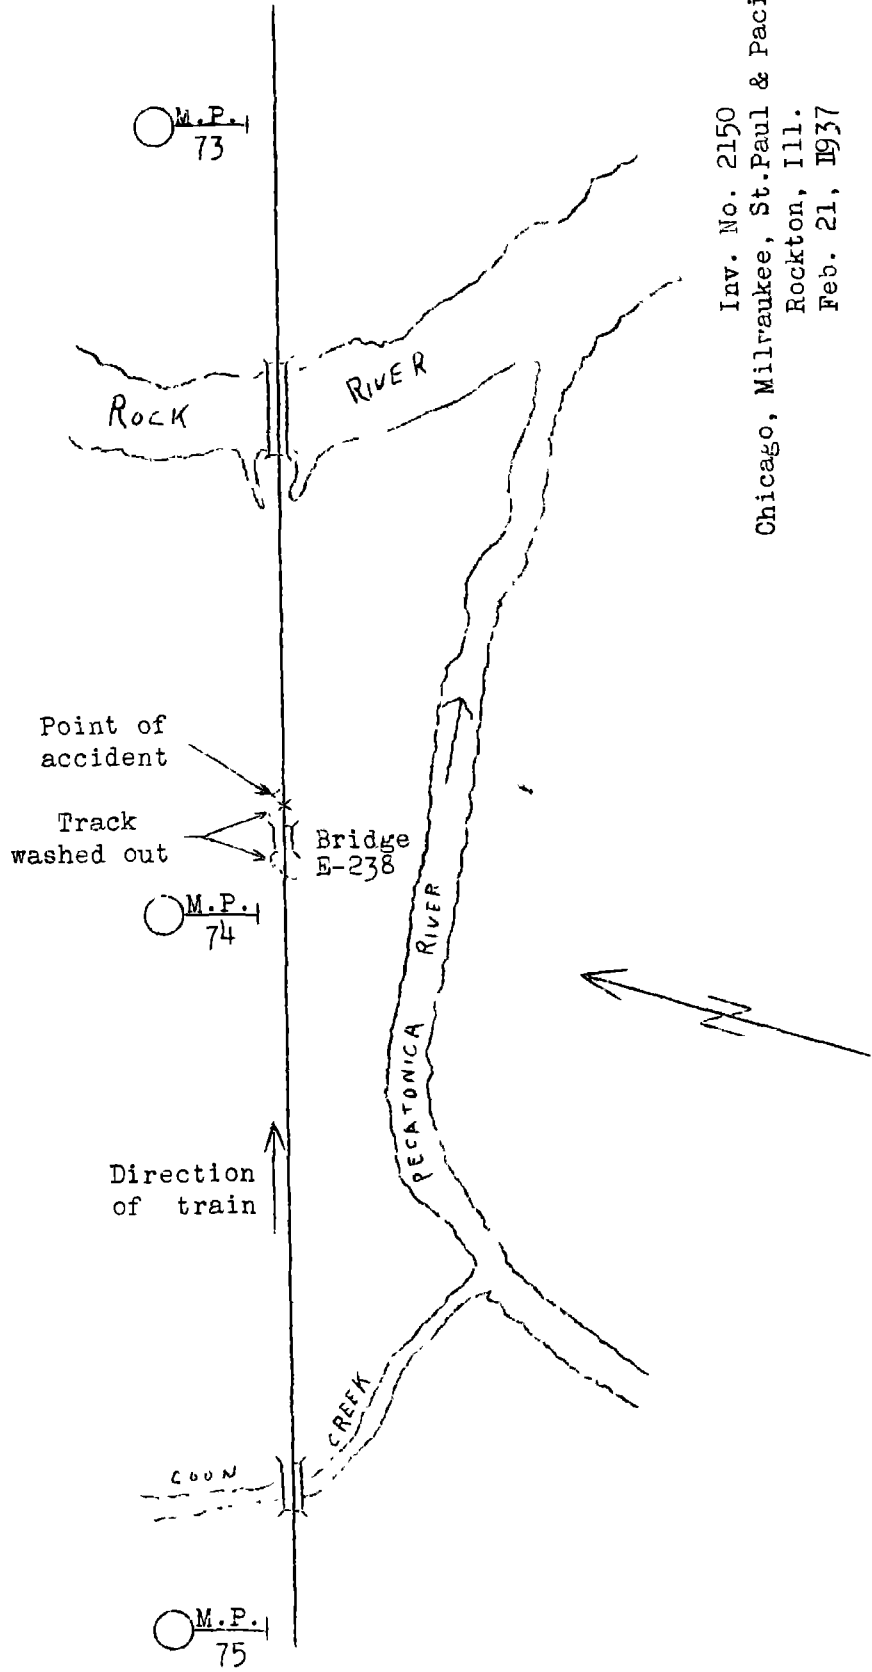
Inv. No. 2150
 Chicago, Milwaukee, St. Paul & Pacific R.R.
 Rockton, Ill.
 Feb. 21, 1937

| ○ Sturtevant, Wis. |
| 42.7 mi. |
| ○ Darien |
| 29.8 mi. |
| ○ Kittredge, Ill. |

This accident occurred on that part of the Second District of the Milwaukee Division extending between Kittredge, Ill., and Sturtevant, Wis., a distance of 112.2 miles; in the vicinity of the point of accident this is a single-track line over which trains are operated by time table, train orders and a manual block-signal system. The derailment occurred about 1.5 miles west of Rockton, at a point approximately 10 feet east of bridge E-238; approaching this point from either direction the track is tangent for several miles. The grade is practically level, being 0.1 percent ascending for eastbound trains at the point of accident. The maximum authorized speed for passenger trains is 60 miles per hour.
