REPORT NO. 3743

CHICAGO, MILWAUKEE, ST. PAUL AND PACIFIC
RAILROAD COMPANY

AT MAUSTON, WIS., ON

APRIL 2, 1957

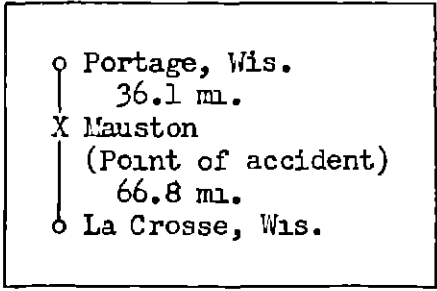
Report No. 3743
Chicago, Milwaukee, St. Paul and Pacific Railroad
Mauston, Wis.
April 2, 1957

To Portage ↑

↓ To La Crosse

The forward portion of the train stopped with the front end 1 mile west of the station. The derailed cars stopped in various positions on or near the tracks, and several of the cars struck the station. The station was demolished, 14 cars were destroyed, 22 were heavily damaged, and 1 was slightly damaged.

Examination of the track structure of the westward main track after the accident occurred disclosed that westward from a point 3,783 feet east of the station at Mauston bond wires on the south side of the south rail were broken or scraped intermittently and the east ends of the tops of the joint bars were scored. At a rail-highway grade crossing 2,481 feet east of the station the east end of a plank outside the south rail had been struck and splintered. A plank inside the north rail at this crossing bore marks indicating that wheels had become derailed to the south. The wheels had moved approximately in line with the track to the north rail of the crossover. They had been deflected to the north at the latter point, and the rear truck of the thirty-ninth car had become separated from the car. The general derailment occurred a short distance west of the crossover.
