INVESTIGATION NO. 2690
THE CHICAGO, ROCK ISLAND & PACIFIC
RAILWAY COMPANY
REPORT IN RE ACCIDENT
NEAR TIE PLANT, ARK., ON
APRIL 4, 1943

Accident near Tie Plant, Ark., on April 4, 1943, caused by
an inferior train occupying the main track on the time
of an opposing superior train.

Inv. No. 2690
 Chicago, Rock Island & Pacific Railway
 Tie Plant, Ark.
 April 4, 1943

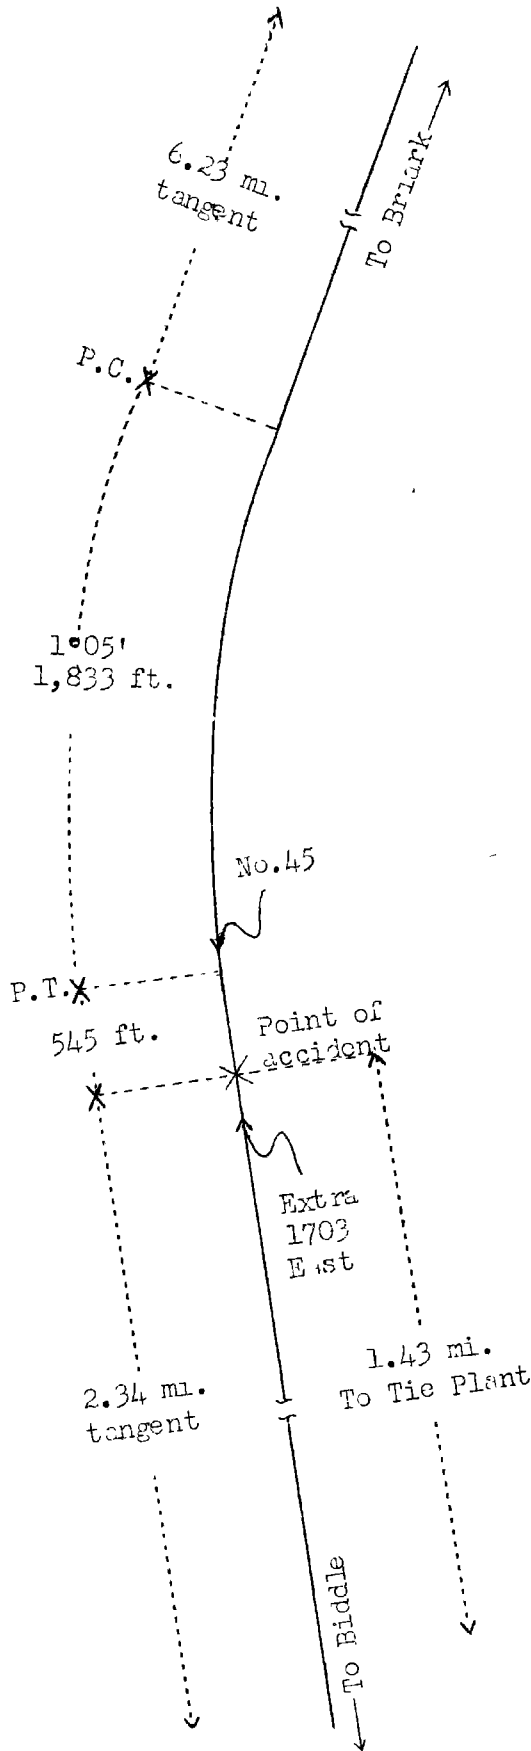
○ Briark, Ark.	5.3 mi.
○ Hulbert	59.1 mi.
○ Cotton Belt Jct.	43.0 mi.
○ Lonoke	16.67 mi.
X Point of accident	1.43 mi.
○ Tie Plant	2.3 mi.
○ North Little Rock	0.9 mi.
○ MoPac Crossing	0.1 mi.
○ Little Rock	2.3 mi.
○ Bidale, Ark.

Location of Accident and Method of Operation
