REPORT NO. 3734

CHICAGO, ROCK ISLAND AND PACIFIC  
RAILROAD COMPANY

NEAR AULNE, KANS., ON

DECEMBER 6, 1956

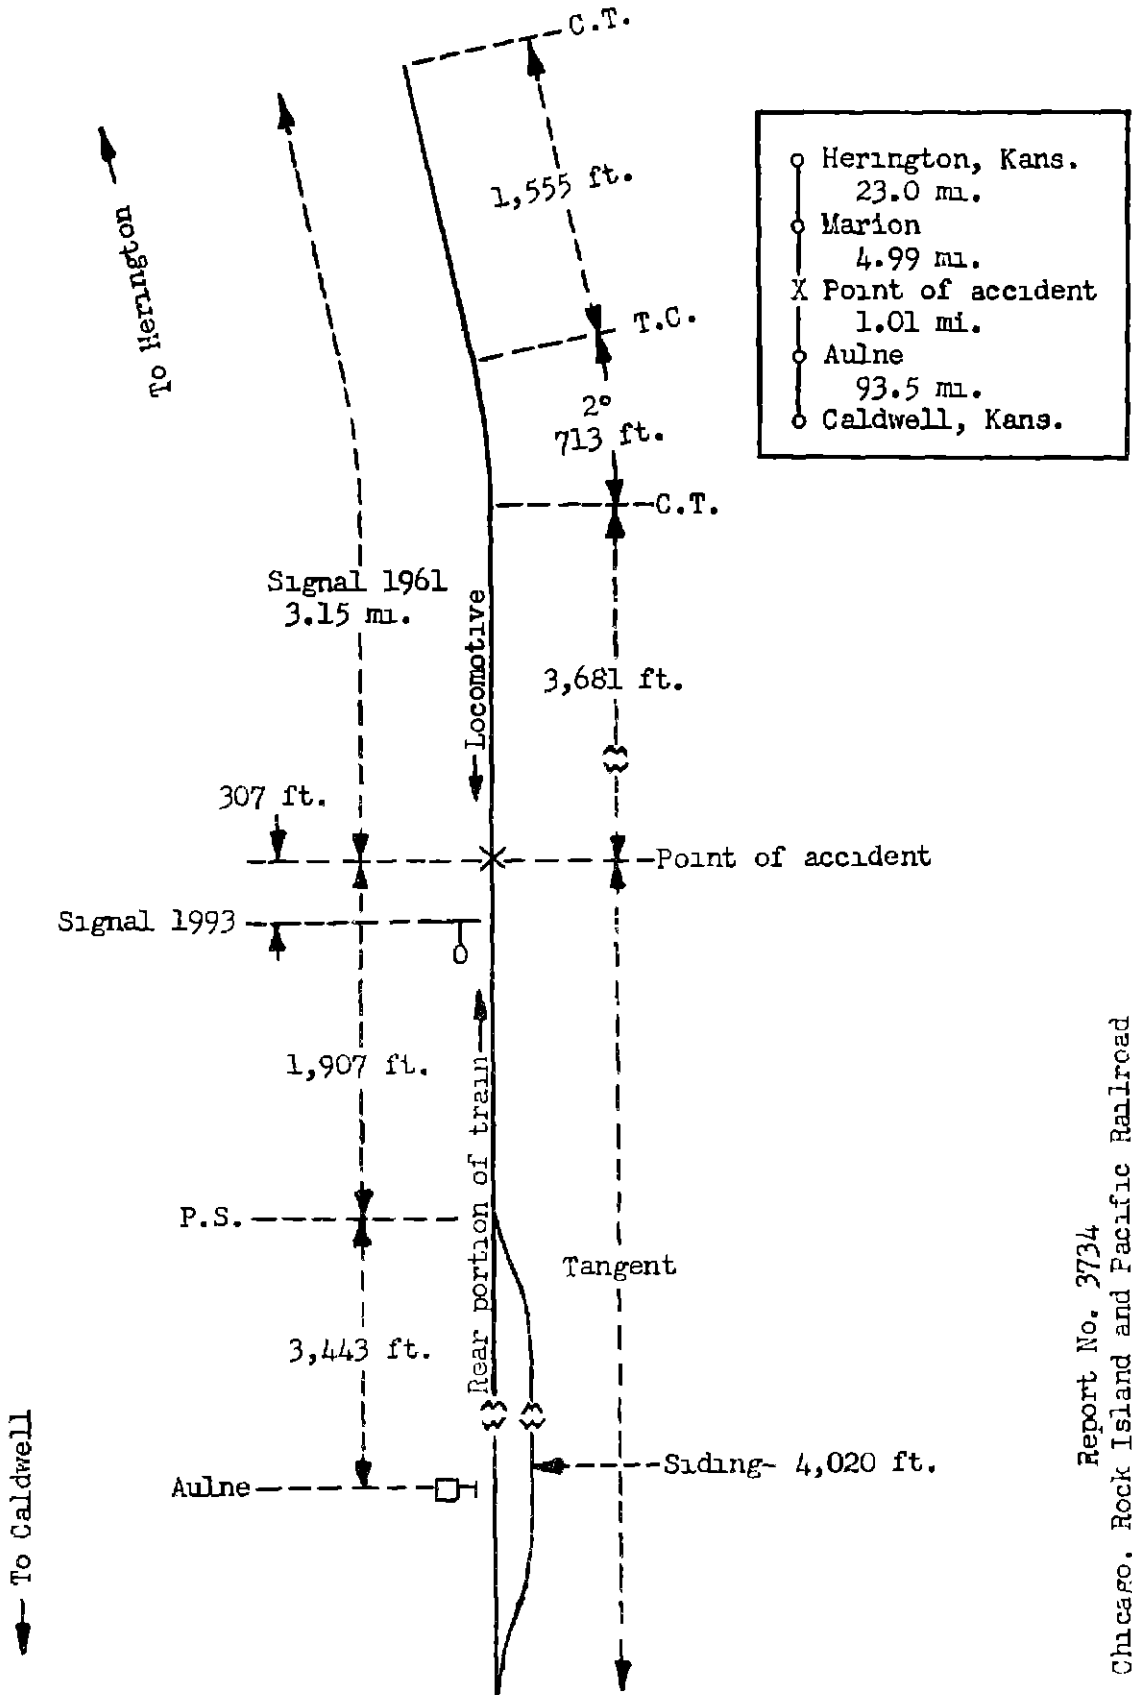
Report No. 3734  
 Chicago, Rock Island and Pacific Railroad  
 Aulne, Kans.  
 December 6, 1956

After the forward portion of the train reached Marion, the rear portion of the train on the main track at Aulne and north of Aulne caused all southward signals between Aulne and Marion to continue to display their most restrictive aspects. The conductor obtained permission from the train dispatcher for the locomotive to pass a southward absolute signal at the south end of the siding at Marion to return for the rear portion of the train, and the locomotive then departed southbound. The members of the train crew were in the control compartment at the south end of the locomotive, and the enginemen were in the control compartment at the north end. The headlight at the south end of the locomotive was lighted brightly. The engineer said that the southward movement was made at a speed of from 15 to 20 miles per hour. The members of the crew saw the aspect displayed by signal 1961. They knew that this aspect was displayed because of the rear portion of their train in the block of the signal, and for this reason they did not stop before passing the signal. The conductor said that after the locomotive passed the crest of an ascending grade about 2,500 feet north of the point of accident the speed appeared to increase slightly. The front brakeman said that he then gave reduce-speed signals with his lantern from the door on the east side of the control compartment. These signals were not acted upon, and the conductor said that he then gave reduce-speed signals from the door on the opposite side of the control compartment. There was no response to these signals. The conductor and the brakeman thought the signals were given throughout a distance of about 1,400 feet. They said that the flagman,

Under the rules of this carrier the aspect displayed by signal 1961 for the movement of the locomotive of Extra 134 North required that the locomotive stop before passing the signal and then proceed at low speed through the entire block. Low speed is defined in part as a speed that will permit stopping short of an obstruction but not exceeding 15 miles per hour. The rules also provide that when an engine leaves a portion of its train on a main track under conditions which may make it difficult for the returning engineer to locate the standing portion, two torpedoes must be placed not less than 20 car lengths in advance of the head end of rear portion to serve as a warning. In the instant case the conductor of Extra 134 North said he knew the location of the north end of the rear portion of his train with respect to the location of signal 1993, and since he did not anticipate any difficulty in locating the rear portion of the train he did not consider the use of torpedoes necessary.
