RAILROAD ACCIDENT INVESTIGATION

Report No 3893

CHICAGO, ROCK ISLAND AND PACIFIC RAILROAD COMPANY

PRATT, KANS

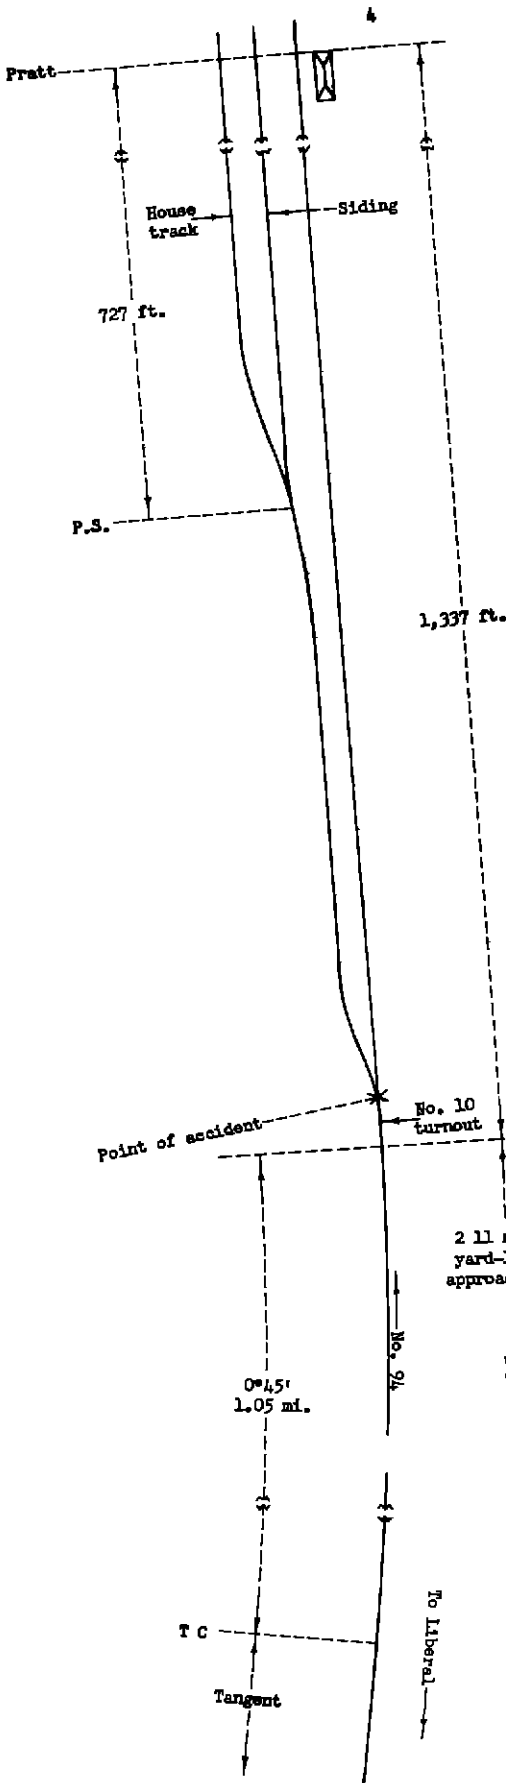
Chicago, Rock Island and Pacific Railroad
 Pratt, Kans
 June 26, 1960

○	Pratt, Kans.	0.2 mi.
X	Point of accident	4.4 mi.
○	Smalley	52.4 mi.
○	Kingsdown	7.8 mi.
○	Bloom	33.7 mi.
○	Misler	17.0 mi.
○	Kinsst	17.1 mi.
○	Liberal, Kans.

This accident occurred on that part of the Missouri-Kansas Division extending between Liberal and Pratt, Kans., 132.6 miles, a single track line, over which trains are operated by timetable, train orders and an automatic block signal system. At Pratt a siding parallels the main track on the north. The west switch of this siding is 1,337 feet west of the station and the east siding-switch is located a considerable distance east of that point. An auxiliary track designated as the house track parallels the siding on the north and converges with it at a switch located 727 feet west of the station. The west yard-limit-approach sign and the yard-limit sign are located, respectively, 2.11 miles and 1.34 miles west of the west siding-switch. The accident occurred within yard limits on the turnout of the west siding-switch. From the west the main track is tangent throughout a considerable distance and then there is a 0°15' curve to the left 1.05 miles to the west switch of the siding and the No. 10 turnout on which the derailment occurred. The siding is tangent a considerable distance immediately east of the point of accident. The grade for eastbound trains in this territory is generally descending eastward and between Sralley, 4.6 miles west of Pratt, and the point of accident it varies between 0.7 percent descending and 0.7 percent ascending and is 0.7 percent ascending at that point.
