ACCIDENT ON THE  
CHICAGO, ROCK ISLAND & PACIFIC RAILWAY

BRANDT, S. DAK.

FEBRUARY 20, 1939.

INVESTIGATION NO. 2334

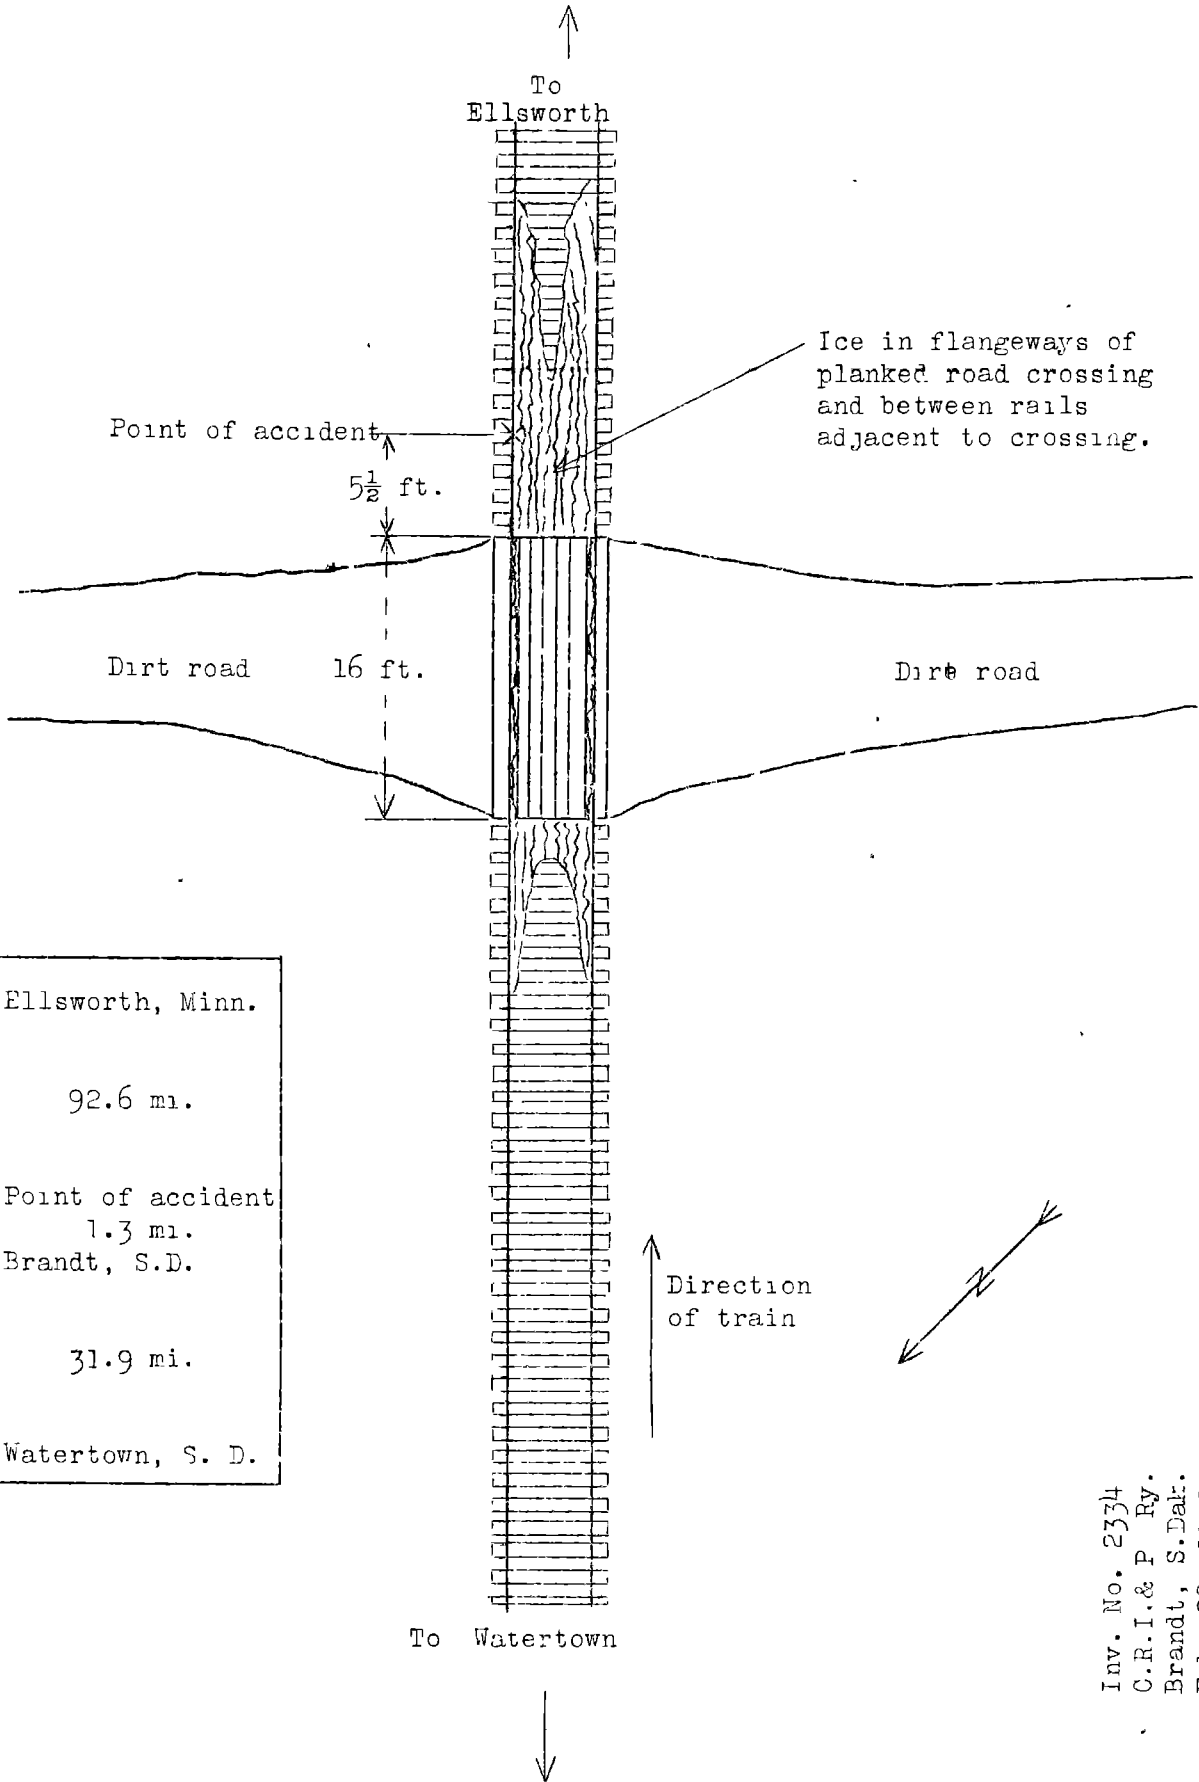
Inv. No. 2334  
 C.R.I. & P Ry.  
 Brandt, S. Dak.  
 Feb. 20, 1939

o Ellsworth, Minn.
92.6 mi.
X Point of accident
1.3 mi.
o Brandt, S.D.
31.9 mi.
o Watertown, S. D.

This accident occurred on that part of the Cedar Rapids Division designated as Sub-Division 22 which extends between Elsworth, Minn., and Watertown, S. Dak., a distance of 125.8 miles. This is a single-track line over which trains are operated by timetable and train orders, no block-signal system being in use. The accident occurred at a point 1.3 miles east of Brandt. Approaching from the west there is a tangent of almost two miles extending to and about 900 feet beyond the point of accident. The grade for eastward trains is 0.661 percent ascending to within 10 feet of the point of accident where it is practically level.
