INVESTIGATION NO. 2933
THE CHICAGO, ROCK ISLAND AND PACIFIC
RAILWAY COMPANY
REPORT IN RE ACCIDENT
NEAR GASCONDY, MO., ON
SEPTEMBER 22, 1945

Railroad: Chicago, Rock Island and Pacific
Date: September 22, 1945
Location: Gascondy, Mo.
Kind of accident: Rear-end collision
Trains involved: Freight : Freight
Train numbers: 92 : Extra 25⁰¹ East
Engine numbers: ~~2057~~ : 2591
Consist: ~~32 cars~~, caboose : caboose
Estimated speed: Standing : 15 m. p. h.
Operation: Timetable and train orders
Track: Single; 6⁰ curve; 0.76 percent ascending grade eastward
Weather: Raining
Time: 7:20 a. m.
Casualties: 1 killed
Cause: Failure to provide adequate protection for preceding train

Accident near Gascondy, Mo., on September 22, 1945, caused
by failure to provide adequate protection for the
preceding train.

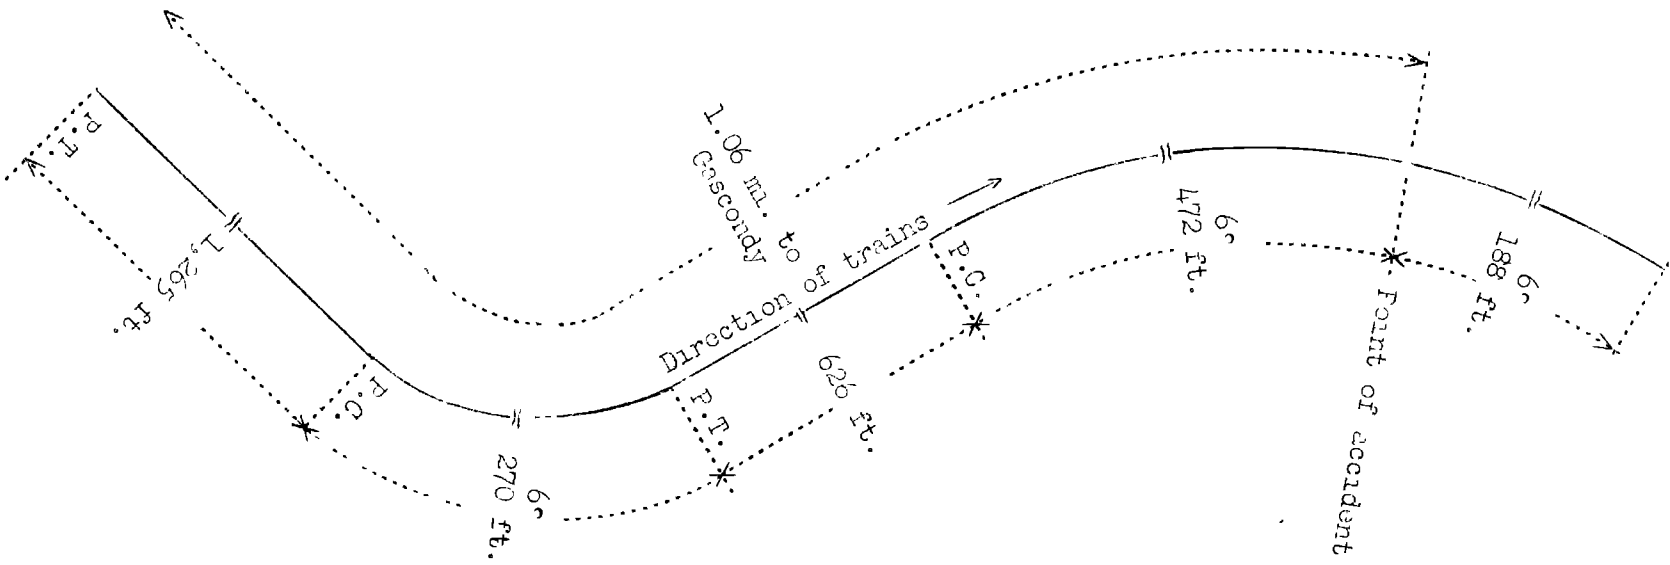
Inv. No. 2933
 Chicago, Rock Island and Pacific Railway
 Gascondy, Mo.
 September 22, 1945

○	Lackland, Mo.
	100.44 mi.
X	Point of accident
	1.06 mi.
	Gascondy
○	Elden, Mo.
	45.60 mi.

Location of Accident and Method of Operation

Because of moisture on the rails on a 0.76 percent ascending grade and an obstruction in the sand pipes of the engine which prevented sand from being deposited upon the rails, the engine of No. 92 stalled and the train stopped on the main track about 1 mile east of Gascondy about 7:17 a. m., with the rear end standing 472 feet east of the west end of a 6° curve to the right. About 3 minutes later the rear end was struck by Extra 2591 East.
