REPORT NO. 3288  
CHICAGO, ROCK ISLAND AND PACIFIC  
RAILROAD COMPANY  
IN RE ACCIDENT  
NEAR MEADE, KANS., CN  
OCTOBER 10, 1949

Accident near Meade, Kans., on October 10, 1949, caused  
by a washout.

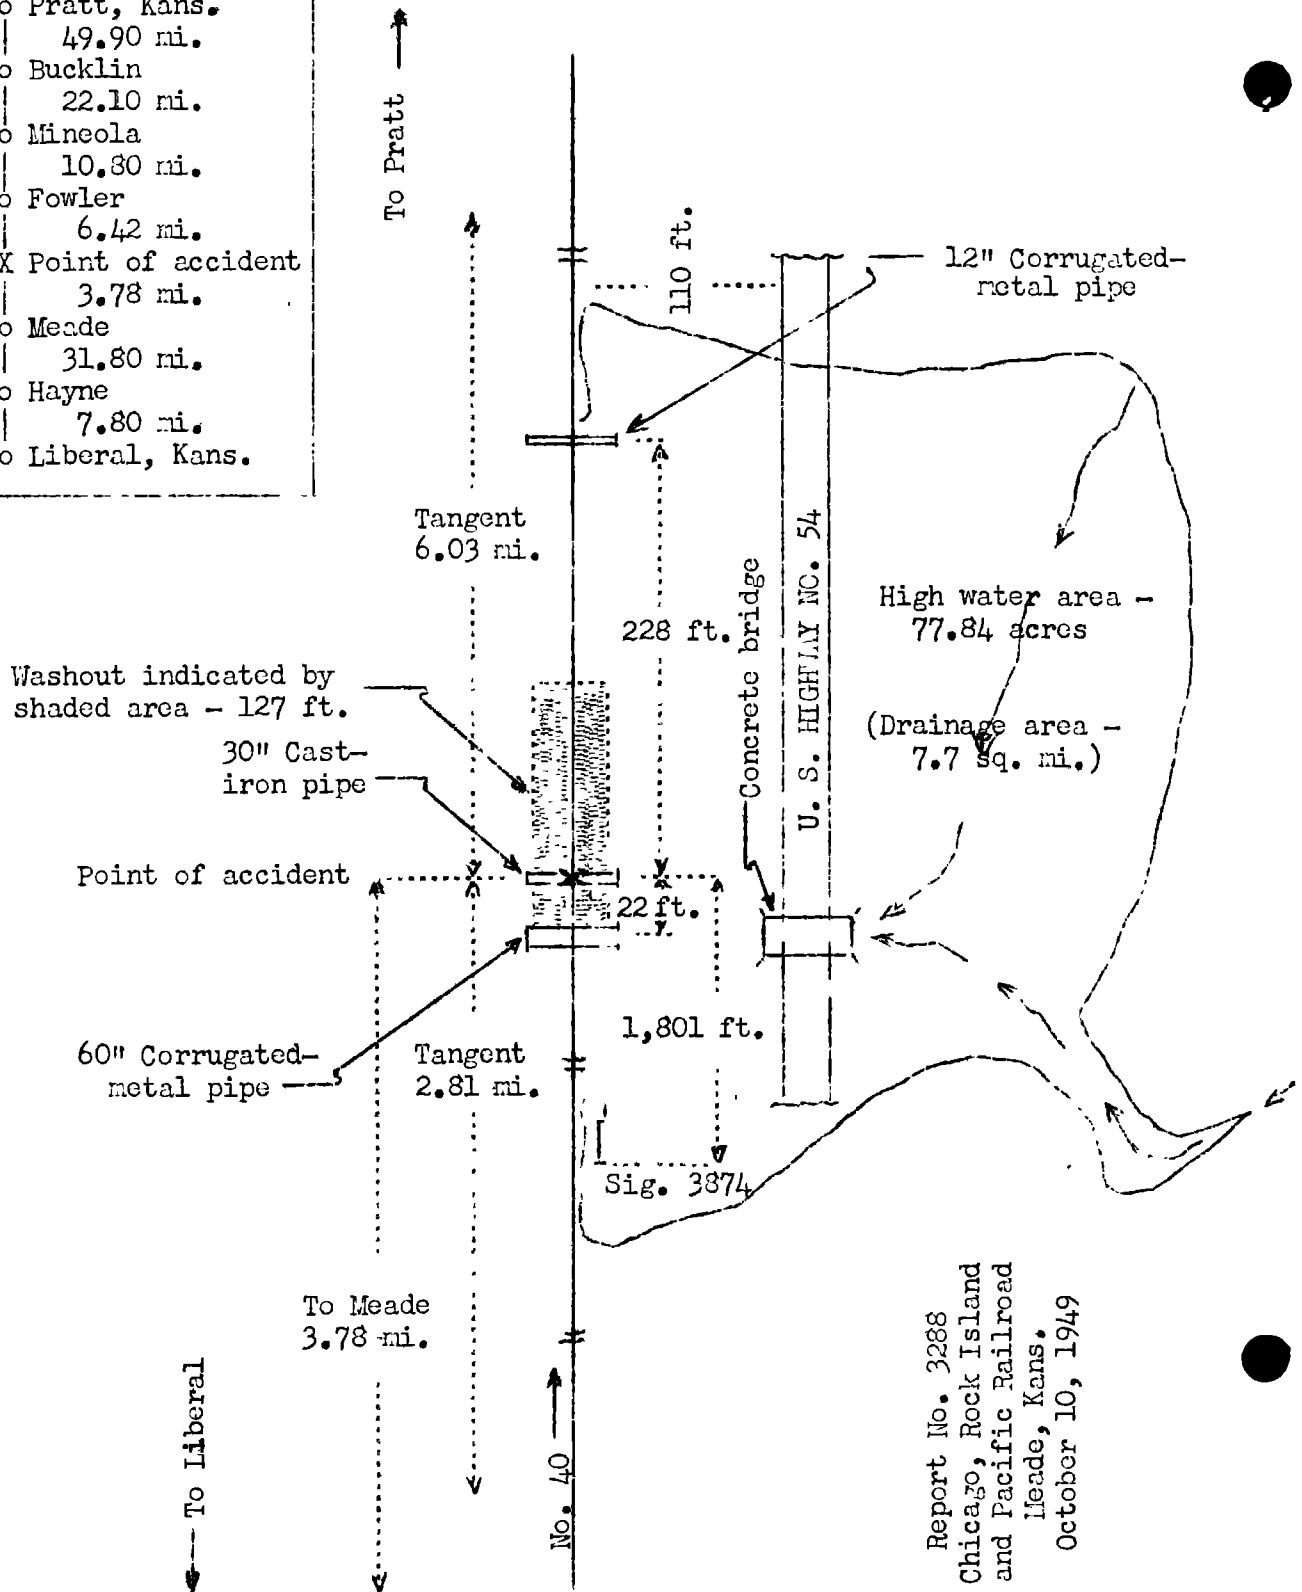
Report No. 3288  
 Chicago, Rock Island  
 and Pacific Railroad  
 Meade, Kans.  
 October 10, 1949

- Pratt, Kans. 49.90 mi.
- Bucklin 22.10 mi.
- Mineola 10.80 mi.
- Fowler 6.42 mi.
- X Point of accident 3.78 mi.
- Meade 31.80 mi.
- Hayne 7.80 mi.
- Liberal, Kans.

Location of Accident and Method of Operation
