INVESTIGATION NO 2824  
THE CHICAGO, ROCK ISLAND & PACIFIC  
RAILWAY COMPANY  
REPORT IN RE ACCIDENT  
NEAR NORTON, KANS., ON  
SEPTEMBER 3, 1944

Accident near Norton, Kans., on September 3, 1944, caused  
by failure to deliver a meet order.

Inv. No. 2824  
 Chicago, Rock Island & Pacific Railway  
 Norton, Kans.  
 September 2, 1944

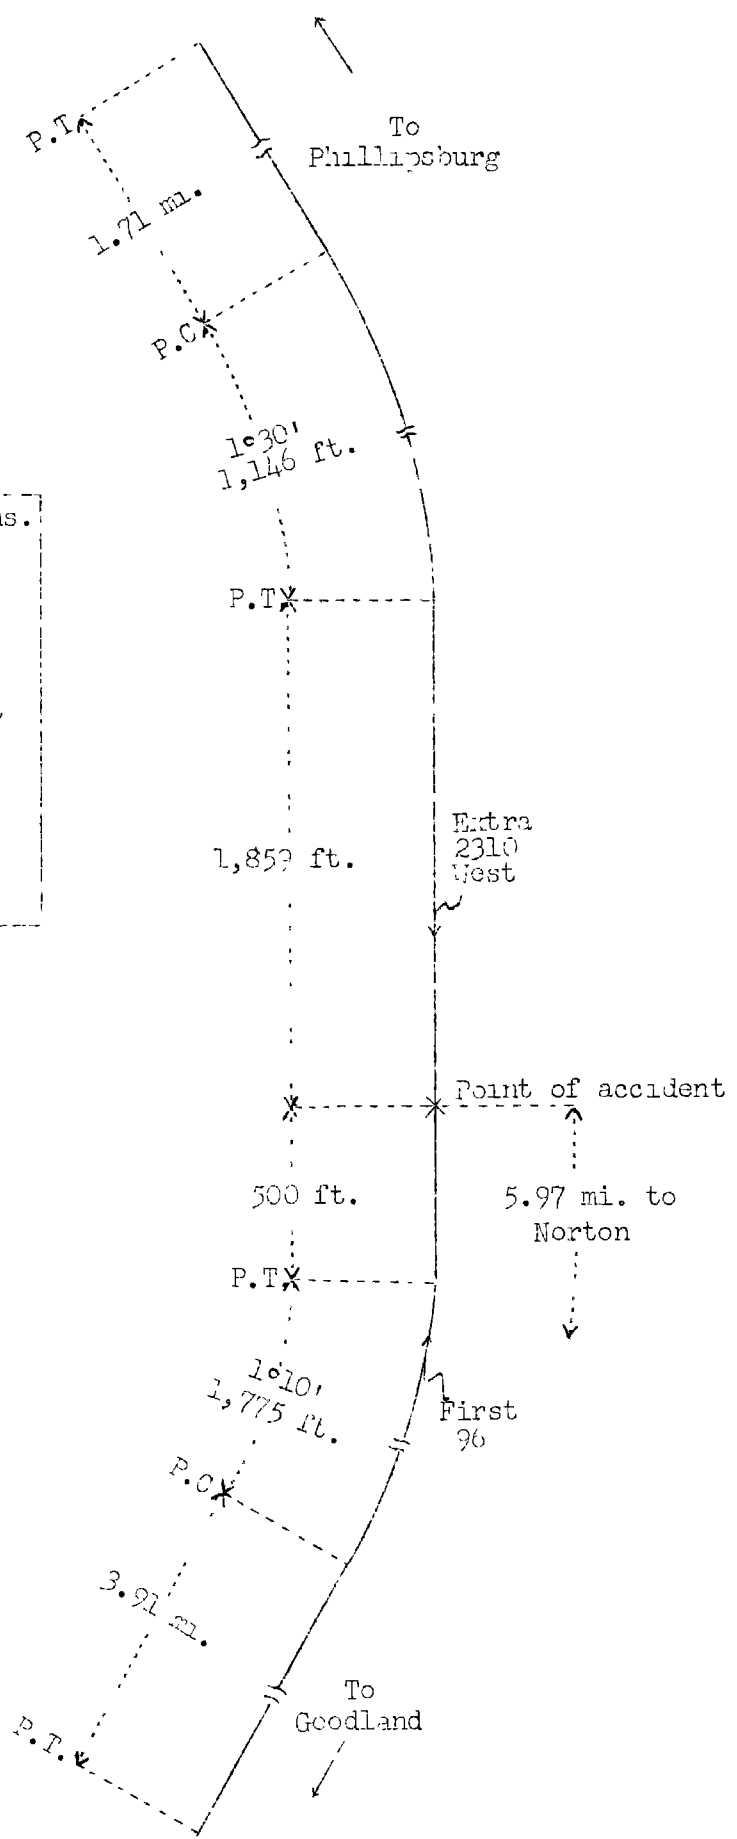
- Phillipsburg, Kans. 14.40 mi.
- Prairie View 8.20 mi.
- Almena 5.53 mi.
- ✕ Point of accident 5.97 mi.
- Norton 42.20 mi.
- Selden 63.00 mi.
- Goodland, Kans.

Location of Accident and Method of Operation
