INVESTIGATION NO. 2881
THE CHICAGO, ROCK ISLAND AND PACIFIC
RAILWAY COMPANY
REPORT IN RE ACCIDENT
AT SAGINAW, TEXAS, ON
APRIL 3, 1945

Railroad: Chicago, Rock Island and Pacific
Date: April 3, 1945
Location: Saginaw, Texas
Kind of accident: Derailment
Train involved: Freight
Train number: Extra 2688 South
Engine number: 2688
Consist: 53 cars, caboose
Estimated speed: 10 m. p. h.
Operation: Timetable and train orders
Track: Single; 7° curve; 0.75 percent
descending grade southward
Weather: Cloudy
Time: 2:01 p. m.
Casualties: 1 killed
Cause: Improperly maintained turnout

Accident at Saginaw, Texas, on April 3, 1945, caused by
an improperly maintained turnout.

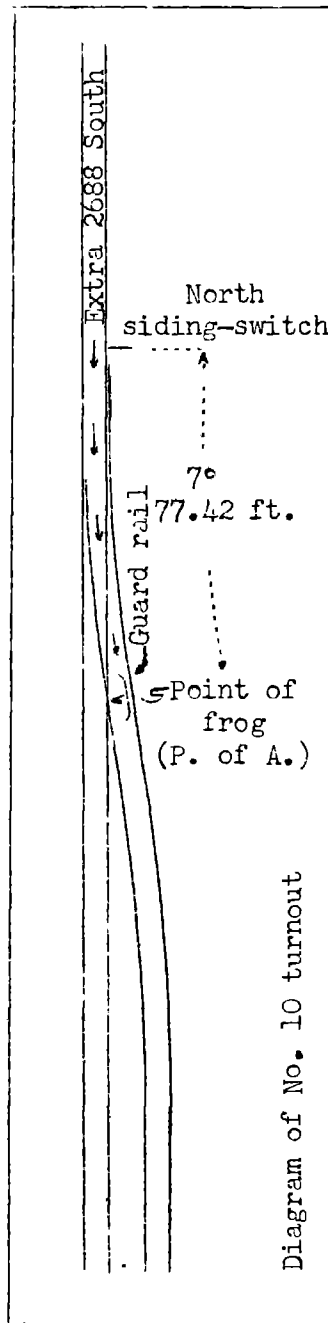
Inv. No. 2881
 Chicago, Rock Island and Pacific Railway
 Saginaw, Texas
 April 3, 1945

To Waurika ←

← To Fort Worth

- o Waurika, Okla. 91.60 mi.
- o Newark, Texas 13.00 mi.
- X Saginaw (P. of A.) 8.50 mi.
- o Fort Worth, Texas

Location of Accident and Method of Operation
