INVESTIGATION NO. 2467  
THE CHICAGO, ROCK ISLAND & PACIFIC RAILWAY  
COMPANY

REPORT IN RE ACCIDENT  
AT MAPELLO, IOWA, ON  
DECEMBER 15, 1940

Accident at Wapello, Iowa, on December 15, 1940, caused by  
failure to control speed of train properly when approach-  
ing meeting point.

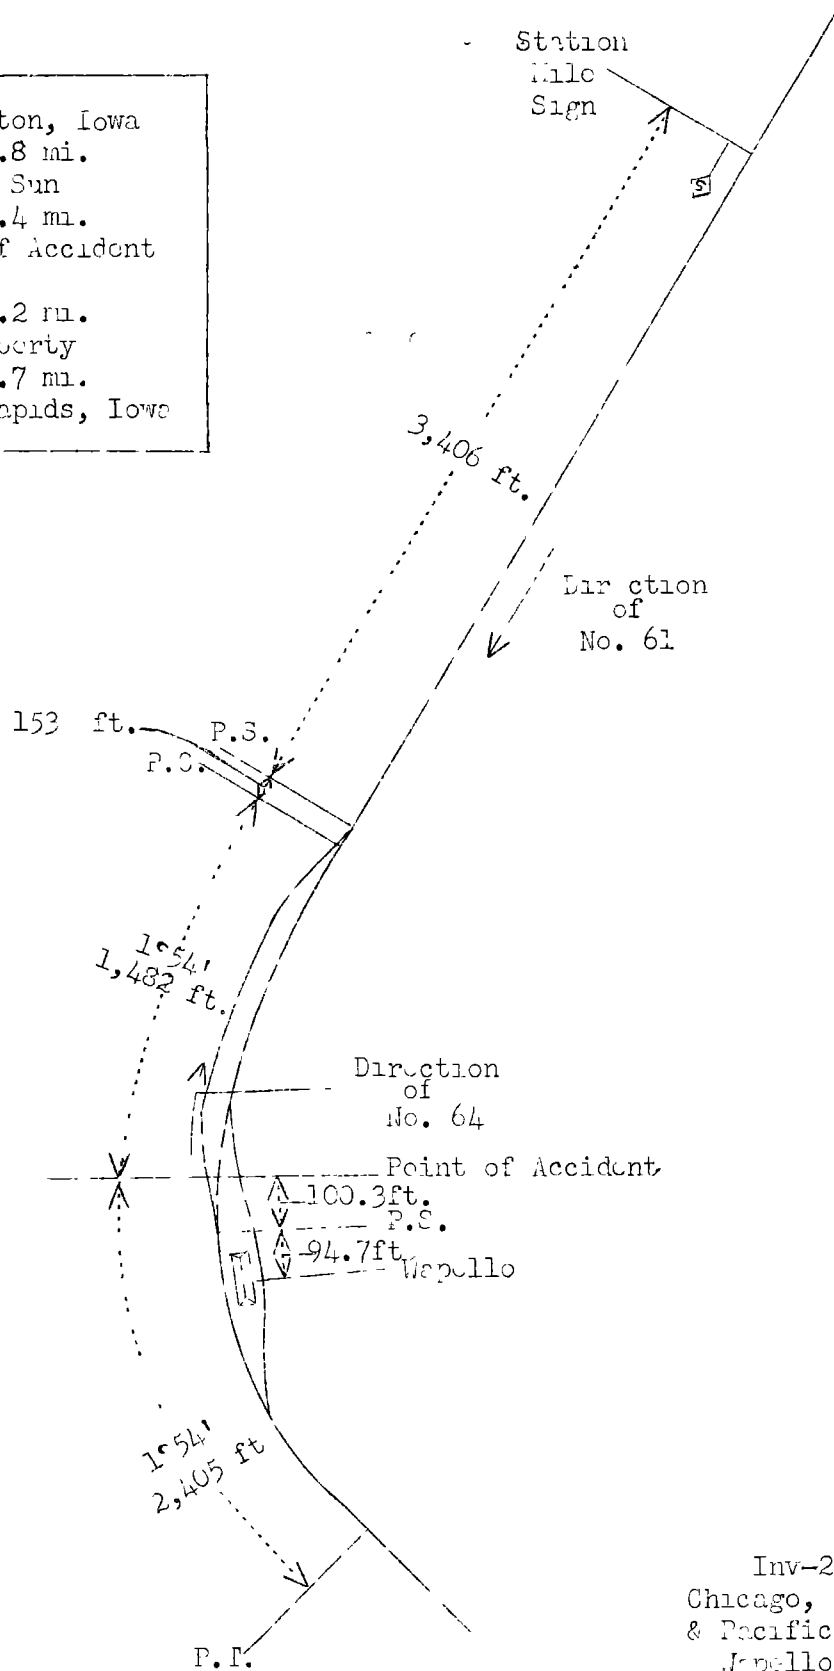
Inv-2467  
 Chicago, Rock Island  
 & Pacific Railway  
 Wapello, Iowa  
 December 15, 1940

○	Burlington, Iowa	22.8 mi.
○	Morning Sun	6.4 mi.
⊗	Point of Accident	Wapello
○	West Liberty	32.2 mi.
○	Cedar Rapids, Iowa	36.7 mi.
