REPORT OF THE DIRECTOR
BUREAU OF SAFETY

:
: ACCIDENT ON THE
:
CHICAGO, ROCK ISLAND AND PACIFIC RAILWAY

WASHBURN, IOWA

INVESTIGATION NO. 2300

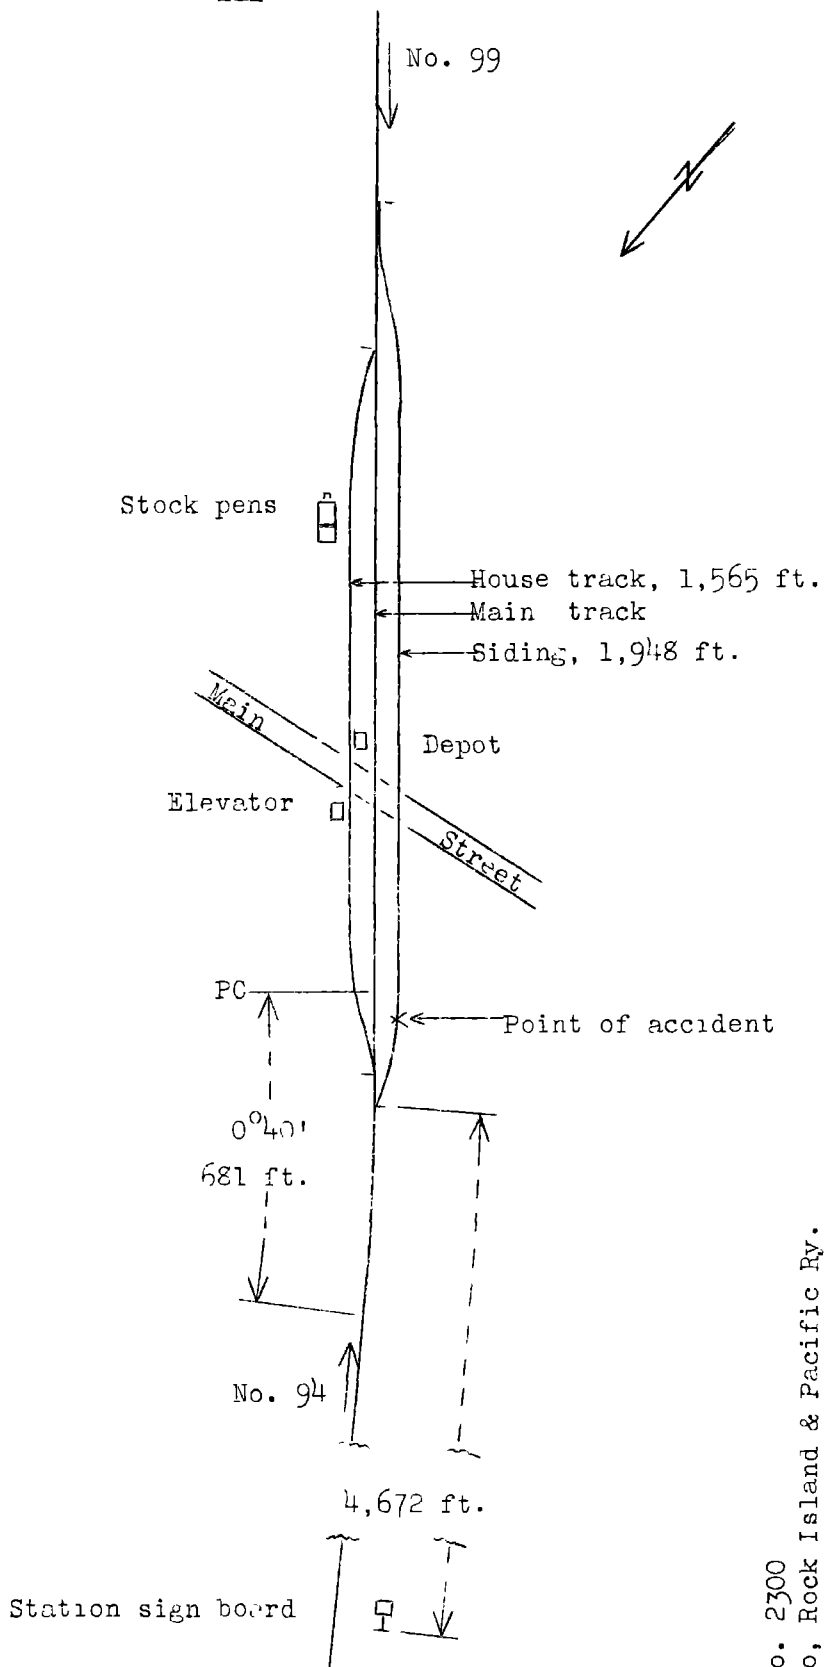
Inv. No. 2300
Chicago, Rock Island & Pacific Ry.
Washburn, Iowa
October 15, 1938.

o Cedar Rapids, Iowa (Union Station)	0.8 mi.
o Cedar Rapids Yard	22.9 mi.
o Vinton	14.3 mi.
o LaPorte City	8.0 mi.
o Washburn (P of A)	4.9 mi.
o East Yard	2.0 mi.
o Waterloo	74.9 mi.
o Manly, Iowa

This accident occurred on that part of the Cedar Rapids Division designated as Sub-Division 16 which extends between Cedar Rapids and Manly, Iowa, a distance of 127.9 miles. In the vicinity of the point of accident this is a single-track line over which trains are operated by timetable and train orders, no block-signal system being in use. The accident occurred on the siding at Washburn at a point approximately 250 feet east of the west switch. Approaching this point from the west the track is tangent 9,170 feet followed by a $0^{\circ} 40'$ curve to the left 681 feet in length, the accident occurred on this curve at a point about 44 feet west of its east end. The grade for east-bound trains is slightly ascending a distance of 1,300 feet, and then descending 0.18 percent a distance of approximately 1,630 feet to the point of accident. Approaching from the east the track is tangent a distance of 4,995^{1/2} feet followed by the curve on which the accident occurred. The siding at Washburn is 1,948 feet in length, has a capacity of 32 cars, and parallels the main track on the south. A house track, 1,565 feet in length, the west switch of which is located approximately 100 feet east of the west switch of the siding, parallels the main track on the north. Stock pens are located near the west end and to the north of the house track. The depot is located between the main track and the house track approximately 741 feet east of the west house-track switch. Immediately west of the depot Main Street extends across the three tracks at grade and at an angle of about 60 degrees. There is an elevator located just west of the crossing and to the north of the house track approximately 604 feet east of the west house-track switch. The switches at the west end of both the siding and the house track are equipped with high Star switch stands, each having an 18-inch, red-enameled, round-disc target, the center of which is 61 inches above the top of the ties. The station board for east-bound trains is located 4,672 feet west of the west switch of the siding.
