REPORT NO. 3347
CHICAGO, ROCK ISLAND AND PACIFIC
RAILROAD COMPANY
IN RE ACCIDENT
NEAR WEST UNION, IOWA, ON
JULY 29, 1950

Kind of accident: Head-end collision

Accident near West Union, Iowa, on July 29, 1950, caused
by failure to provide adequate protection for the
movement of a track motor-car.

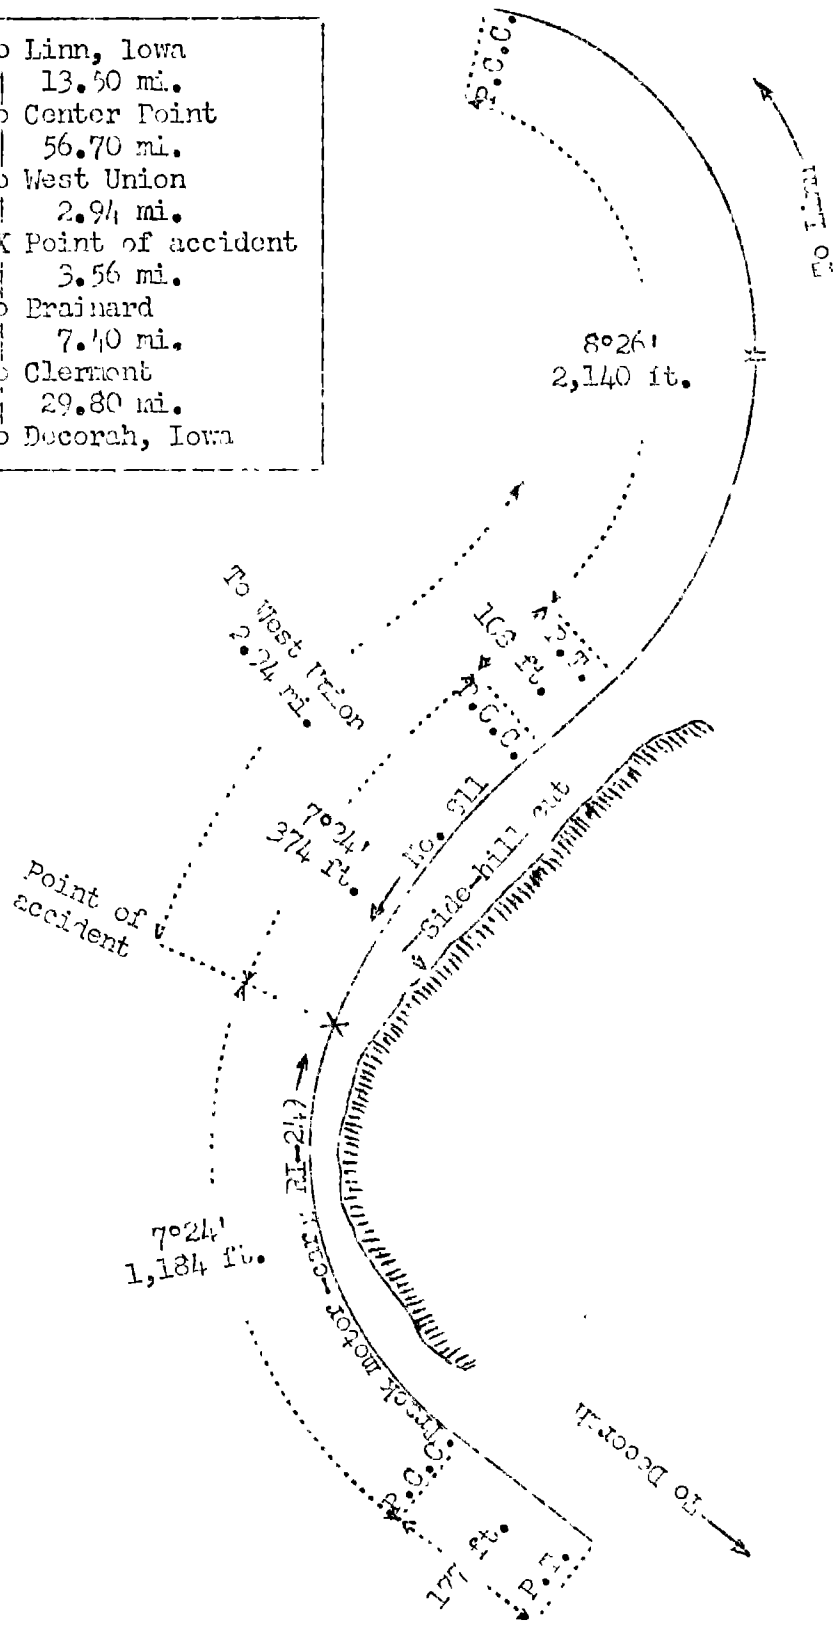
- o Linn, Iowa
- | 13.50 mi.
- o Center Point
- | 56.70 mi.
- o West Union
- | 2.9 1/4 mi.
- X Point of accident
- | 3.56 mi.
- o Brainard
- | 7.40 mi.
- o Clermont
- | 29.80 mi.
- o Decorah, Iowa

Report No. 2317
 Chicago, Rock Island and Pacific Railroad
 West Union, Iowa
 July 27, 1950
