REPORT NO. 3455
CHICAGO, SOUTH BORE AND SOUTH BEND RAILROAD
IN RE ACCIDENT
AT GARY, IND., ON
MARCH 4, 1952

Kind of accident: Collision

Accident at Gary, Ind., on March 4, 1952, caused by
failure to operate the following train in
accordance with signal indications.

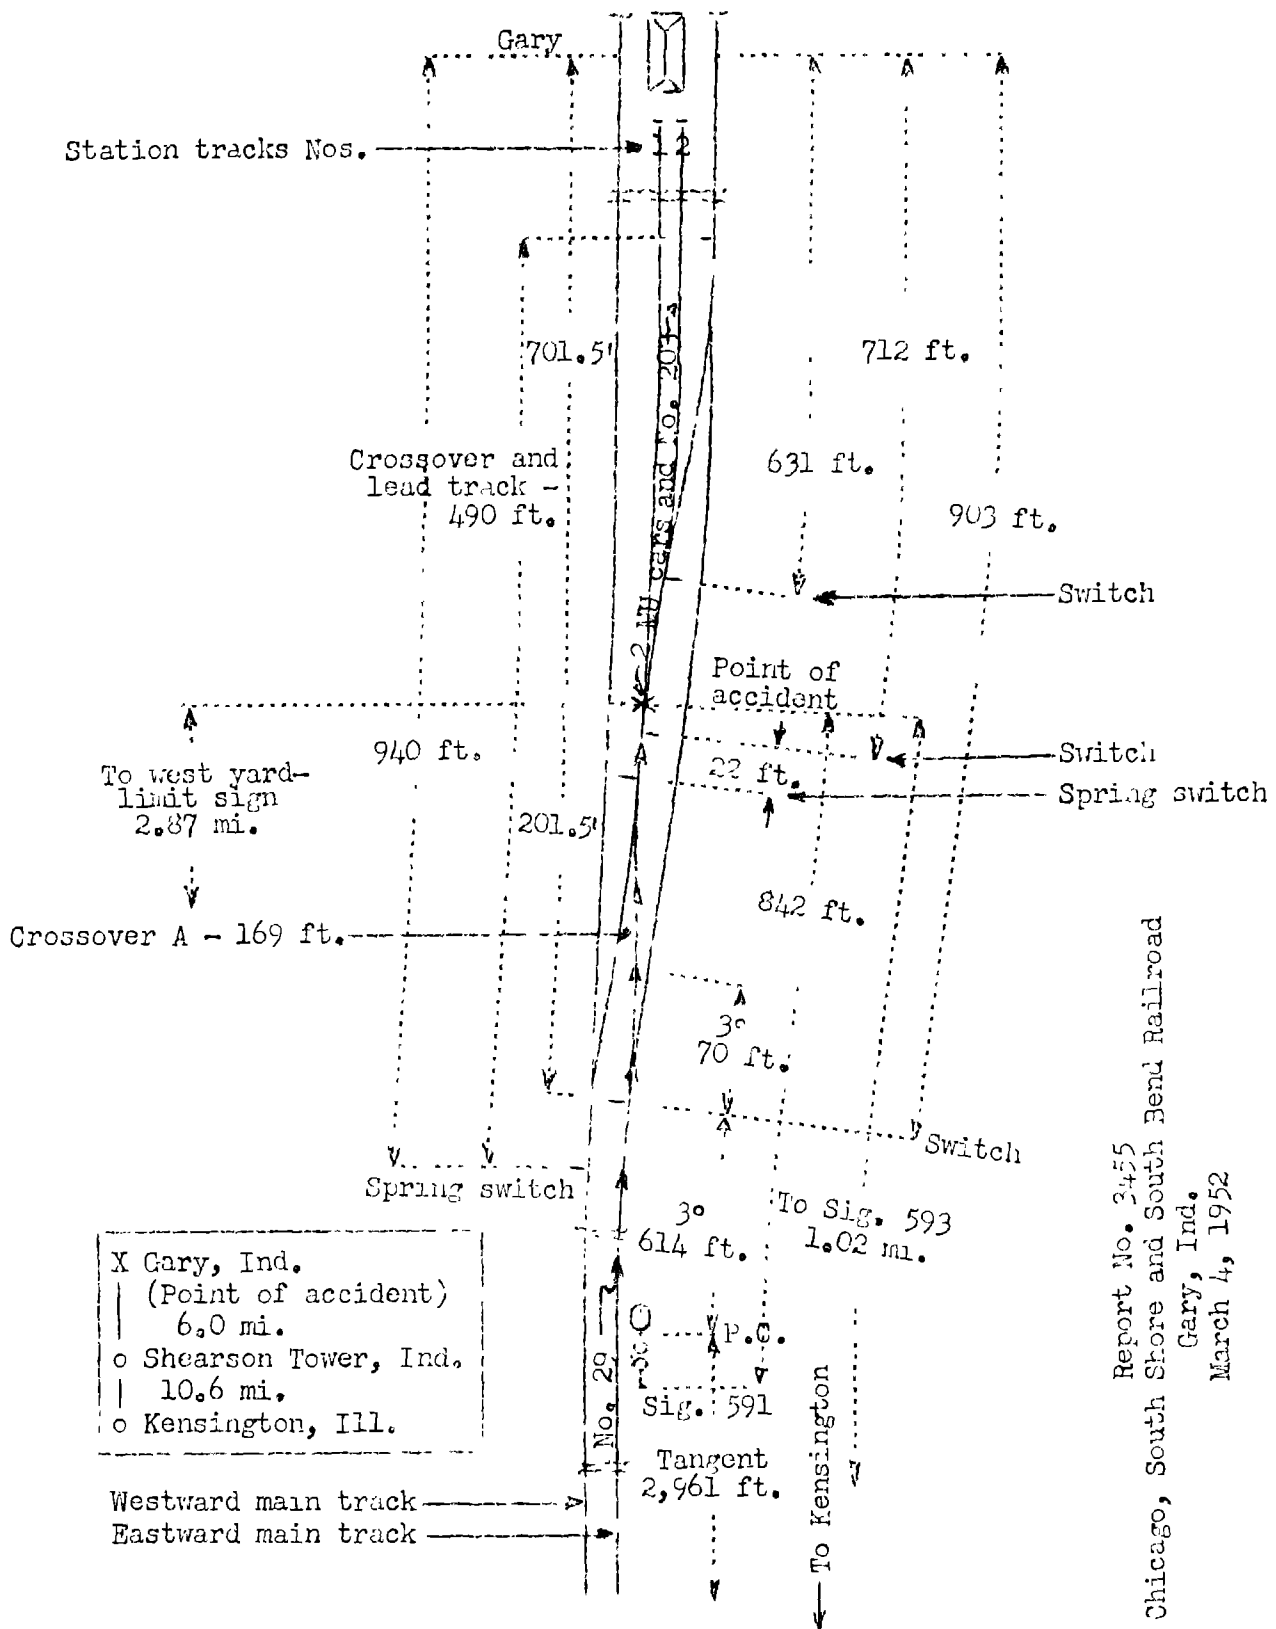
Report No. 3455
 Chicago, South Shore and South Bend Railroad
 Gary, Ind.
 March 4, 1952

X Gary, Ind.
 | (Point of accident)
 | 6.0 mi.
 o Shearson Tower, Ind.
 | 10.6 mi.
 o Kensington, Ill.

approaching and then he became aware that it had entered crossover A. He inserted the reverser key and opened the controller and the passenger-equipment train moved eastward and against the rear end of No. 203 immediately before the collision occurred. The helper said that he had lined the west switch of crossover A for entry to the station tracks before the arrival of No. 203 and he was in the vicinity of the switch of track No. 2 when that train arrived. When he observed that the passenger-equipment train was moving westward he proceeded to the west switch of the crossover and lead track to line it for the movement of the equipment to the station tracks. He said that the switch lock was frozen and it took longer than usual to open it. He restored the switch to normal position when the passenger-equipment train cleared the westward main track and then proceeded to the south side of the eastward main track and passed the west switch of crossover A without restoring it to normal position. The helper said that the arrival of the west-bound extra freight train and the return movement of the passenger equipment of No. 130 to the station tracks had not been anticipated and required a variation from the normal routine of movements. Because he became concerned with the movement of a baggage car which was to be added to No. 29 when it arrived, he overlooked the position of the main-track switch of crossover A. He was in the vicinity of the yard tracks south of the eastward main track when No. 29 entered crossover A and struck the passenger-equipment train.
