REPORT OF THE DIRECTOR
BUREAU OF SAFETY

ACCIDENT ON THE
CHICAGO, ST. PAUL, MINNEAPOLIS
& OMAHA RAILWAY

MERRIAM, MINN.

INVESTIGATION NO. 2045

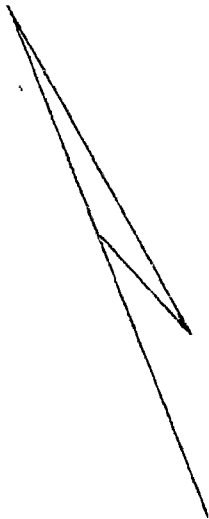
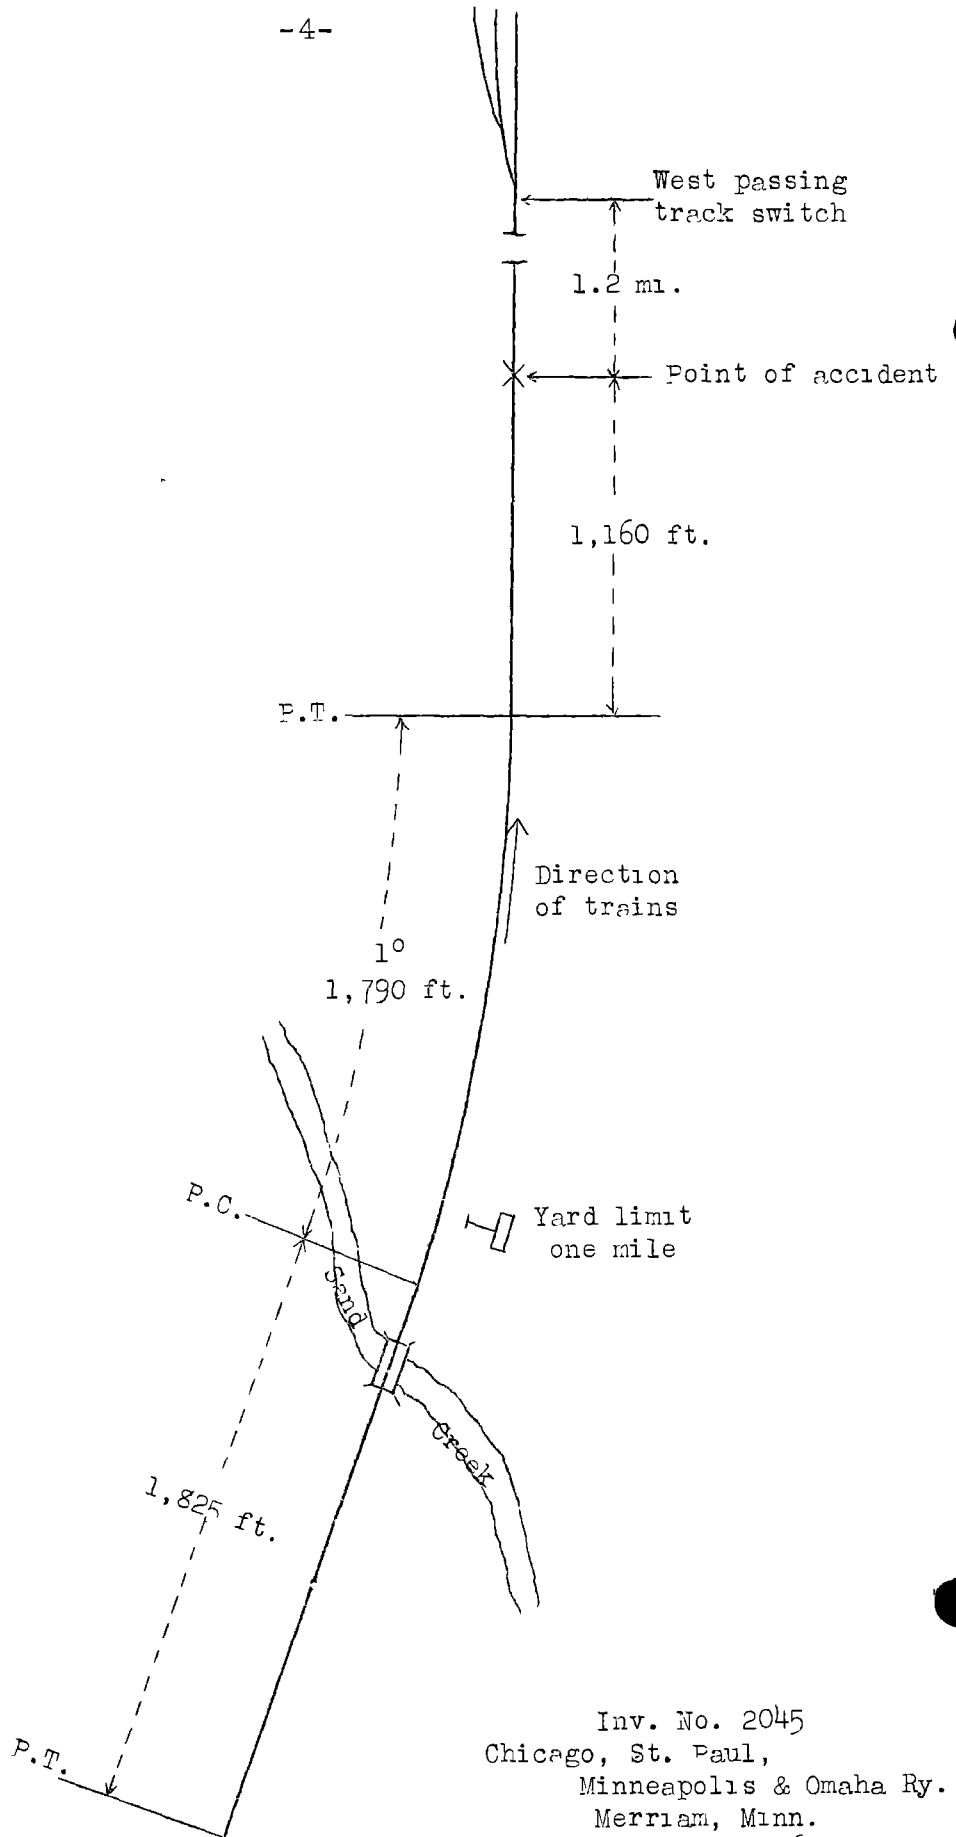
Inv. No. 2045
 Chicago, St. Paul,
 Minneapolis & Omaha Ry.
 Merriam, Minn.
 Feb. 17, 1936.

St. Paul, Minn.
34.0 mi.
Merriam
1.2 mi.
*Point of accident
2.3 mi.
Mudbaden
4.2 mi.
Lawrence
4.8 mi.
Belle Plaine
72.2 mi.
St. James, Minn.
