REPORT OF THE DIRECTOR

BUREAU OF SAFETY

CHICAGO, ST. PAUL, MINNEAPOLIS & OMAHA RAILWAY

NORTHLINE, WIS.

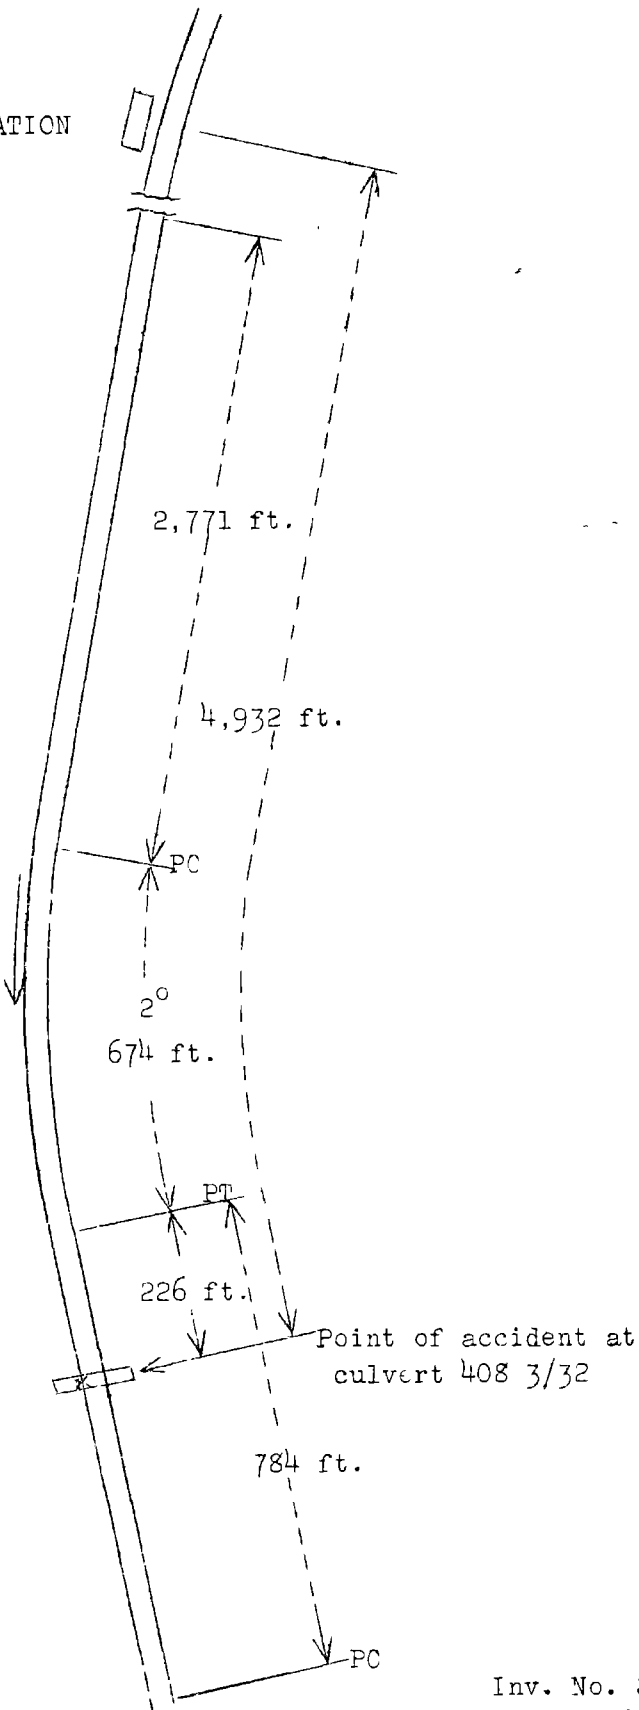
Inv. No. 2289
 C. St. P. M. & O. Ry.
 Northline, Wis.
 Sept. 9, 1938

Direction of train

STATION
