INTERSTATE COMMERCE COMMISSION
WASHINGTON

INVESTIGATION NO. 2994
CHICAGO, SAINT PAUL, MINNEAPOLIS AND OMAHA
RAILWAY COMPANY

REPORT IN RE ACCIDENT
AT ST. JAMES, MINN., ON

MAY 18, 1946

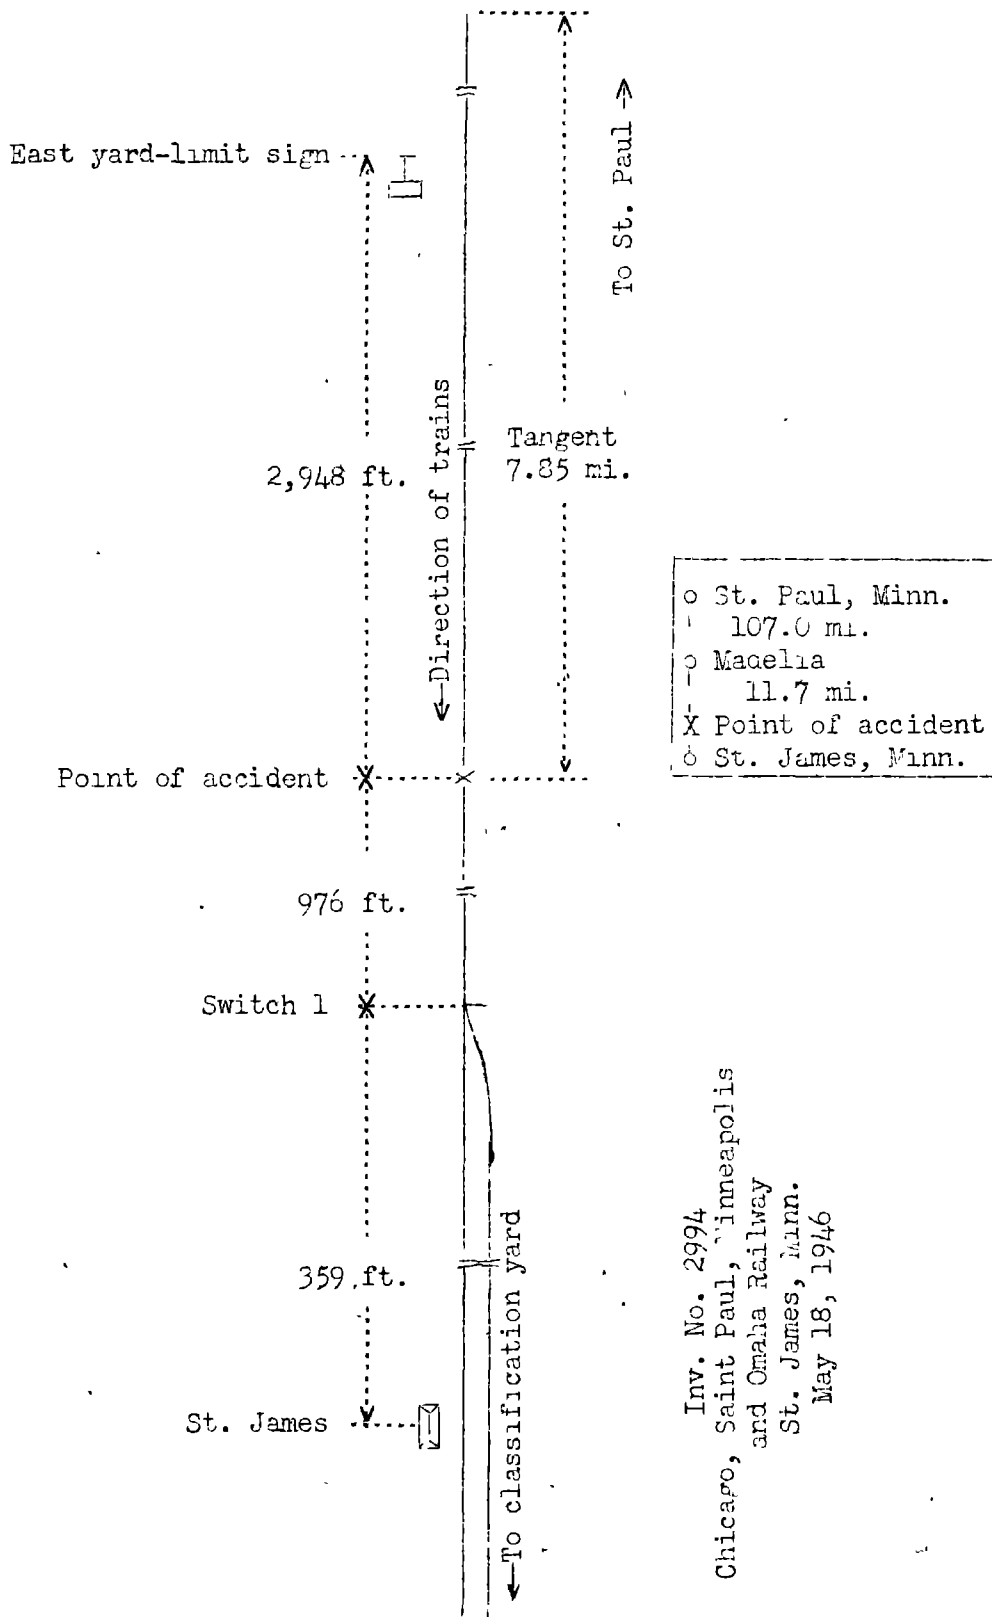
Location of Accident and Method of Operation

This accident occurred on that part of the Western Division extending between St. Paul and St. James, Minn., 118.7 miles, a single-track line in the vicinity of the point of accident, over which trains are operated by timetable and train orders. There is no block system in use. At St. James, the east switch of a classification yard located south of the main track is 1,335 feet east of the station, and is designated as switch 1. The accident occurred within yard limits on the main track at St. James, at a point 2,948 feet west of the east yard-limit sign and 976 feet east of switch 1. From the east the main track is tangent 7.85 miles to the point of accident and a considerable distance westward. The grade for west-bound trains is 0.417 percent ascending.
