INVESTIGATION NO. 3129

CHICAGO, SAINT PAUL, MINNEAPOLIS AND OMAHA  
RAILWAY COMPANY

REPORT IN RE ACCIDENT

AT ST. PAUL, MINN., ON

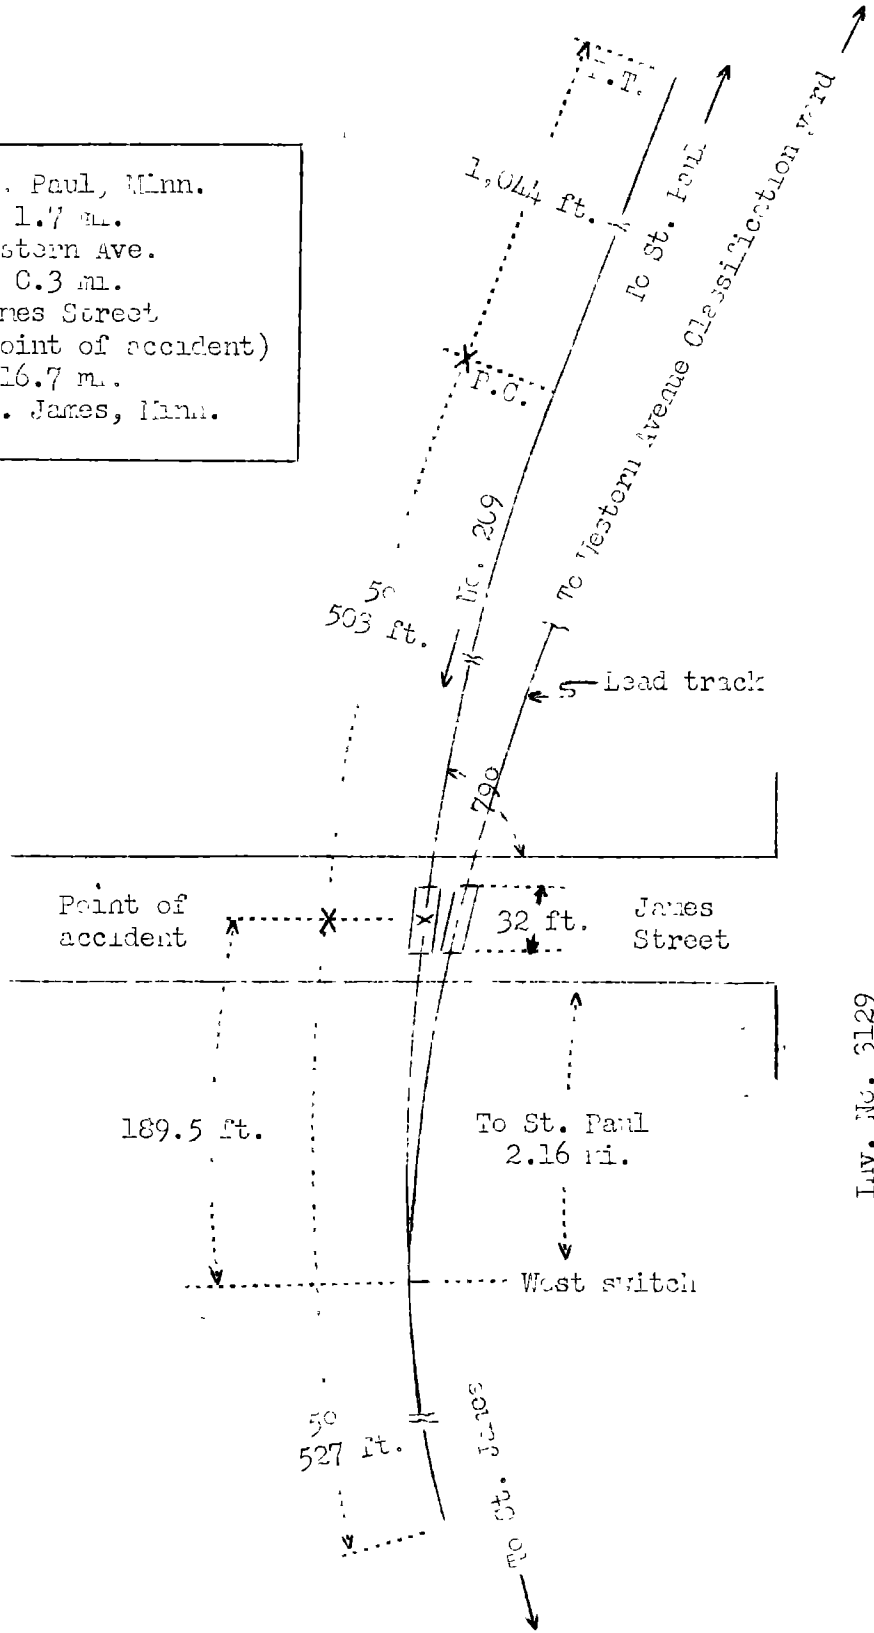
Inv. No. 3129  
 Chicago, Saint Paul, Minneapolis and Omaha Railway  
 St. Paul, Minn.  
 September 20, 1947

o St. Paul, Minn.  
 | 1.7 mi. 
 - Western Ave.  
 | 0.3 mi. 
 X James Street  
 (Point of accident)  
 | 116.7 mi. 
 o St. James, Minn.

Location of Accident and Method of Operation
