## INTERSTATE COMMERCE COMMISSION

REPORT OF THE DIRECTOR OF THE BUREAU OF SAFETY CONCERNING AN  
ACCIDENT ON THE CINCINNATI & LAKE ERIE RAILROAD NEAR  
SPRINGFIELD, OHIO, ON AUGUST 10, 1935.

Inv. No. 2003  
 Cincinnati & Lake Erie RR,  
 Springfield, Ohio  
 August 10, 1935

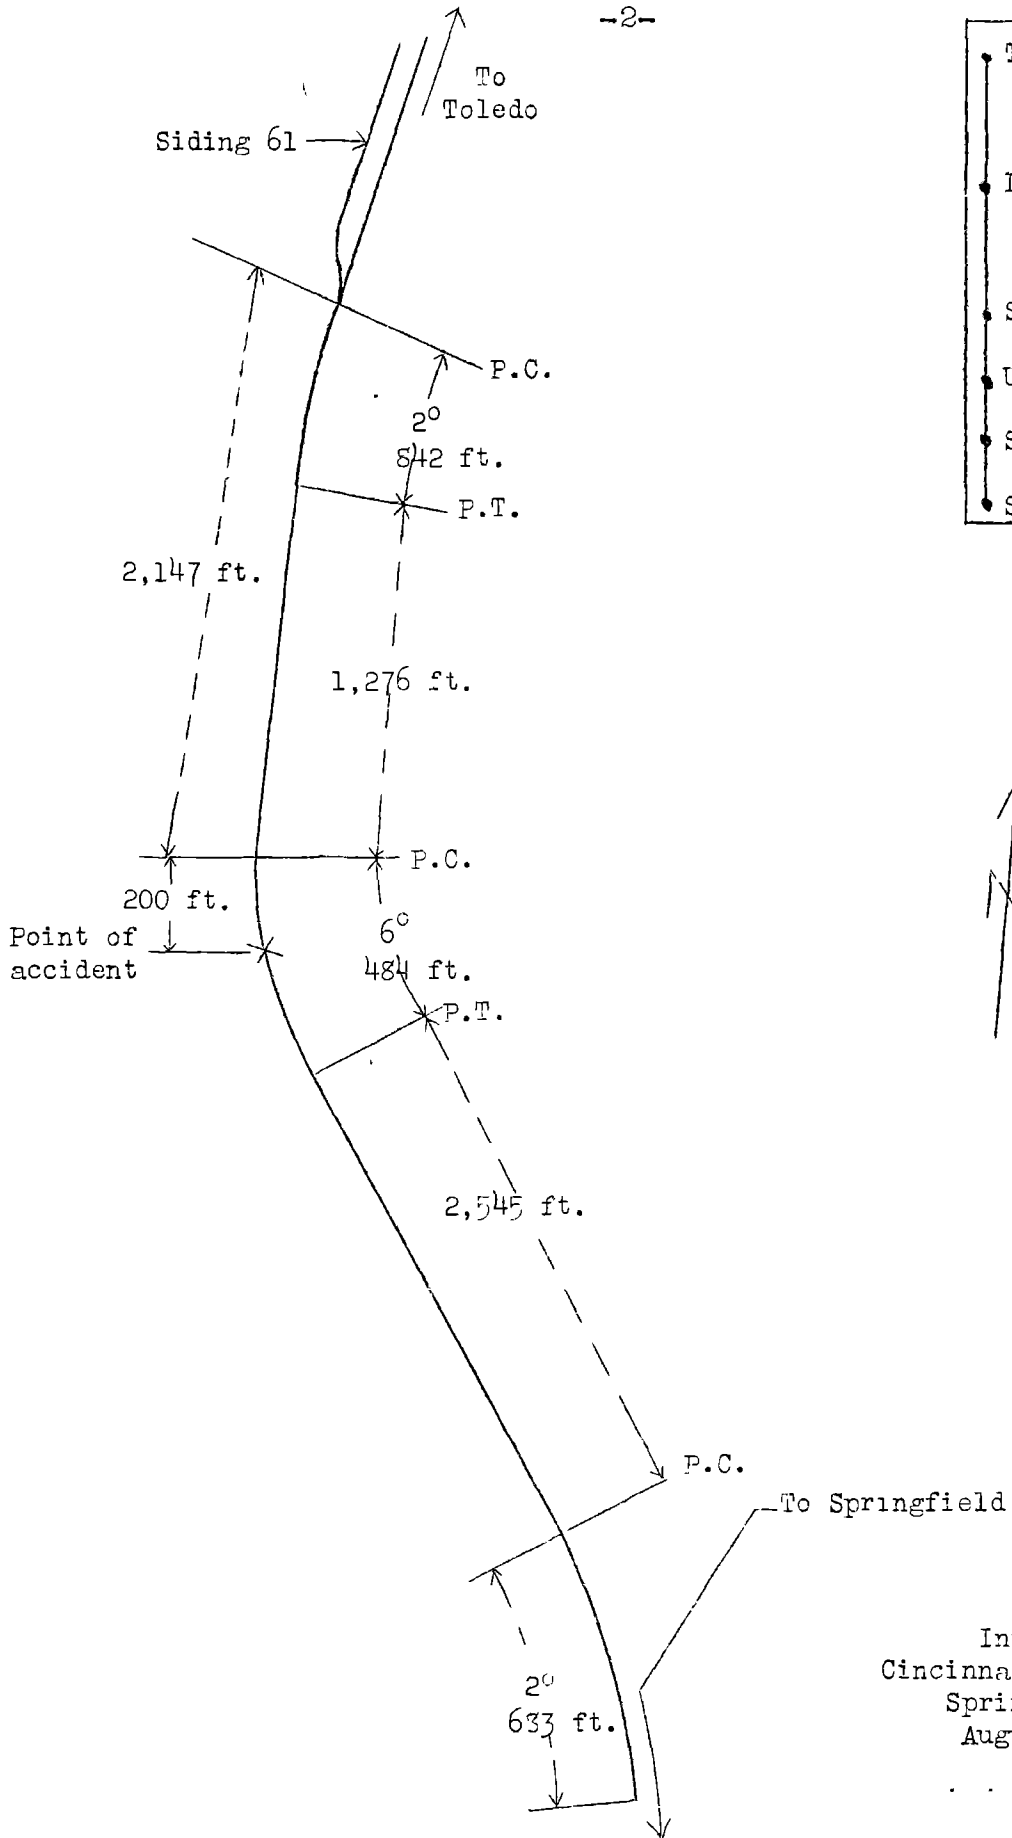
• Toledo, Ohio
73.2 mi.
• Lima
38.2 mi.
• Siding No. 38
14.1 mi.
• Urbana
8.8 mi.
• Siding No. 61
4.6 mi.
• Springfield, Ohio

This accident occurred on the Toledo Division, an electric line extending between Toledo and Springfield, Ohio, a distance of 138.9 miles; in the vicinity of the point of accident this is a single-track line over which trains are operated by time table and train orders, no block-signal system being in use. A siding, known as Siding No. 61, parallels the main track on the west; the accident occurred at a point 2,347 feet south of this siding, or 4.2 miles north of the station at Springfield. Approaching the point of accident from the north, there is a 2° curve to the left 843 feet in length, then tangent track for a distance of 1,276 feet, followed by a 6° curve to the left 484 feet in length, the accident occurring on the latter curve at a point approximately 200 feet south of its northern end. Approaching from the south, there is a 2° curve to the left 683 feet in length, from which point the track is tangent for a distance of 2,545 feet, followed by the curve on which the accident occurred. The grade for south-bound trains is 2.43 percent ascending at the point of accident.

Owing to a highway, which parallels the railroad on the east and is about 3 feet higher than the track, and to trees and an embankment on the east side of the highway south of the point of accident, the view of opposing trains is restricted to a maximum of about 1,900 feet.
