REPORT NO. 3571

THE CINCINNATI, NEW ORLEANS & TEXAS PACIFIC
RAILWAY COMPANY
SOUTHERN RAILWAY SYSTEM

IN RE ACCIDENT
NEAR SADIEVILLE, KY., ON

MAY 25, 1954

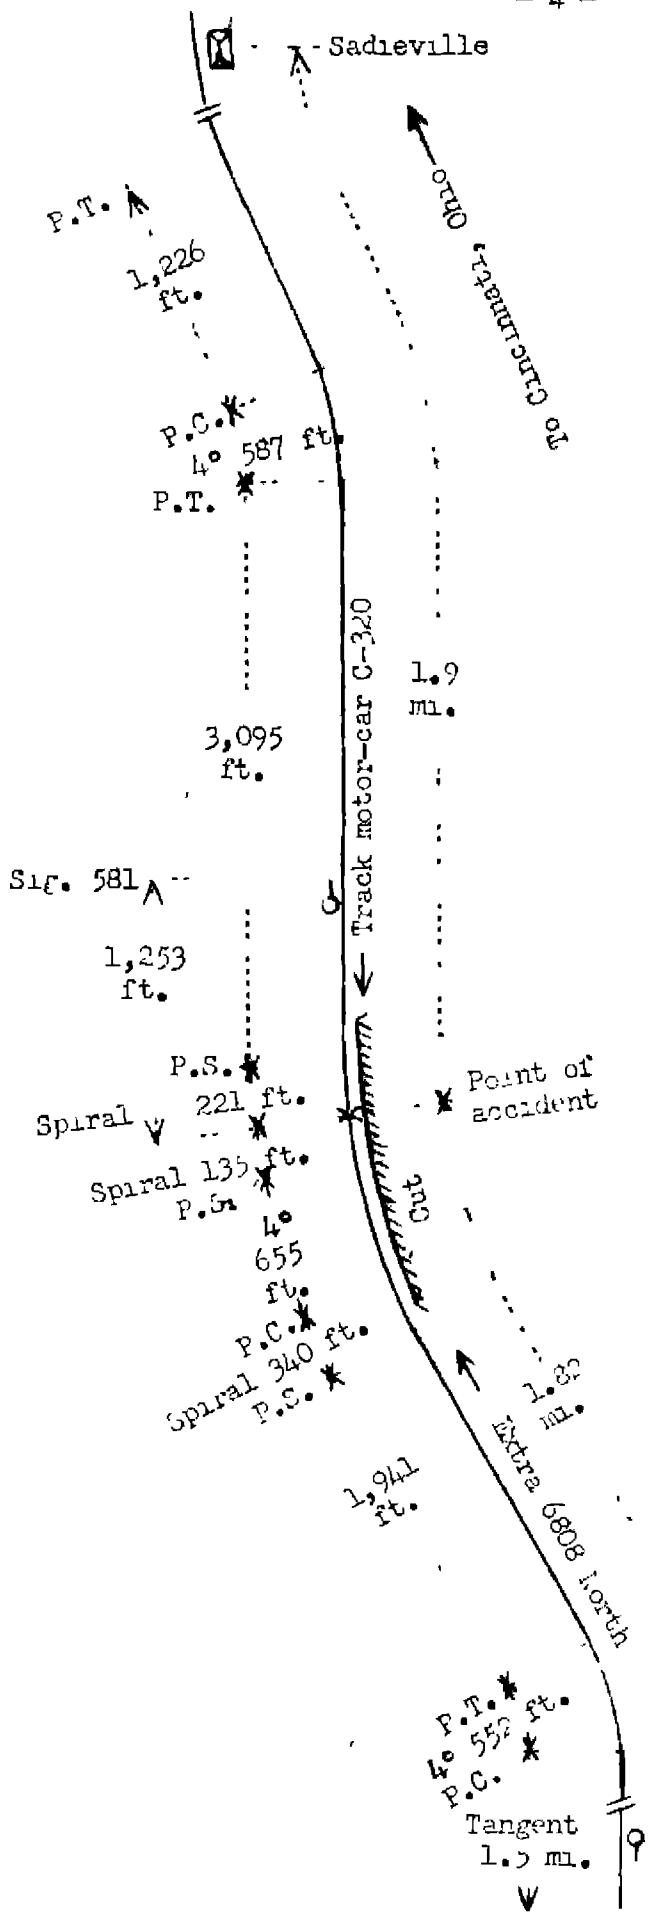
Report No. 3571
 Cincinnati, New Orleans & Texas Pacific railway
 Southern Railway System
 Sadieville, Ky.
 May 25, 1954

○ Cincinnati, Ohio	3.0 mi.
● Ludlow, Ky.	40.0 mi.
● Mason	5.7 mi.
● Corinth	1.9 mi.
● Rohan	1.2 mi.
● Hinton	4.8 mi.
● Sadieville	1.9 mi.
X Point of accident	3.7 mi.
┌ Rogers Gap	7.6 mi.
● Georgetown	11.9 mi.
● Lexington	11.3 mi.
● Nicholasville	5.1 mi.
● Wolmore	6.9 mi.
● Dix	11.6 mi.
● Danville, Ky.

Track motor-car C-320, occupied by a track repairman and a track repairman helper, departed south-bound from Corinth, 48.7 miles south of Cincinnati, about 7:20 a. m. While it was moving southward at an undetermined rate of speed, it collided with Extra 6808 North at a point 1.9 miles south of the station at Sadieville.
