INVESTIGATION NO. 2627

THE CLEVELAND, CINCINNATI, CHICAGO & ST. LOUIS
RAILWAY COMPANY

REPORT IN RE ACCIDENT

SEPTEMBER 16, 1942

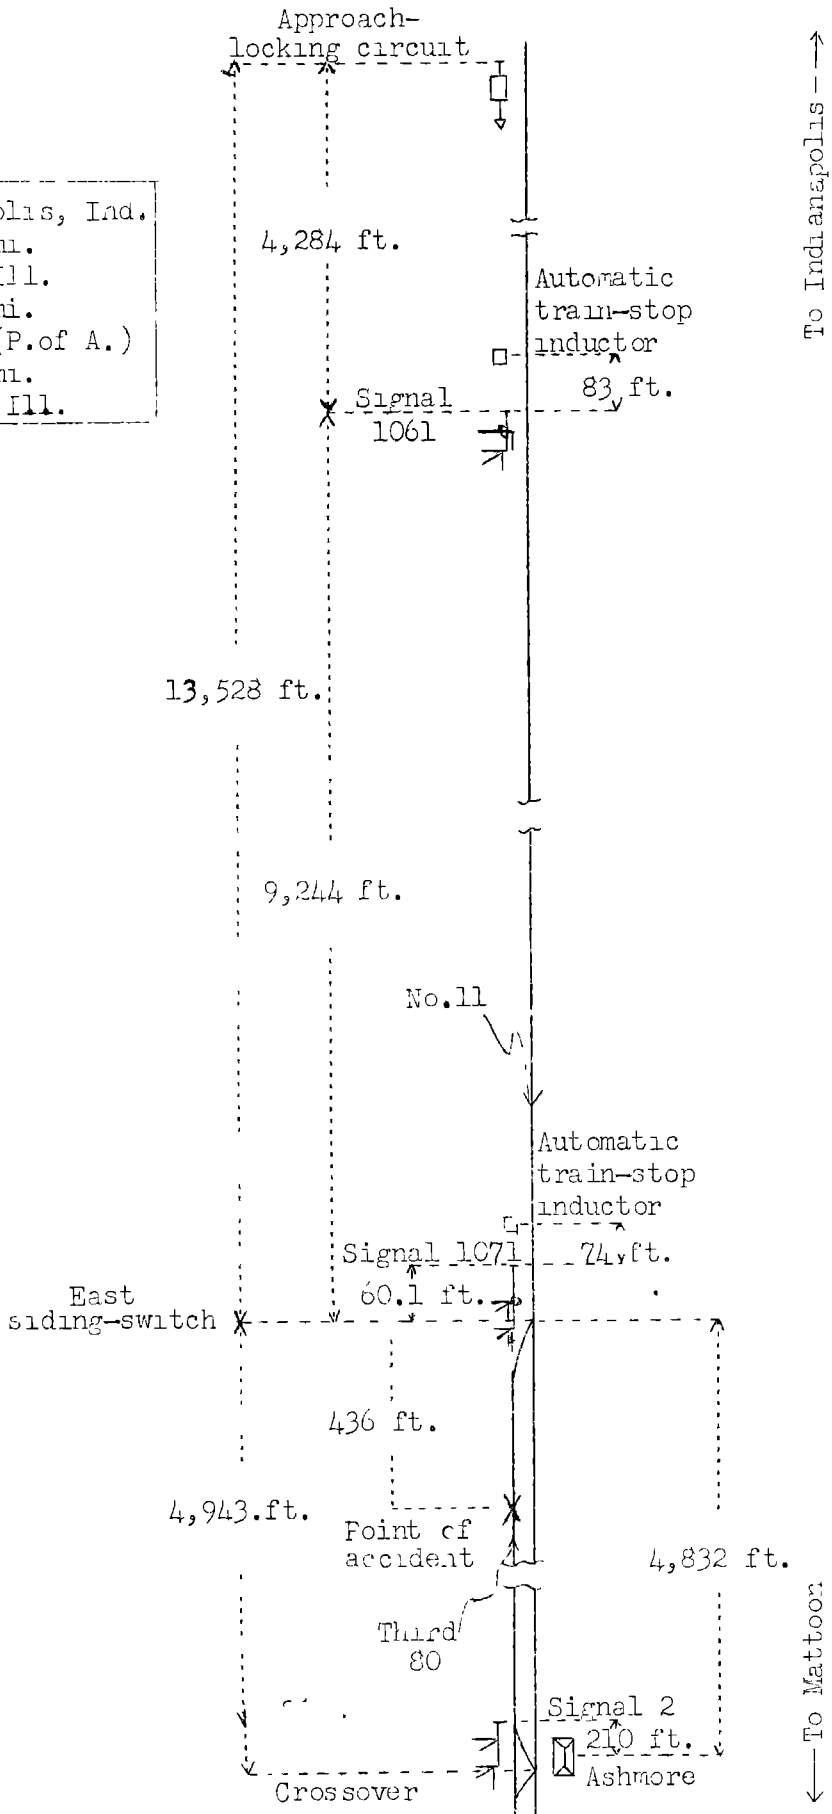
Inv. No. 2627
 Cleveland, Cincinnati, Chicago & St. Louis Railway
 Ashmore, Ill.
 September 16, 1942

- Indianapolis, Ind. 104.4 mi.
- Kansas, Ill. 4.4 mi.
- ✕ Ashmore (P. of A.) 19.4 mi.
- Mattoon, Ill.

Location of Accident and Method of Operation
