INTERSTATE COMMERCE COMMISSION

INVESTIGATION NO. 2938

THE CLEVELAND, CINCINNATI, CHICAGO AND ST. LOUIS  
RAILWAY COMPANY

REPORT IN RE ACCIDENT

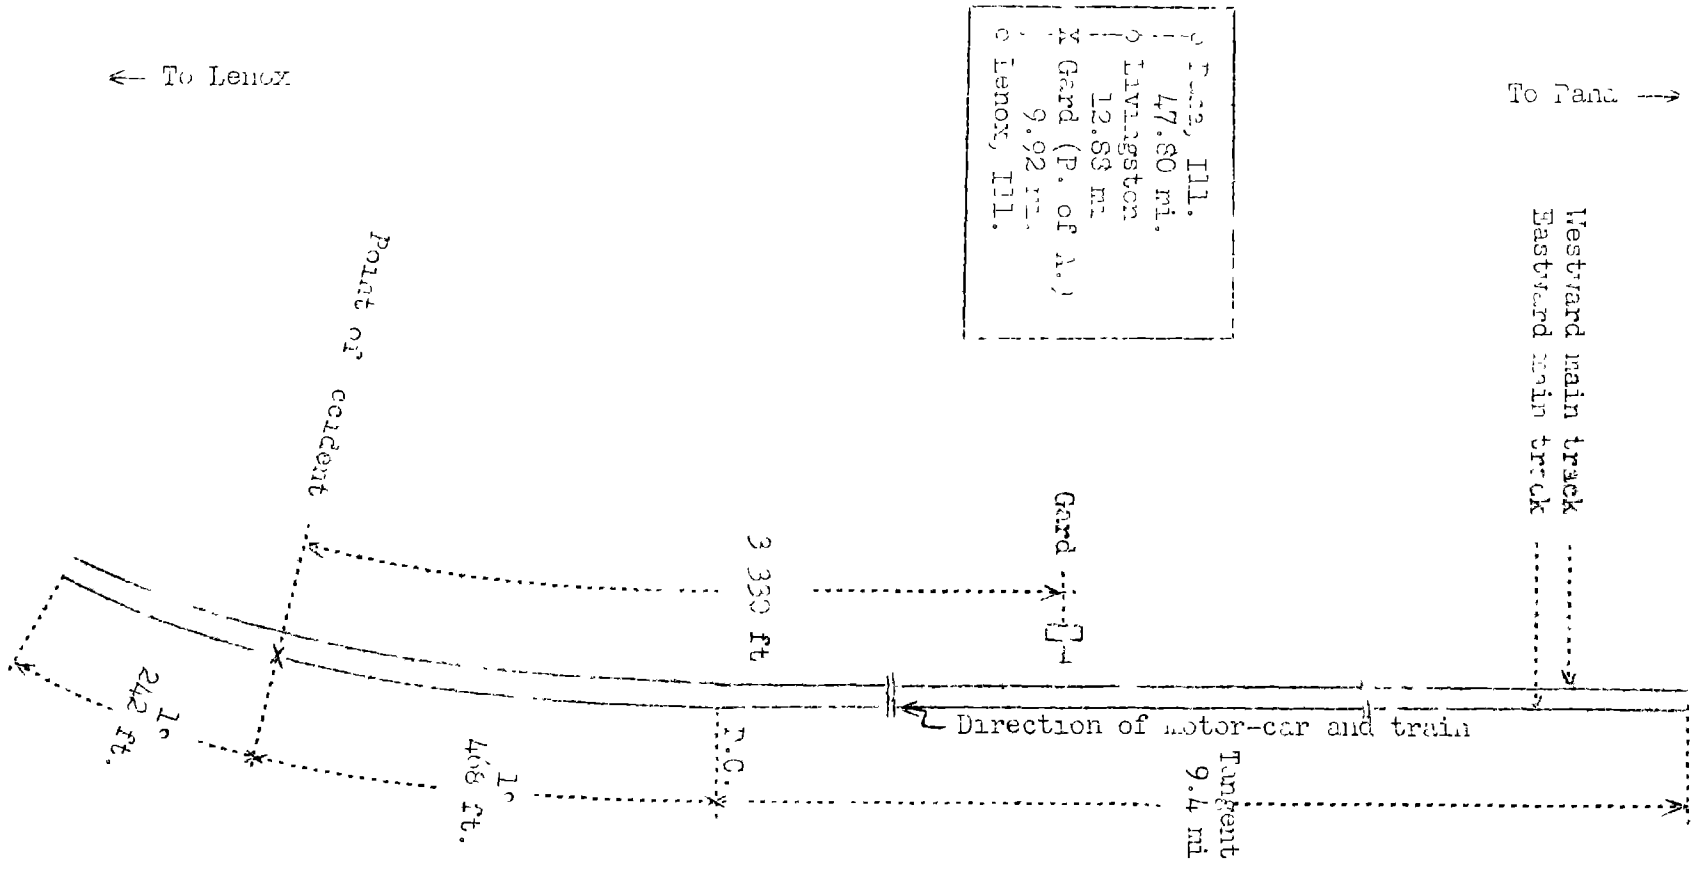
Inv. No. 2938  
 Cleveland, Cincinnati, Chicago and St. Louis Railway  
 Gard, Ill.  
 October 2, 1945

Location of Accident and Method of Operation
