INVESTIGATION NO. 2747
THE CLEVELAND, CINCINNATI, CHICAGO & ST. LOUIS
RAILWAY COMPANY
REPORT IN RE ACCIDENT
AT LUDLOW FALLS, OHIO, ON
NOVEMBER 28, 1943

Kind of accident: Head-end collision

Accident at Ludlow Falls, Ohio, on November 28, 1943, caused
by lap of authority of two opposing trains.

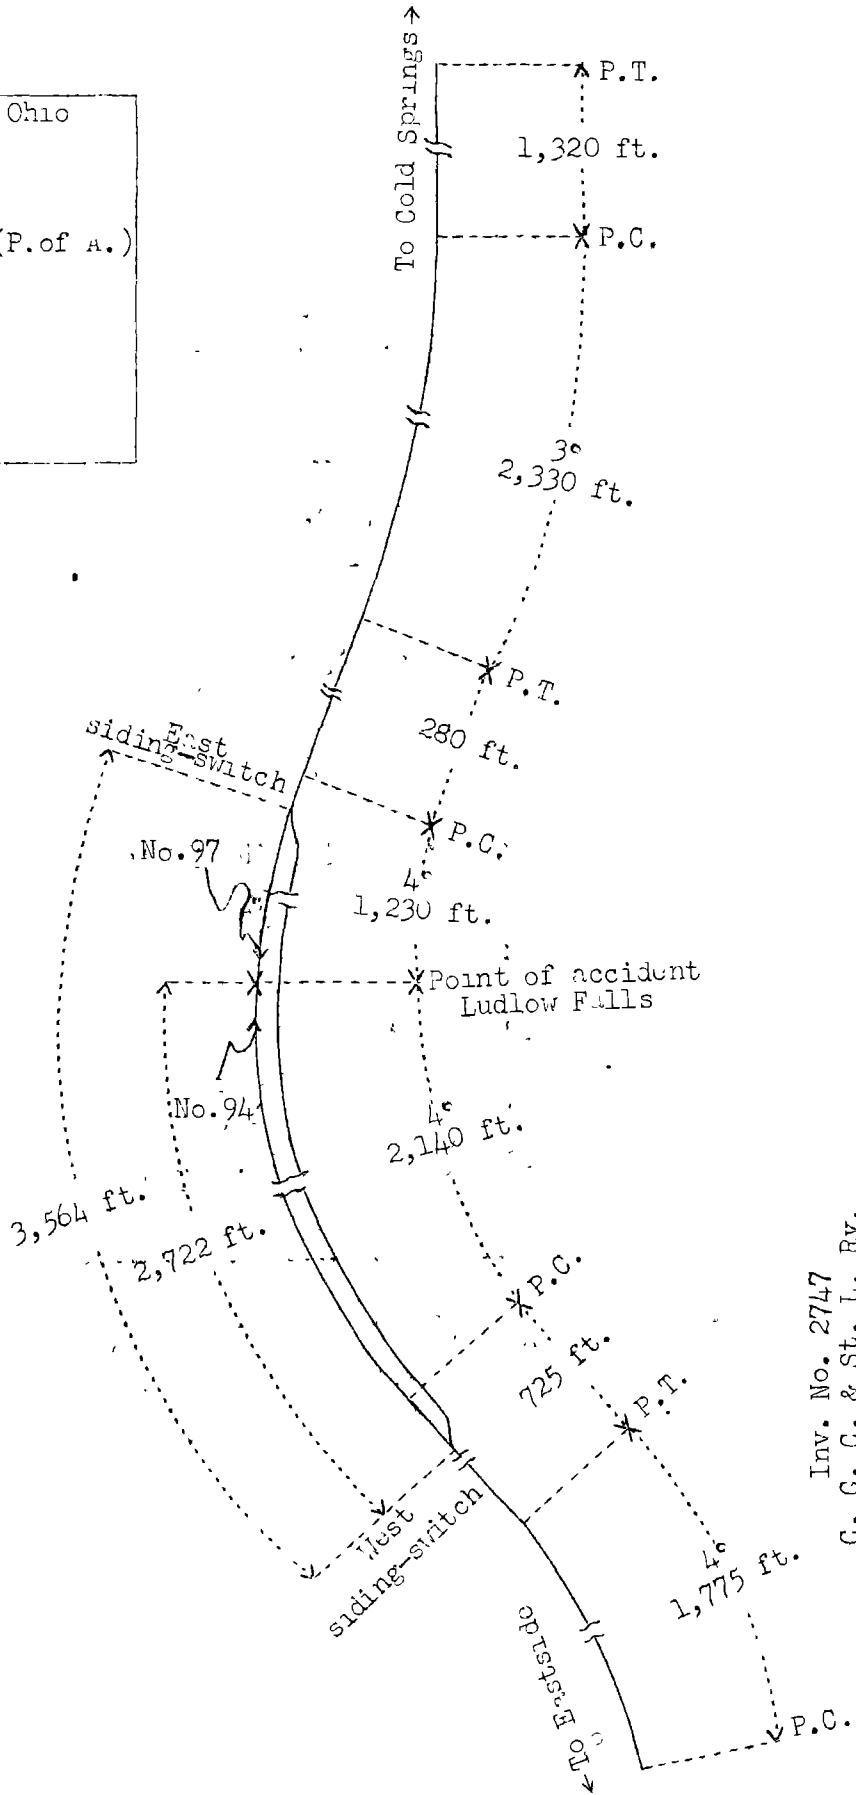
Inv. No. 2747
C. C. C. & St. L. Ry.
Ludlow Falls, Ohio
November 28, 1943

- o Cold Springs, Ohio
19.5 mi.
- o Troy
9.4 mi.
- X Ludlow Falls (P. of A.)
19.3 mi.
- o Hewitt, Ohio
15.8 mi.
- o Lynn, Ind.
60.2 mi.
- o Eastside, Ind.
