INTERSTATE COMMERCE COMMISSION

REPORT OF THE DIRECTOR

CLINCHFIELD RAILROAD

DANTE, VA.

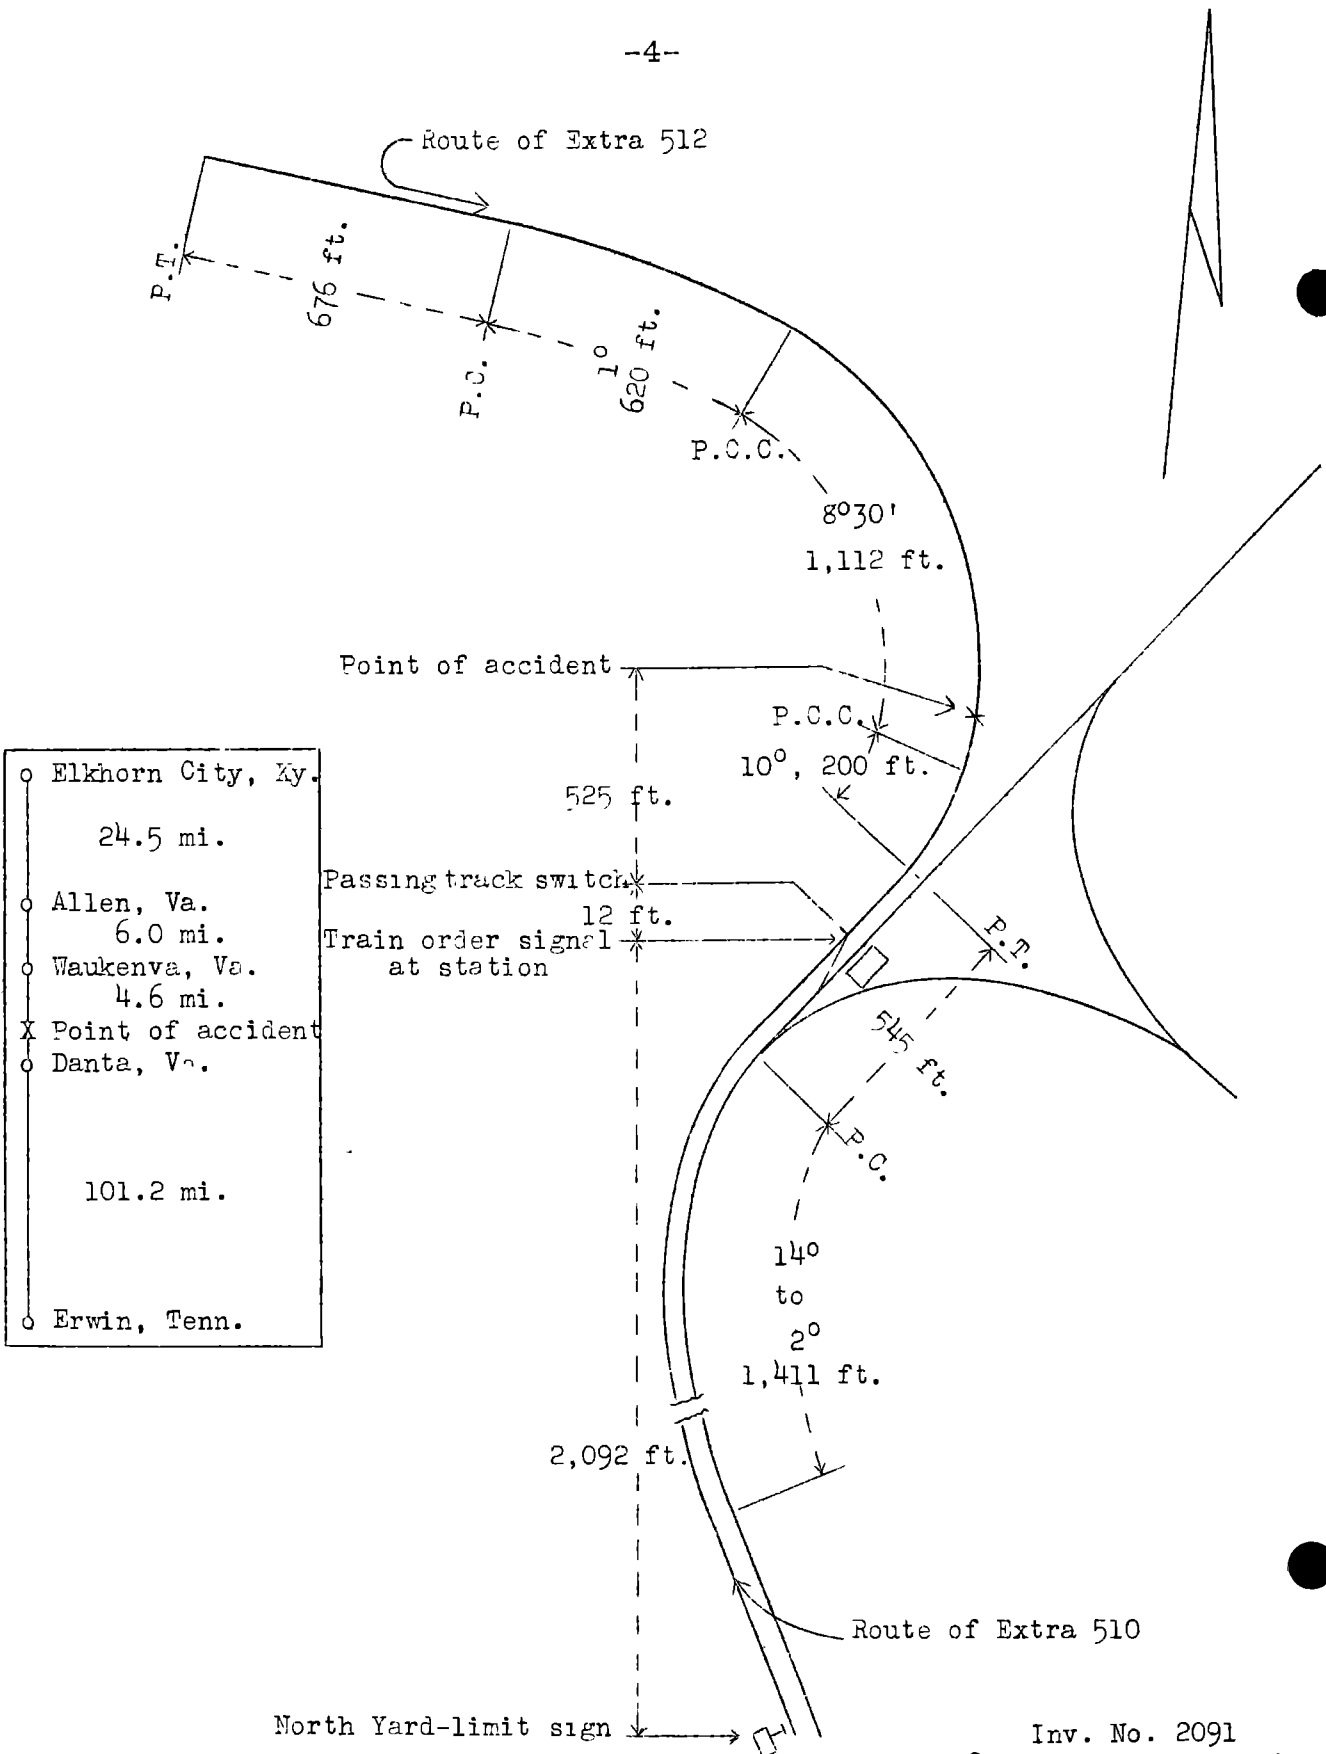
| ○ | Elkhorn City, Ky. |
| ○ | Allen, Va. |
| ○ | Waukenva, Va. |
| X | Point of accident |
| ○ | Danta, Va. |
| ○ | Erwin, Tenn. |

This accident occurred on that part of the Clinchfield Railroad which extends between Elkhorn City, Ky., and Erwin, Tenn., a distance of 136.3 miles; in the vicinity of the point of accident this is a single-track line over which trains are operated by timetable and train orders, no form of block-signal system being in use. At Dante there is a yard from which trains serving an adjacent coal producing territory are operated. The yard is located east of the main track, and the lead track, designated in the timetable as a passing track, parallels the main track on the east and extends from the station to the engine coal chute, a distance of 6,313 feet. The north switch of this track is opposite the station and constitutes the northern entrance to the yard, although the north yard limit sign is located 2,104 feet south of this switch. The accident occurred at a point 525 feet north of the north switch of the passing track; approaching this point from the south there are several curves and short tangents, followed by a compound curve to the left, consisting of a 10° curve for 200 feet, an $8^{\circ}30'$ curve for 1,112 feet, and a 1° curve for 620 feet, the accident occurring on the $8^{\circ}30'$ portion of the curve at a point 73 feet from its southern end. Approaching from the north the track is tangent for a distance of 676 feet, followed by the compound curve on which the accident occurred. The grade for south-bound trains is 1.5 percent descending.

Due to the track being laid through a side cut on the west or inside of the curve in the immediate vicinity of the point of accident, the view of opposing trains is limited to less than 200 feet.
