REPORT OF THE DIRECTOR  
BUREAU OF SAFETY

ACCIDENT ON THE  
CLINCHFIELD RAILROAD

HUNTDALE, N. C.

INVESTIGATION NO. 2422

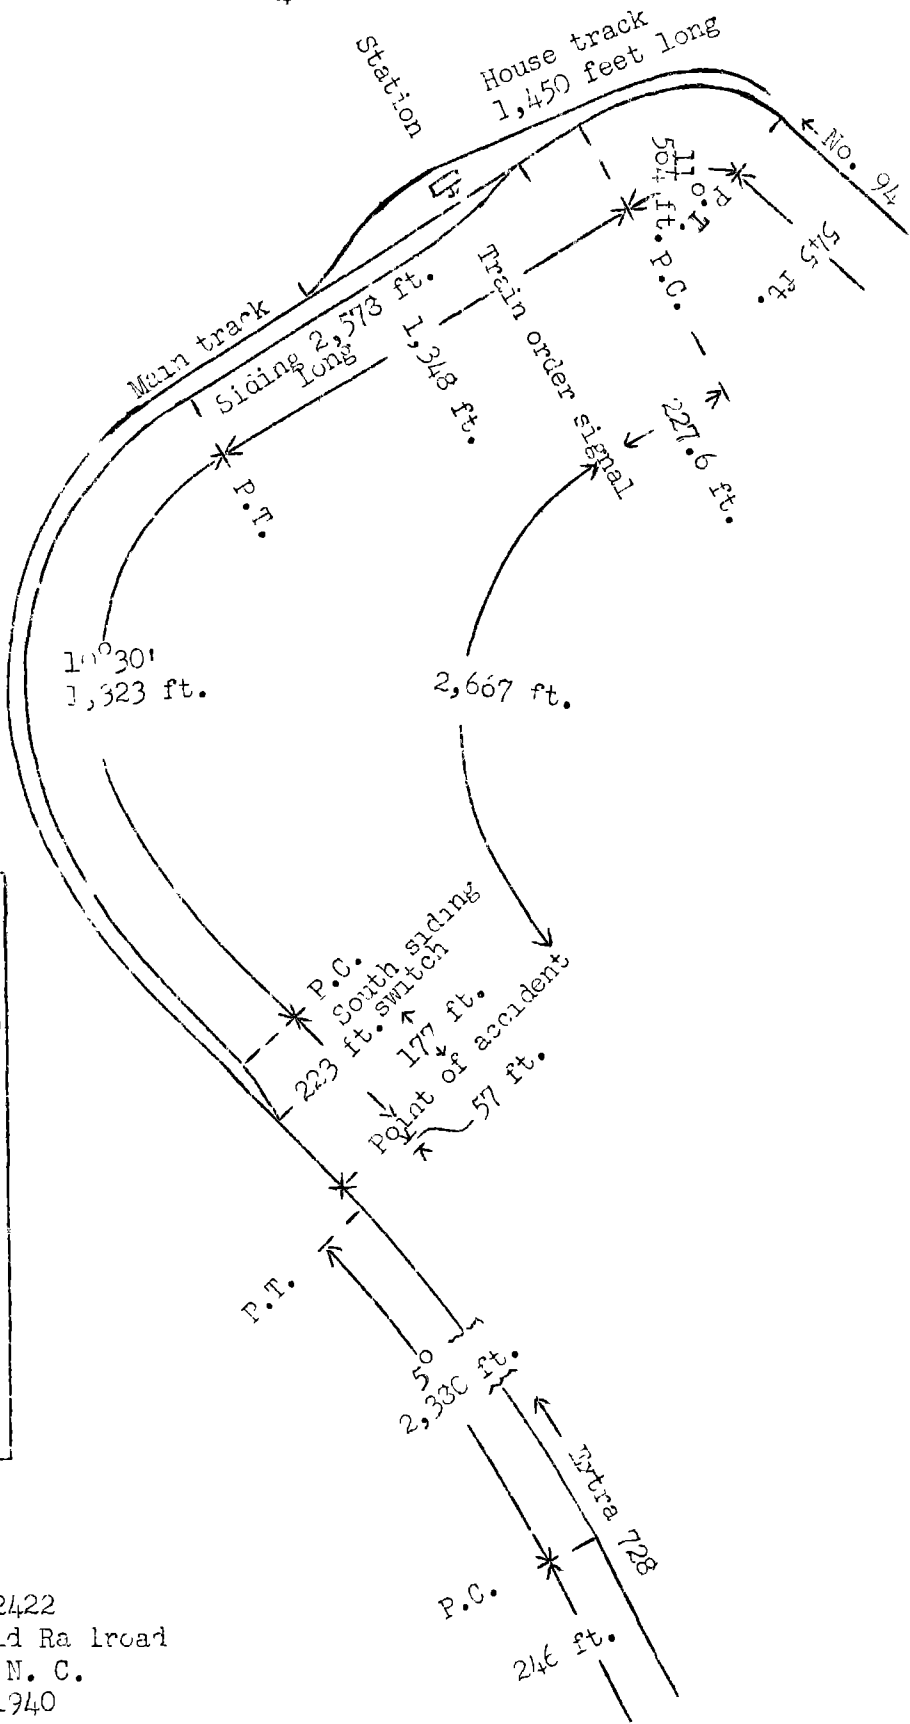
Inv. No. 2422  
 Clinchfield Ra road  
 Hunt Dale, N. C.  
 April 8, 1940

- Erwin, Tenn. 12.3 mi.
- Poplar, N.C. 4.4 mi.
- x Hunt Dale (P. of A.) 7.2 mi.
- Green Mountain 6.3 mi.
- Toecane 6.1 mi.
- Iunday 10.5 mi.
- Spruce Pine 5.0 mi.
- Ridge, N.C. 39.2 mi.
- Spartanburg, S.C.

This accident occurred on that part of the railroad which extends between Erwin, Tenn., and Spartanburg, S. C., a distance of 141 miles. In the vicinity of the point of accident this is a single-track line over which trains are operated by timetable and train orders; there is no block system in use. Time-table directions, which are north and south, are used in this report. In the vicinity of the point of accident the track parallels the east bank of the Toe River and is laid in a series of cuts. The accident occurred at a point 2,667 feet south of Hunt Dale station. Approaching from the north there are, in succession, a tangent 545 feet in length, an  $17^{\circ}$  curve to the left 564 feet in length, a tangent 1,348 feet in length, a  $10^{\circ}50'$  curve to the left 1,323 feet in length, and a tangent 223 feet to the point of accident and 57 feet beyond. Approaching from the south there are, in succession, a tangent 246 feet in length, a compound curve to the left 2,380 feet in length with a maximum curvature of  $5^{\circ}$ , and the tangent on which the accident occurred. At the point of accident the grade is 0.15 percent ascending southward.
