INVESTIGATION NO. 2854
THE COLORADO AND SOUTHERN RAILWAY COMPANY
REPORT IN RE ACCIDENT
NEAR DENVER, COLO., ON
DECEMBER 28, 1944

Railroad: Colorado and Southern
Date: December 28, 1944
Location: Denver, Colo.
Kind of accident: Rear-end collision
Trains involved: D. & R. G. W. : C. & S.
passenger passenger
Train numbers: 34 : 30
Engine numbers: 1524 : 350
Consist: 7 cars : 8 cars
Estimated speed: Standing : 10 m. p. h.
Operation: Operating rules and special
instructions
Track: Double; 6°30' curve; level
Weather: Foggy
Time: About 7:13 a. m.
Casualties: 18 injured
Cause: Failure properly to control speed
of following train moving in
restricted-speed territory

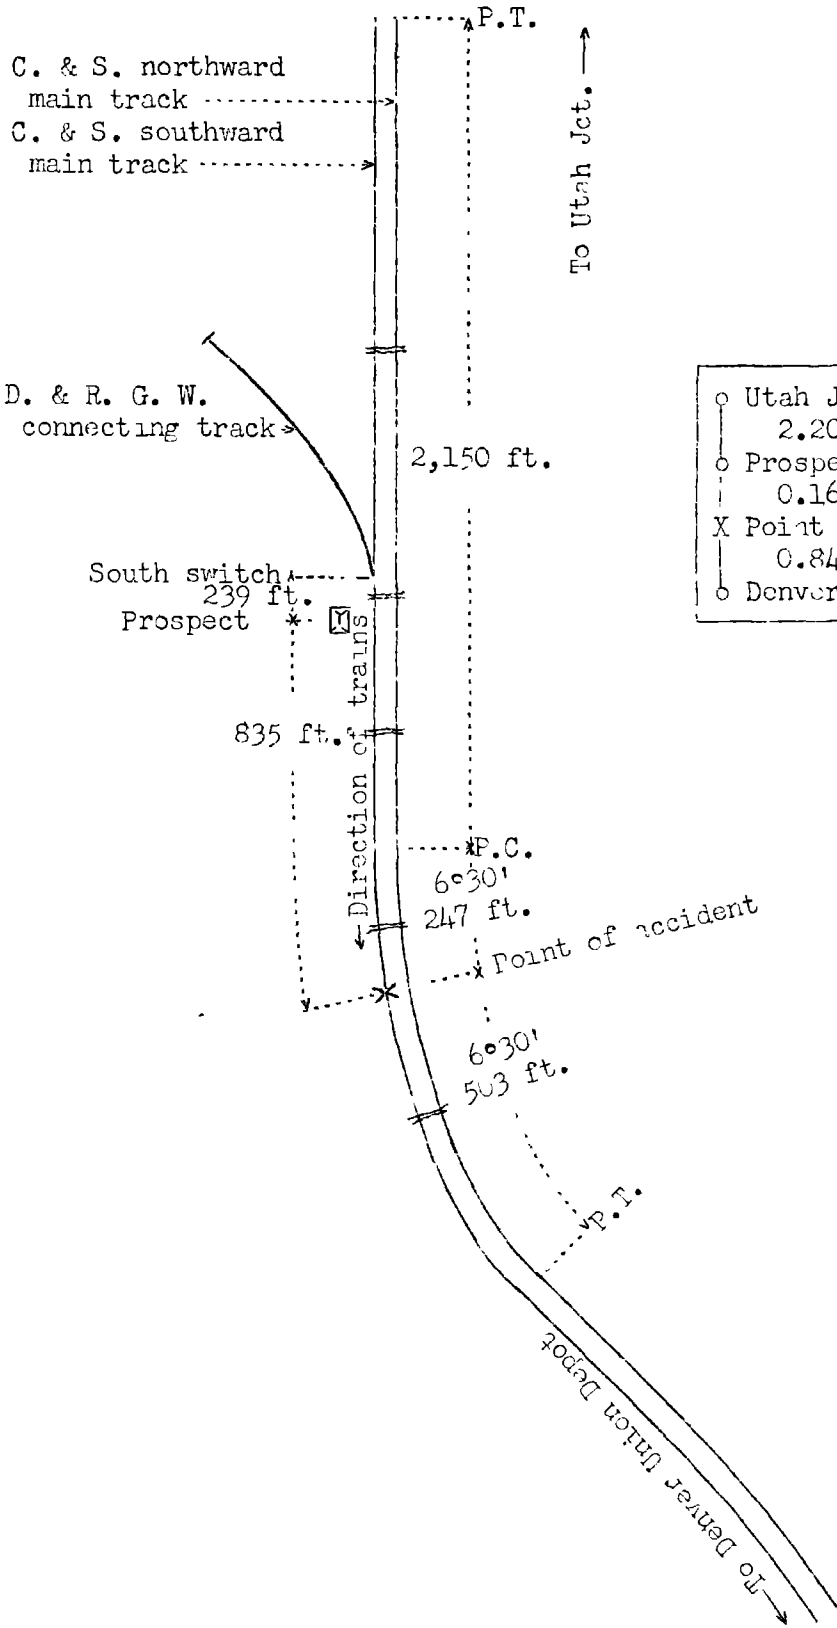
Inv. No. 2854
 Colorado and Southern Railway
 Denver, Colo.
 December 28, 1914

| o | Utah Jct., Colo. | 2.20 mi. |
| o | Prospect | 0.16 mi. |
| X | Point of accident | 0.84 mi. |
| o | Denver Union Depot, Colo. | |
